# Dike failures in the Carpathian Basin

László Nagy

Department of Geotechnics and Engineering Geology, Budapest University of Technology and Economics,  
Budapest, Hungary

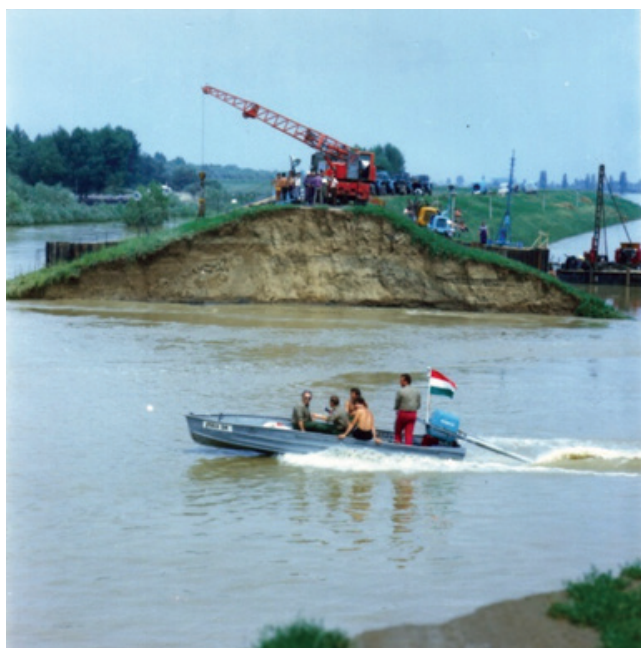
**Figure 4** | Dike breach in 1980 in the Körös valley  
Source: ABKSZ

Undoubtedly, most dike failure mechanisms (77% of all dike failures with known mechanisms) were due to erosion after the failure (see e.g. the cases in *Fig. 4, 6*). This failure mechanism means the occurrence of a water level higher than the design water level or the construction level of the dike (*Table 1*).

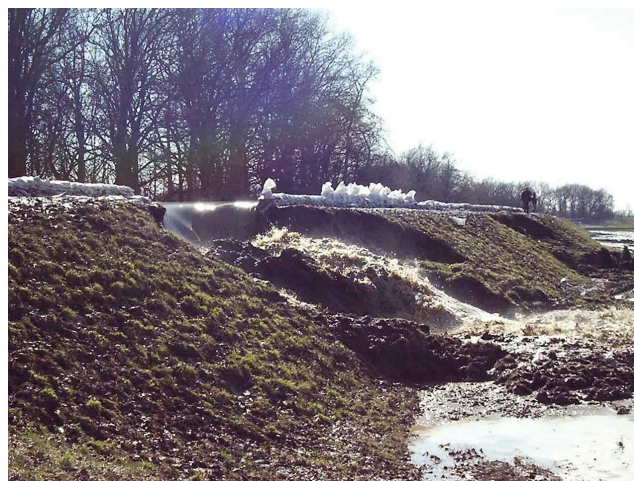
**Figure 6** | The beginning of the dike failure in 2001 at Tarpa  
Source: ABKSZ

The last dike failures on the Tisza were in 2001. In Hungary, the dike failed in three places, two of which came together. The location of one of the dike failures as an emblematic image of the flood is shown in *Fig. 6*. At the same time, 42 dikes failed on the Ukrainian side.

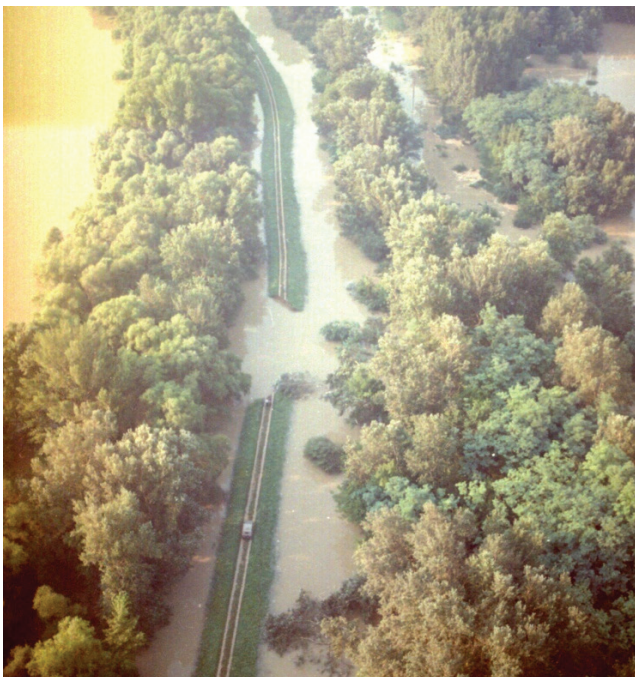
**Figure 9** | Dike breach at Surány (Danube right bank) 09 August 1991  
Source: ABKSZ
