FAILURE OF REMANUFACTURED GEARS

Béla CSORBA¹, Ferenc VÉGVÁRI²

John von Neumann University, GAMF Faculty of Engineering and Computer Science, Kecskemét, Hungary

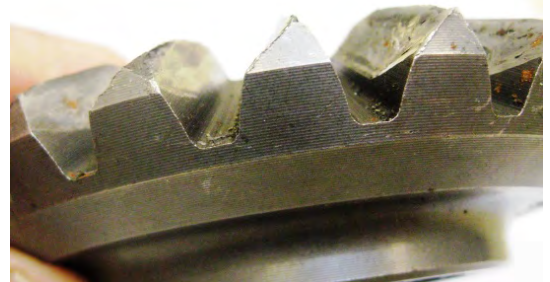
One very serious mistake is if the starting material is selected from non-alloy structural steel marked A50, A60 according to the old, or S355J2 according to the new marking system. This steel

does not belong to the heat treatable types of steel. The so produced gear can be good for geometry, but it is inappropriate for real use. **Figure 1.** shows a structural steel cone gearwheel made for general purposes which went wrong too soon. The teeth, after a short period of use became edgy and worn out.

Figure 1. Soon worn gear made of structural steel

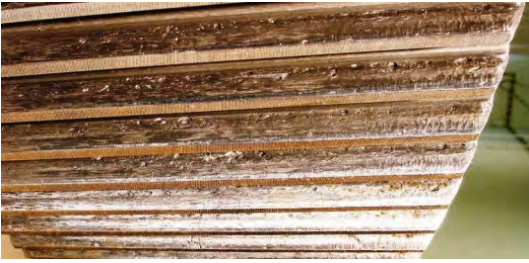
There might be problems even if we use heat-treatable steel of higher quality when heat treatment is abandoned or improperly performed. In **Figure 2**, a 132 kW Flender KENW 320 pump has a failed gear, after only 159 hours operating time. [1] The gear shown in **Figure 2** is made of material C60. In order to find bark thickness, Vickers hardness test was carried out perpendicularly to the tooth surface, the results of which are shown in **Figure 3**. The figure shows

Figure 2. Non-heat-treated gears made of C60 steel after 159 hours of operation

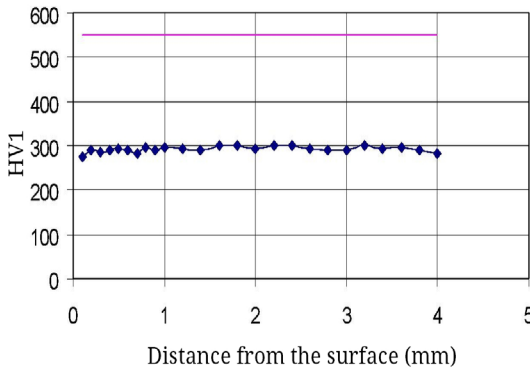
Figure 3. No hardened bark can be seen on the steel gear made of C60

that there was no bark on the surface. The measured 300HV1 hardness could be a normalized, possibly a very tempered structure.

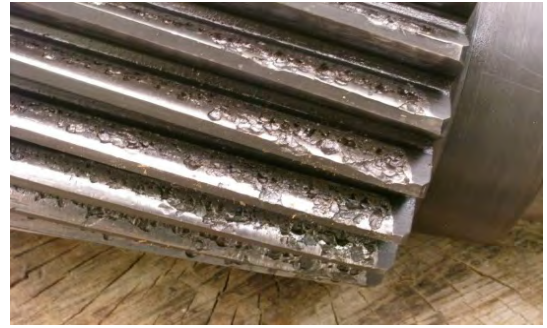
Gears can also be made of alloyed improvable steel. **Figure 4.** illustrates how - after 159 hours of operation - gear wheel with slanting teeth of the previously shown engine made of steel 42CrMo4 goes wrong due to heavy bearing.

Figure 4. Gear wheel with no heat treatment made of steel 42CrMo4 going wrong after 159 hours of operation

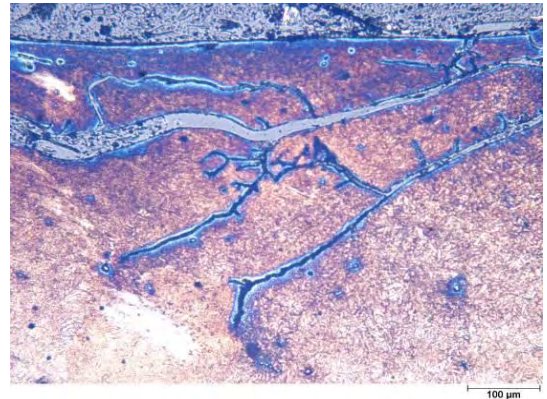
There was no bark thickness on the gear wheel. The hardness was 300HV1 here as well. There is a large pitting on the surface of the teeth resulting from surface fatigue due to high stress (Hertz-stress). This is well demonstrated by cracks from fatigue on the cut at the right angle to the surface. (**Figure 5.**).

Figure 5. Cracks caused by surface fatigue

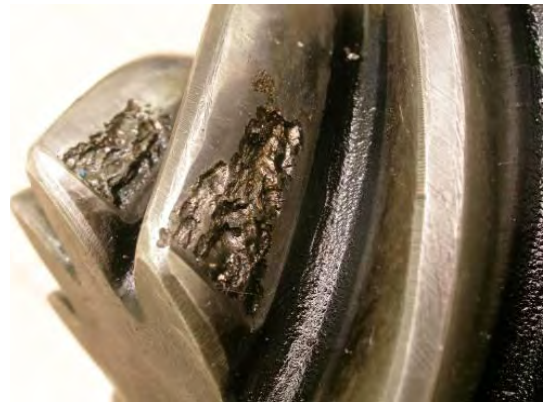
Figure 6. shows the failure of a trained insertion piece made of 16MnCr5 material. The part

Figure 6. Failure of stainless steel made of 16MnCr5 scraper within a one-week operation

running continuously did not reach a week without failure. The bark thickness achieved during insertion hardening was determined and measured (**Figure 7.**), giving a result of 0.85 mm.

The above mentioned planetary carrier was subjected to high surface pressure, and the stress on the surface is likely to exceed the permissible value of Hertz's stress, so it has been largely pitted

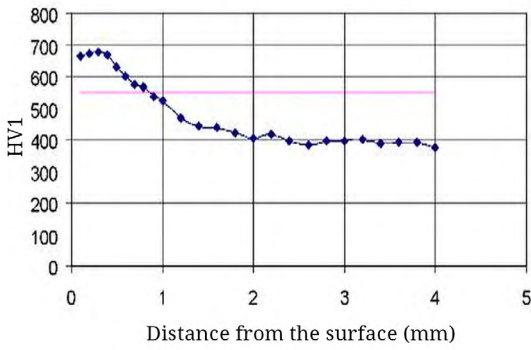
Figure 7. Bark thickness of planetary carrier made of 16MnCr5 steel

due to repeated en-durance. The bark thickness on the gear-wheel is at the lower limit of the bark thickness suggested for the 5 to 6 modules (0.8 to 1.2 mm). In addition to the increased surface stress, the teeth could not be evenly burdened along their entire length due to inaccurate manufacturing or assembly. The transmission of torque was only subject to ~ half the length of the teeth.

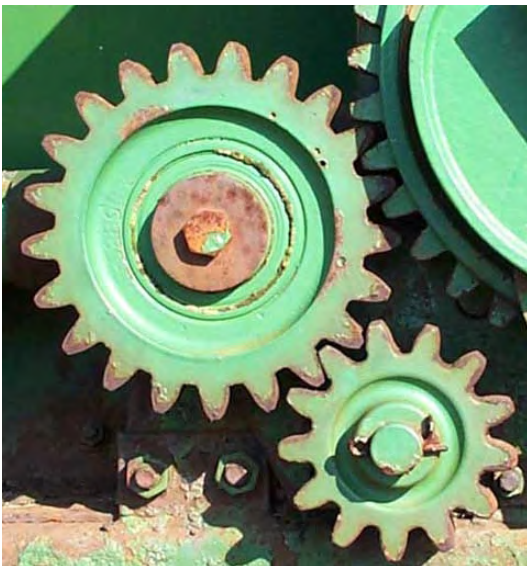
Agricultural machines quite often work in very harsh conditions. Sprockets are exposed to weather conditions, precipitation, dust, etc. again and again. In the absence of lubrication, they soon get worn (Figure 8.). In many cases the gears in the protected area also operate in a very dusty environment.

Figure 8. Outbound Gears of Agricultural Machinery [3]

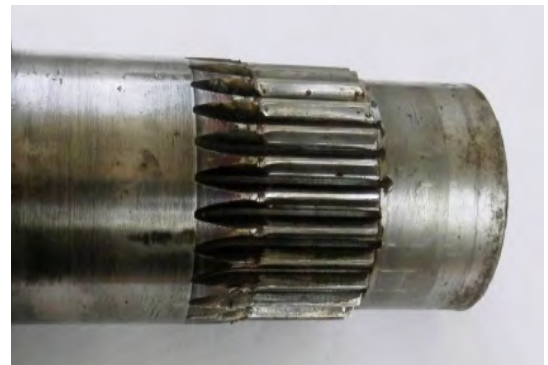
Renewing gears on agricultural machines also lacks occasionally the expertise or responsibility. The ribs of the rib shaft shown in Figure 9. got pointed after a few hours of operation. The particle grinding revealed that the defective ribbing was improved by welding (Figure 10.). The hardness of the welded part is only 220 - 230HV0.2.

Figure 9. Agricultural machine after repairing its sharpened toothed shaft

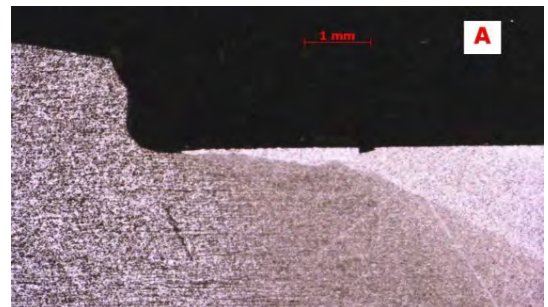
Figure 10. The toothed shaft was repaired by welding
