# Damage Analysis of Broken Orthopedic Implants

## Abstract

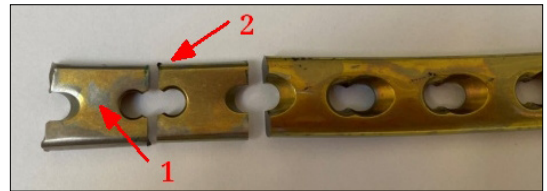
Figure 3. The distal part of the bone fixation plate after dissection. Slice with fracture surface number 1, number used for metallographic and hardness tests 2.

As a result of visual inspection, small and large surface scratches and injuries were clearly visible on the surfaces of the implants. These are presumably generated during removal and are not associated with damage. In the case of the plate, the wear of the anodized layer was conspicuous (Figures 2, 3).

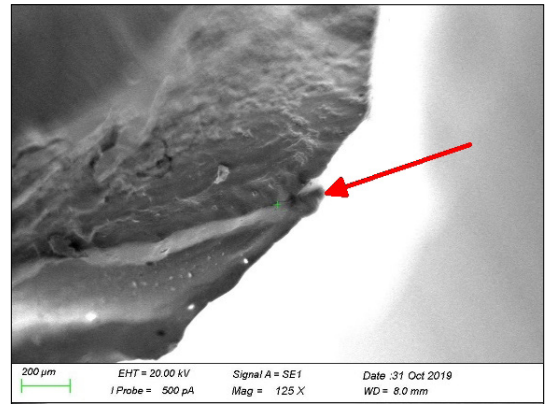
The characteristics of fatigue fracture could be clearly seen on the surface of the samples. Bone cortex remains were not wedged on the fracture surface. In the case of the fixing plate, crack lines starting from the screw thread could be observed (Figure 4). From the surface of the stems, it can be assumed that the fracture was a longer process, the two stems did not break at the same time. On the surface of one stem of the plate there is a plastic deformation due to prolonged impact of the material, while on the other part of the stem the crack propagation characteristic of fatigue fracture is not visible, but rather indicates a brittle fracture. (Figure 5).

**Figure 4.** In this case, too, we thought we would discover the characteristics of a fatigue fracture.

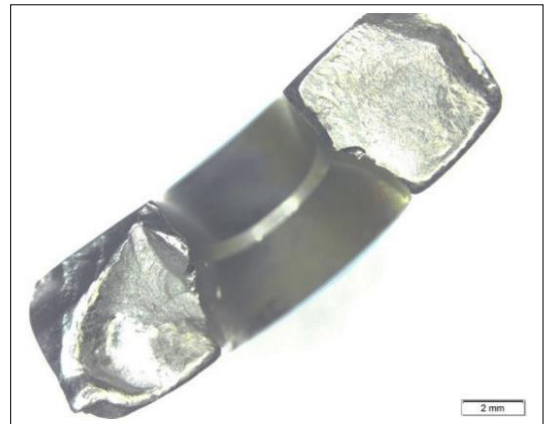
**Figure 5.** Stereomicroscopic image of the fracture surfaces of the bone fixation plate.

In the case of the fixing plate, the cracks that started the fracture came from the screw surface. From the fracture surface, it can be concluded that the two parts did not break at the same time, as a large amount of plastic deformation could be observed on one of the stems, which can be attributed to the continuous collision of the fracture surfaces. The cause of the fracture may have been a scratch caused by a piece of bone, or even excessive tightening of the screw. In the case of the hip implant, the cause of the fracture is unknown. Cracks running to the surface may have been a possible starting point for the fracture. Even during surgery, the surface may have been damaged, causing the implant to break in the long run.

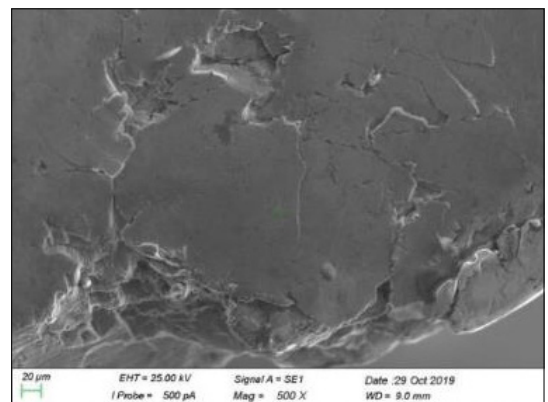
In the case of the prosthesis, several cracks could be observed on the fracture surface that ran to the surface (Figure 6). In this case, too, we thought we would discover the characteristics of a fatigue fracture.

**Figure 6.** Electron microscopic image of the fracture surface of the hip implant. Multiple cracks can be observed at the surface edge.

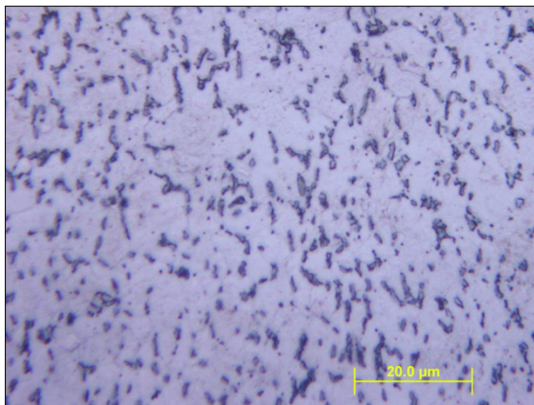
Metallographic examination of the plate revealed that it had a fine-grained, homogeneous grain structure, containing fine and well-dispersed precipitates, which improve significantly the strength (Figure 7). The screw securing the plate was also subjected to metallographic examination. The grain structure was the same as the plate structure.

**Figure 7.** Microstructure of the bone fixation plate; it shows the fine and dispersed precipitates.

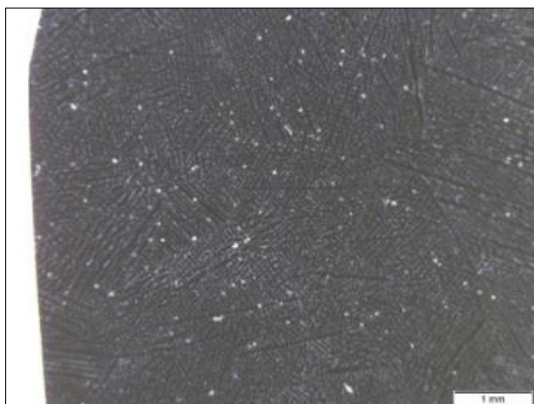
The granular structure of the hip implant was dendritic, which is not conducive to the propagation of cracks (Figure 8). On the electron micrographs, we observed that the fracture lines ran between the dendritic spikes.

**Figure 8.** Dendritic micro-structure of the cast material of the hip implant.
