Comprehensive analysis of local corrosion degradation on austenitic pipeline

To cite this article: P Trampus *et al* 2018 *IOP Conf. Ser.: Mater. Sci. Eng.* **426** 012050

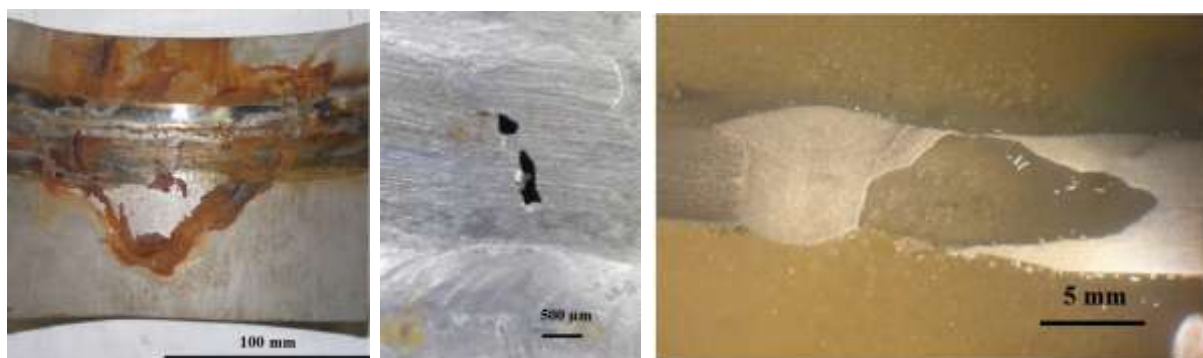
After 26 operating years, leakage was observed in the spent fuel pool cooling system at the Paks Nuclear Power Plant, Hungary. The cooling medium is boric acid with a concentration of $> 14.5 \text{ g}\cdot\text{dm}^{-3}$, and average temperature of $\sim 30^\circ\text{C}$. Two parallel loops operate alternately. Results of the immediate non-destructive examinations and subsequent comprehensive investigations made it clear that the leakage was caused by pitting corrosion on the inner surface of the cooling system pipelines. Some of the pits penetrated through the whole wall thickness. The structural material of the pipelines is Cr-Ni-alloyed, Ti-stabilized austenitic stainless steel (08Ch18N10T, nearly equivalent with steel 1.4541). The diameters vary from 100 to 300 mm; the wall thickness range is 6 to 10 mm. The pipes were laid down in concrete which made their investigations and subsequent replacements difficult and time consuming. *Figure 1* shows a through-wall pit detected by visual inspection and ultrasonic examination as well (left: corrosion products around a circumferential weld; middle: two pits after cleaning and decontamination; right: cross-section with the through-wall damage).

Figure 1. Pitting corrosion around the welded joint – pipe: Ø 219x10 mm (left: as is, middle: after cleaning, right: cross-section with the inside down)

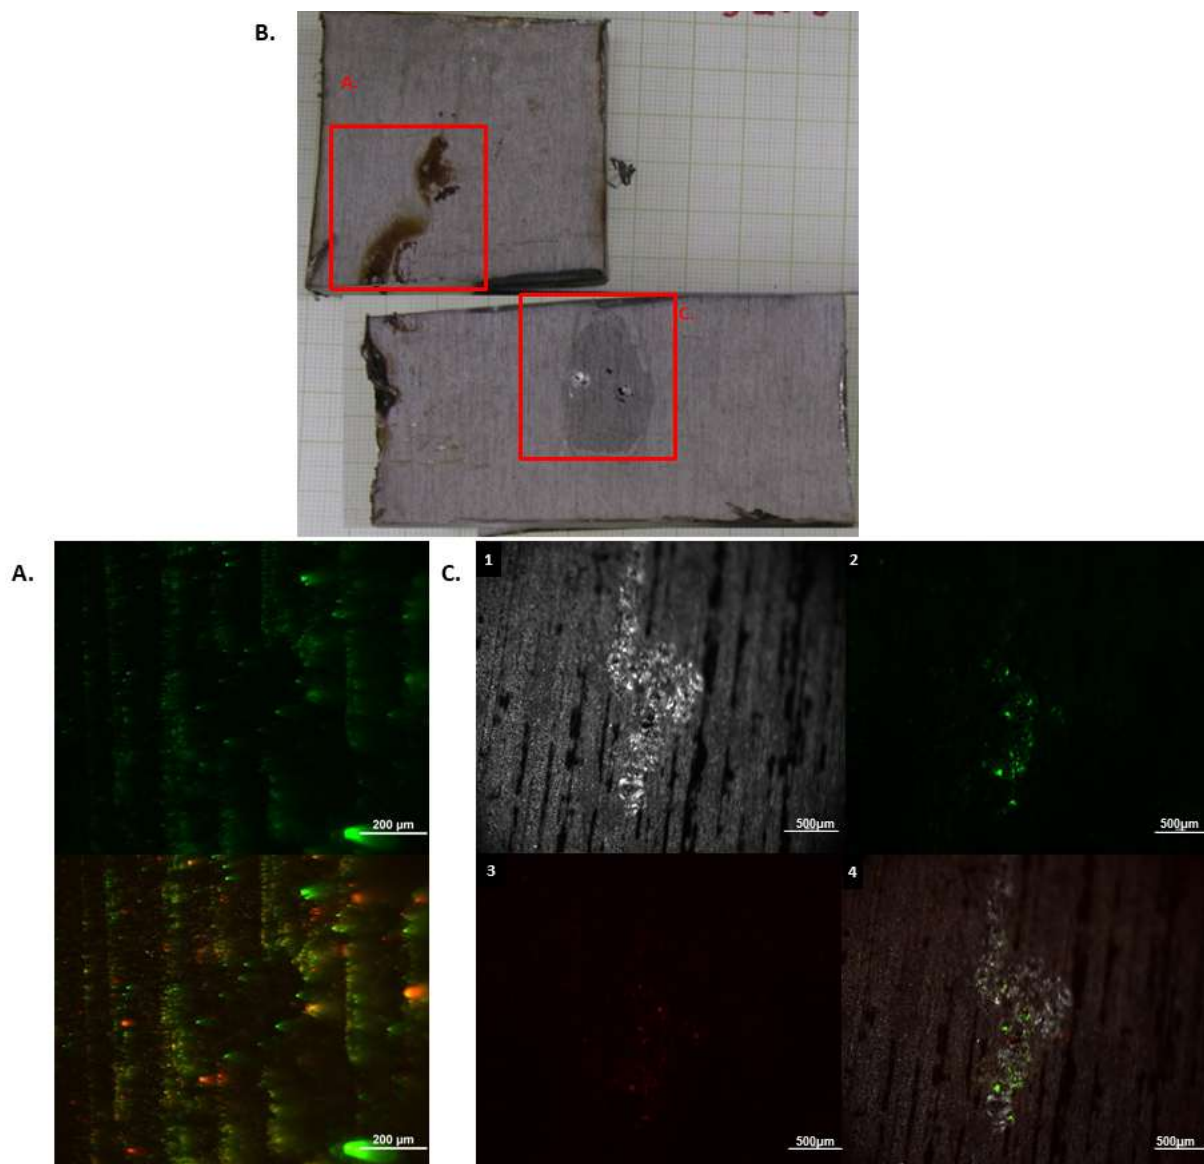
3.1.1. Effect of microbes on the corrosion phenomena. Over a two-year period, we were monitoring biomass changes in the bulk medium and found that most of the time the biomass was in the range of 10^2 - 10^3 ME·mL⁻¹, sometimes increasing up to 10^4 ME·mL⁻¹ (ME = microbial equivalent, cells). Next generation sequencing of the bulk medium revealed that the majority of the microbes is *Ralstonia pickettii*, a mixotrophic species viable in ultrapure water [2, 3]. It can live in an autotrophic manner by using only H₂ as a sole source of energy and CO₂ as the sole carbon source. It is known to produce extracellular polymer material, a matrix needed for biofilm development. The sequencing revealed members of the *Desulfobacteriaceae* and *Desulfovibrionaceae* family, members of the *Burkholderia* family, the *Sediminbacterium* genus that have been implicated in iron oxidation [4], as well as the acid producing *Acinetobacter* genus [5] that has been shown to be a pioneer bacterium in biofilm development [6, 7]. Although the amount or the type of microbes present in the bulk fluid does not represent microbes on the surface, the results suggest that *Ralstonia pickettii* together with other *Ralstonia* species might initiate biofilm development in the presence of boric acid. Biological activity reaction test (BART) [8] performed on corrosion products collected from the bottom of the pipes revealed the presence of both iron oxidizing and iron reducing bacteria, heterotrophic micro-organisms, slime forming bacteria, as well as acid producing bacteria. Sulfate reducing bacteria were not detected. Corroded areas were analyzed by fluorescence staining to visualize live and dead cells inside the pit after cleaning (*Figure 2C*) and on corrosion deposit (*Figure 2A*).

Figure 2. Fluorescence staining of corroded stainless steel.

A. Live cells (upper) and merged image (lower) of corrosion products; B. The corroded surface; C. (1) bright field image, (2) live cells, (3) dead cells, (4) merged image

The pit had a shiny metallic surface (*Figure 2B*: lower picture) suggesting an active corrosion mechanism, and live/dead stain revealed microbes inside the pit but not outside (*Figure 2C*).

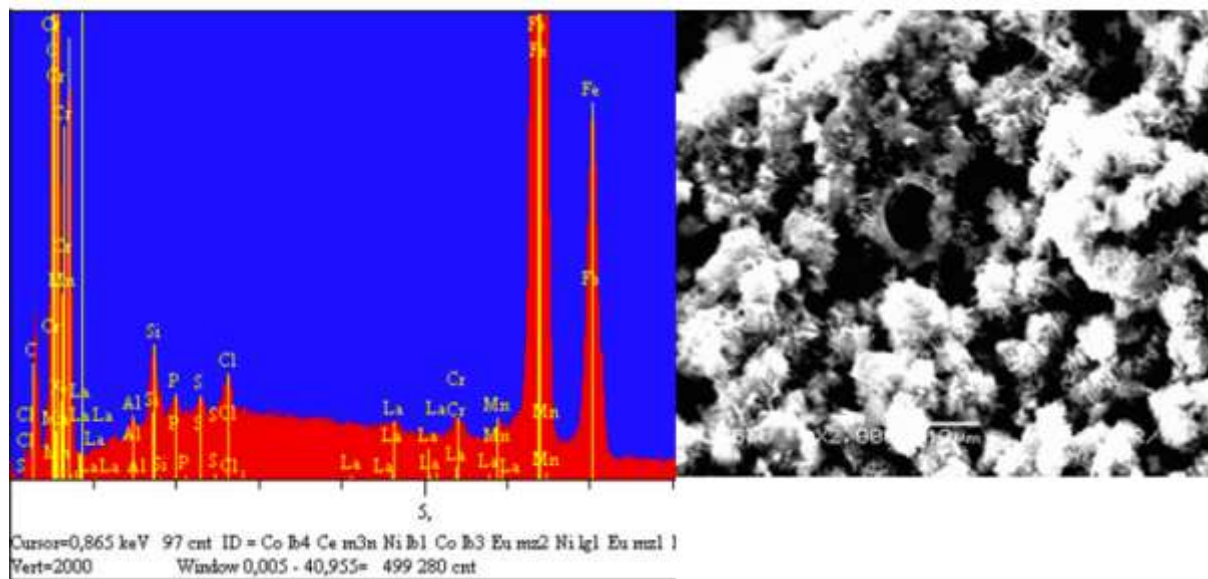
A SEM/EDX analysis at another corrosion site revealed phosphorus, sulfur and carbon that may be indicative of microbial presence at the site of corrosion. Left picture (SEM) in *Figure 3* shows the pit and the porous corrosion product around it; on the right side the EDX spectrum can be seen.

Figure 3. Porous corrosion product (inset) and its EDX-spectrum

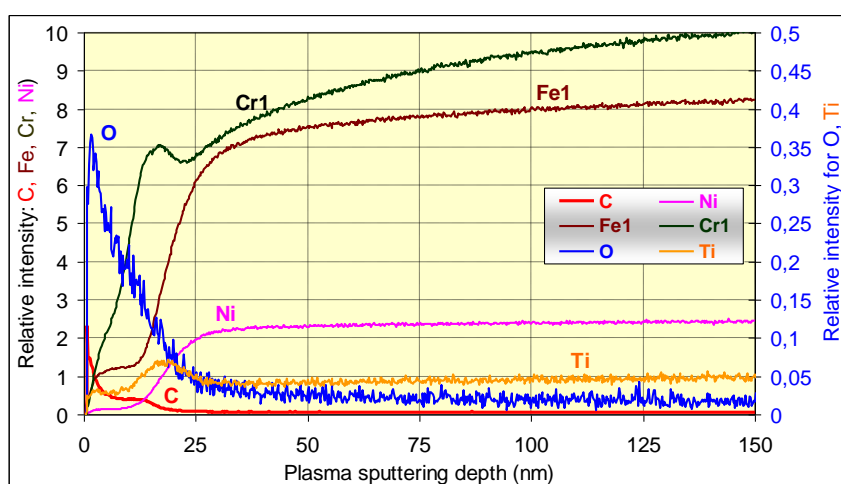
The glow discharge optical emission spectroscopy (GD-OES) is capable of measuring the layer's thickness and determining its tentative chemical composition. In *Figure 4* the GD-OES intensity measured on the transition to HAZ can be seen. First of all, the oxygen content and the distribution of Ni, which has a low inclination to migrate can indicate the boarder of the oxide layer with the thickness being approximately 10 nm. In the middle of the HAZ the thickness approaches 50 nm while on the normal surfaces the passive layer thickness does not exceed 3-4 nm. Intensity of Fe, Cr and Ni

Figure 4. GD-OES intensity of various elements as a function of the sputtering depth, on clean surface

reaches the value characterizing the base material at this depth. The oxide layer's composition is detrimental from the corrosion's point of view because it contains less Cr than the normal passive layer

and has a less beneficial Cr-oxide/Cr and Cr/Fe ratio. On the other hand, during the evolution of the thicker oxide layer more Cr will be detracted from the area beneath the scale than in the case of a normal passive layer.

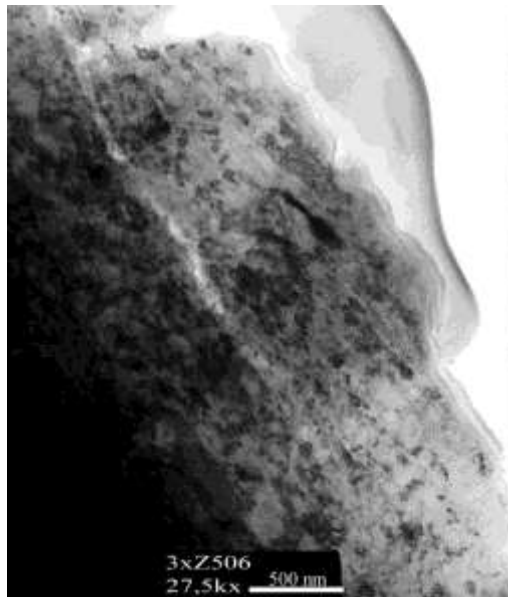
Similar oxide layer thickness could be identified by transmission electron microscopy (TEM). On a segment perpendicular to the surface, the glue indicates the outer surface of the sample, see *Figure 5*, and immediately under it an amorphous oxide layer is visible with a thickness of 50–100 nm.

Figure 5. TEM picture of the welding scale covered thin foil

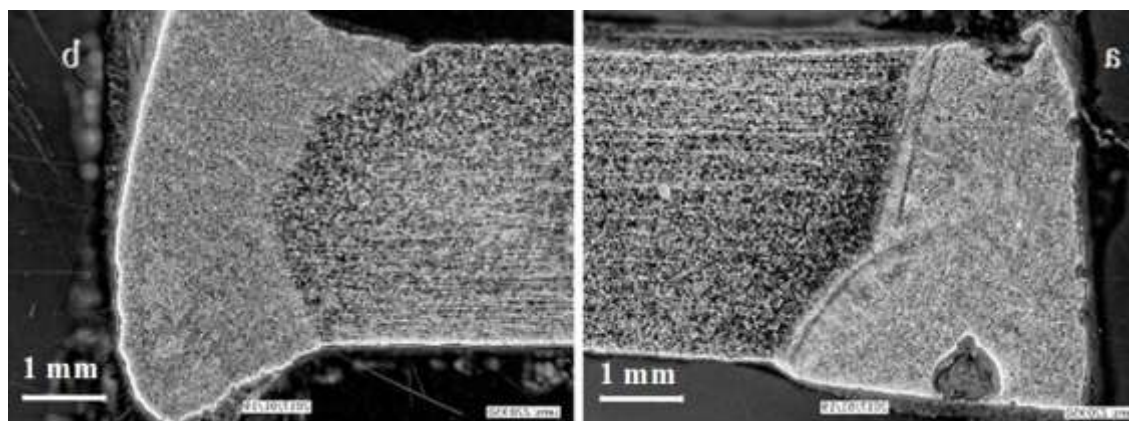
intensive degradation supports the hypothesis that root protection has significant impact on the corrosion sensitivity of the welds. *Figure 7* shows the sample welded in accordance with WPS but without root protection. Pits can be seen both on the weld face and at the root in the sample tested at 50°C. The latter demonstrates the influence of the temperature. Significantly more corrosion products were formed when the solution contained MIC bacteria compared to a non-MIC environment.

Figure 7. Test at 50°C, in 3.6 % FeCl₃ (a); at room-temperature, in 6 % FeCl₃ (b)
