Failure Analysis of a Damaged Turbocharger

János DOBRÁNSZKY

1. The damaged equipment

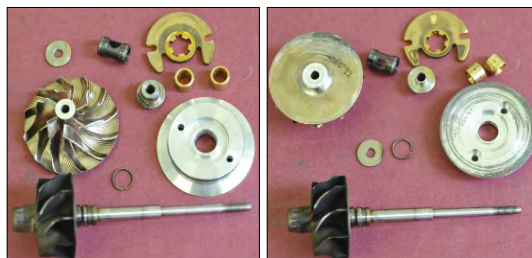
Figure 1. Parts of the internal assembly of the failed turbocharger; the total length of the turbine + shaft assembly is 120 mm.

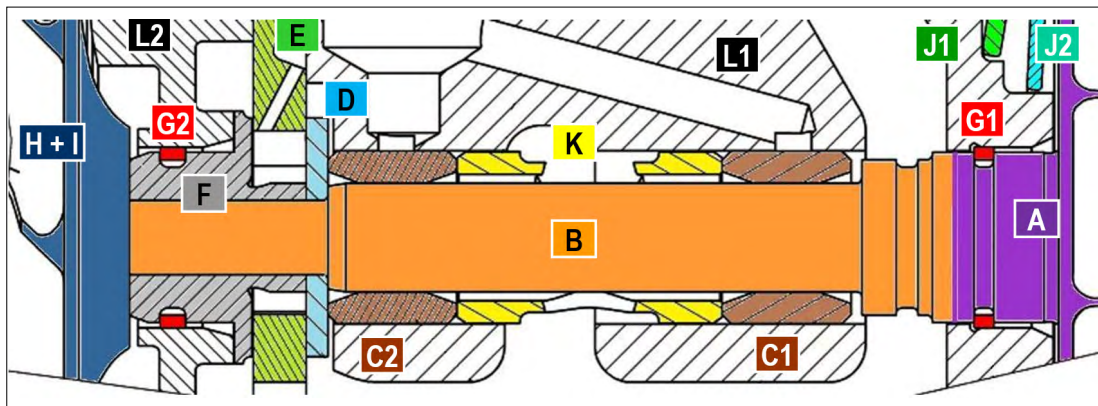
Figure 2. Internal assemblies the turbocharger: A = turbine wheel, B = shaft, C = bearing, D = thrust ring, E = axial bearing, F = sealing bush, G = labyrinth ring, H = back plate, I = compressor wheel, J = heat shield plate (belleville spring), K = journal bearing spacer, L = housing.

Damage to the turbine-side labyrinth ring groove and labyrinth ring (G1 and G2 in [Figure 2](#)) is usually key, but in this case the wear on the parts in question was not significant.

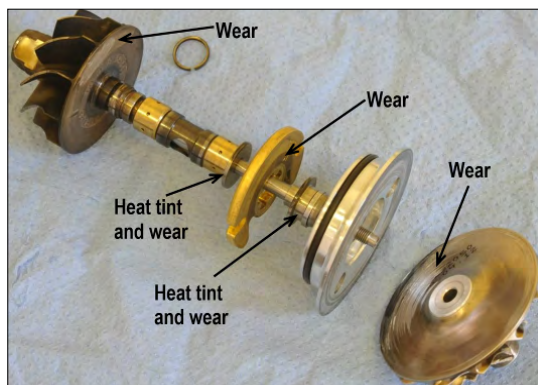
Based on **Figure 2** it is easy to see that it is an extremely complex device consisting of many components, the operating stress of which should be known as it can operate at tens of thousands of revolutions per minute. **Figure 3** shows the assembled internal assembly; the damage locations and modes detected by visual inspection are marked in the figure.

From the wear shown in **Figure 3** it can be concluded that the axis of rotation of the moving parts of the turbine has tilted, and because of this, the moving parts have come into contact with the fixed or stationary parts. In the case of possible wear, the possibility of contact with opposite surfaces of the housing casting must be mentioned. The customer of the damage analysis did not hand over this component for testing, so there is no data on it. Nevertheless, it is not at all excluded that the parts that are clearly visible in **Figure 2** close to some of the surfaces of the housing have experienced friction and wear.

Figure 3. The internal fittings of the turbocharger are loosely assembled.

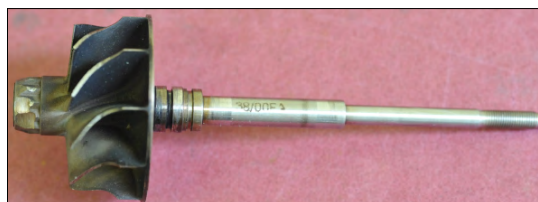
Figure 4. The welded turbine and shaft.

and **6** which show signs of wear on the faceplate and shaft of the turbine

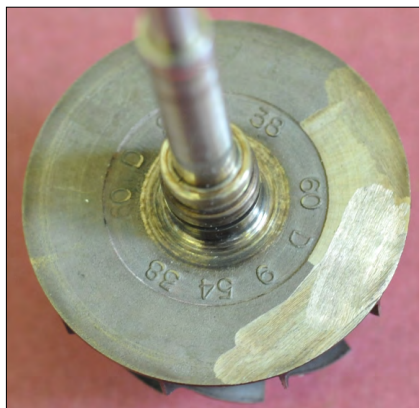
The damage to the turbine wheel shown in **Figure 5** on the blade holder base plate is conspicuous. The wear is only around the circumference of the circular base plate. It extends to a third, but it is strong there. Since the surface is almost completely clean, it can be assumed that the turbocharger was not in operation or only for a very short time after the breakdown leading to wear. Another element of the wear process was presumably the opposite surface of the heat shield and/or the turbine housing.

Figure 5. Wear traces on the turbine wheel.

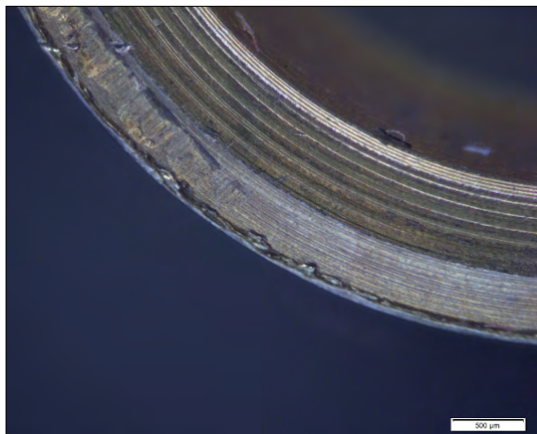
A burr can be seen on the front of the cylindrical ring of the bearing bushings (**Figure 7**).

Figure 7. Traces of burr formation on the bearing.

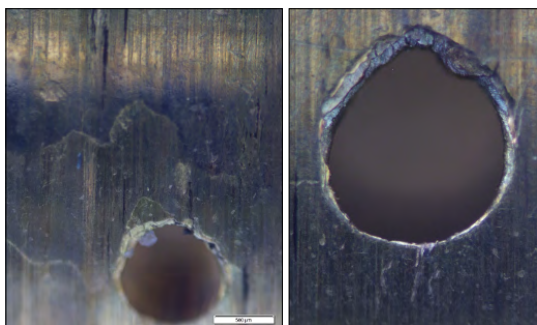
The formation of grey spots on the brass material is noticeable both on the outer and inner surface (**Figure 8**). According to the EDS analysis, the spots are material smears, the material of which is mainly Fe, Cr, Ni, in some places Sn and Pb. A change of shape indicating a strong heating of

the edge can be seen in the holes, and in some cases partial blockage.

Figure 8. Wear of the bore rim on the bearing.

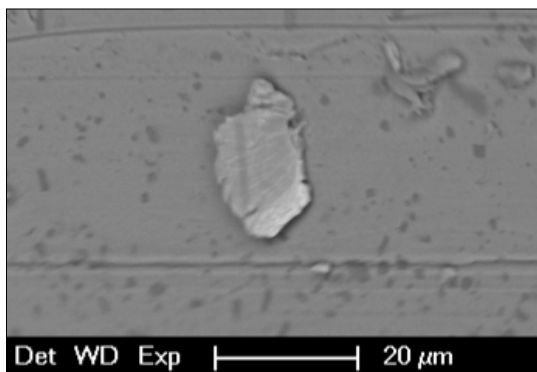
The piece of material shown in [Figure 9](#) was attached to the inner surface of one bearing. Based on the EDS analysis, it could be identified as austenitic steel: Fe-1.7Al-2.7Si-1.9Mo-16.9Cr-2.5Mn-9.4Ni.

Figure 9. A chip stuck to the bearing surface.

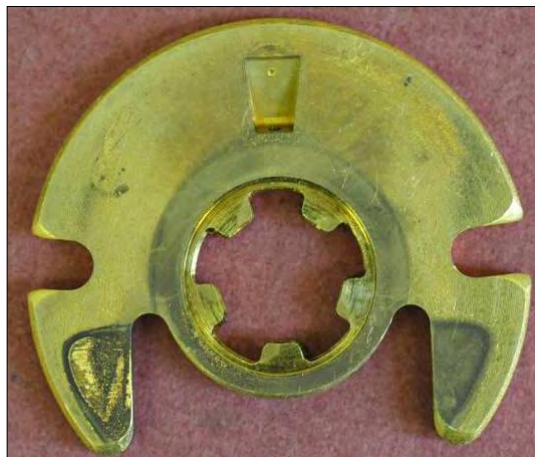
Figure 10. Wear marks on the axial bearing.

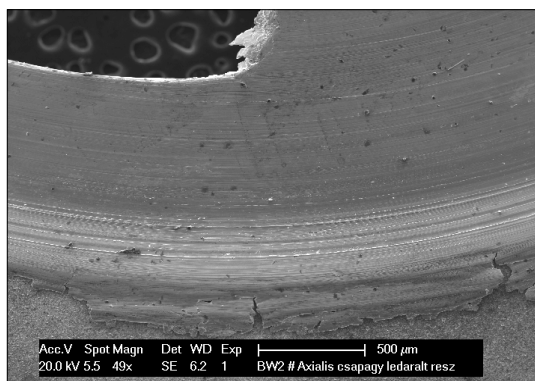
Figure 11. Wear marks on the support bearing.

The wear marks on the support bearing ([Figure 10](#)) can be seen in [Figure 11](#). Rough wear grooves formed on the surface, squeezing the upper material layer out of the contact surface as a burr.

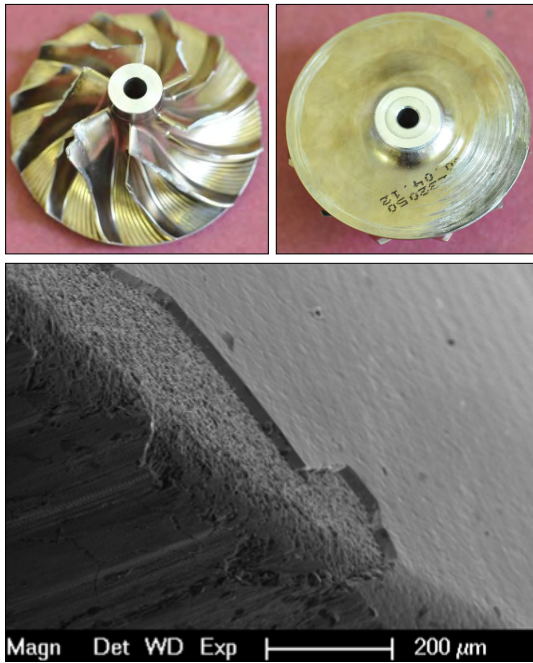
The material of the compression wheel shown in [Figure 12](#): Al-2Mg-2Ag-1Fe-2Ni-3Cu-0.1Zn-0.2Ti-0.35Si-0.1Mn; coating material: nickel alloy with ~10% phosphorous. The most typical mechanism for the wear process is the cracking and flaking of the brittle coating

Figure 12. Wear marks on the compressor wheel.
