## THE ROLE OF METALLOGRAPHY IN THE RESTORATION OF AN INCENSE BURNER FROM PERSIA

**Abstract:** Before the restoration of a metallic object, detailed analysis of the metal and the microstructure could provide useful information about the techniques used for producing it. Additionally, it is possible to obtain data about the metal and the object, which expands the knowledge about the origin of the object and its raw material. This study introduces this field through the metallographic analysis of an incense burner from Persia, from the Quajar period of the 19<sup>th</sup> Century Iran. The results of the metallographic investigation are not only used for the restoration work but also for archaeometry and archeology. The burner was made from a heterogeneous brass alloy. The antecedents of the burner were unknown so local heating was applied to avoid the brittle breakages. Selenium content was detected in the sulfide inclusions which shows a Near-East origin of the raw material.

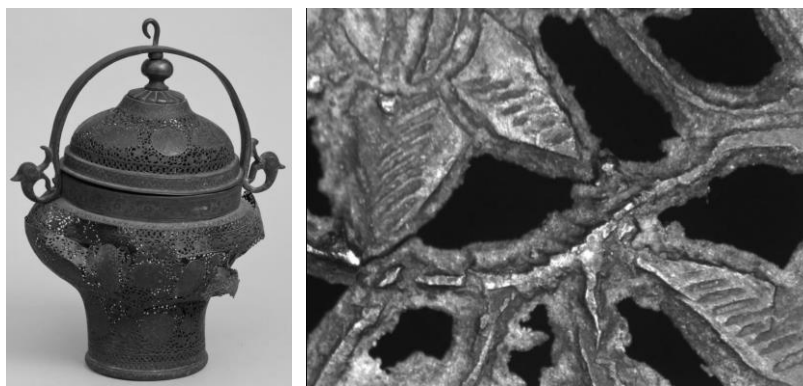
**Figure 1**

*The examined incense burner and the lace like broken part in larger magnification*

As visible on *Figure 1*, the lace-like part of the burner is broken. The larger magnification shows the fine structure of this lace-like part. Elements with small cross sections hold the top of the burner. The picture suggests that this is a carved and inwrought part. A small piece of the material was removed and analysed with SEM-EDS. *Figure 2* shows the micrograph of this part.

The metallography of a small part of the burner revealed that the raw material of the burner is heterogeneous brass with some small-sized lead and sulfide inclusions. The possible manufacturing of the damaged lace-like part is: 1. casting a plate, 2. preparing the carved and inwrought pattern, 3. heat-treatment. The alloy could be brittle based on the chemical composition and the possible manufacturing method. A short-term local heat treatment was applied (~450 °C) before the bending of the material in the damaged parts. The extensions were made from common brass (C26000). The chemical composition of wire brass (C27000) is closer to the burner, although it has a higher tensile strength, and acts like a spring. The cold-rolled state was used for carving. First soldering was planned to fix the parts in the damaged area, but the structure was too fine for a successful application. Finally, sticking was used. Special high strength glue was applied due to the possible remaining elastic stresses.

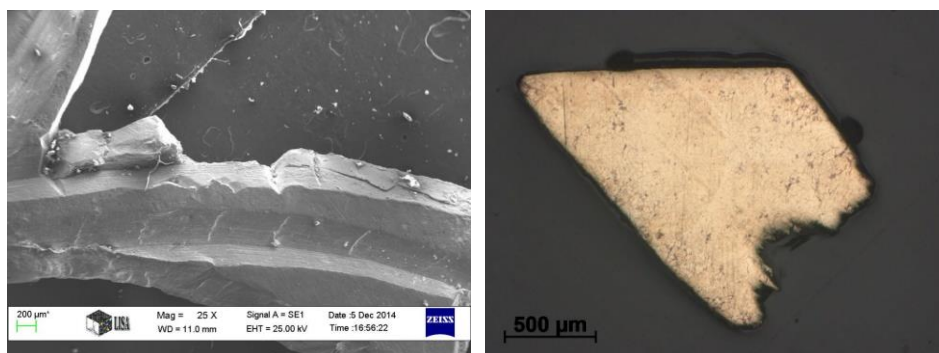
**Figure 2**

*SEM micrograph taken from the examined part of the burner (left) and the prepared cross section of this sample (right)*

The SEM micrograph of *Figure 2* clearly reveals the traces of carving, so this is the necessary technique of production and ornamenting the extensions. The surface of the sample was analysed. The analysis shows that the sample is brass with 30 w% zinc content. Additionally, 1 w% silver and extremely high 8 w% lead content was measured. Consequently, in the following tests, the sample was handled as brass. The lead content on the other hand was too high, so the cross section must be analysed as well to compare with the surface for identifying the extent of the corrosion. The corrosion process causes the segregation of lead to the surface of the metal.

The SEM –EDS analysis of the cross section of the sample shows 35.5 w% zinc content and 0.5–1 w% lead content. Silver was not detected in the bulk. This large difference of the lead content at the surface and the bulk shows a strong corrosion, which was not trivial at the first observation of the burner. As a result, the cleaning of the surface was necessary during the restoration. The zinc content suggests inhomogeneous brass which can be seen on *Figure 3*. The  $\beta$  islands and pins exist in an  $\alpha$  matrix. The pins of  $\beta$  draw the dendritic structure of the raw material. This suggests a cast raw material. On the microstructure of *Figure 2*, the heterogeneous structure, where the top and the bottom of the sample contains more  $\beta$  than the central area of the cross section, can clearly be seen. This shows that a thin plate was cast, and this

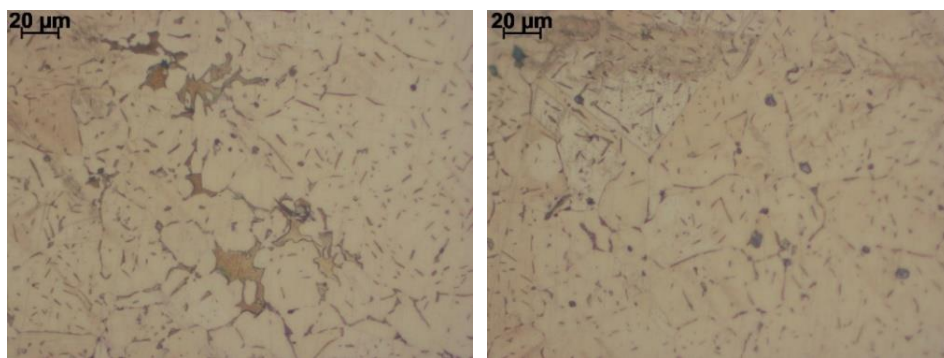
**Figure 3**  
*Optical micrographs from the microstructure of the burner*

plate was then manufactured. The large cooling rate caused the segregation at the surface area. This is supported by the dendritic-like structure as well. The differential interference contrast (DIC) micrographs of the sample (*Figure 4*) reveal the twin boundaries and small grains, which are typical after the recrystallization process. These can be observed mainly near the surface. The carving creates plastic deformation, and the microstructure shows that the material was heat-treated, annealed after carving. The fast cooling can produce brittle brass due to the  $\beta$ - $\beta'$  transformation, and annealing can increase the ductility of the material.

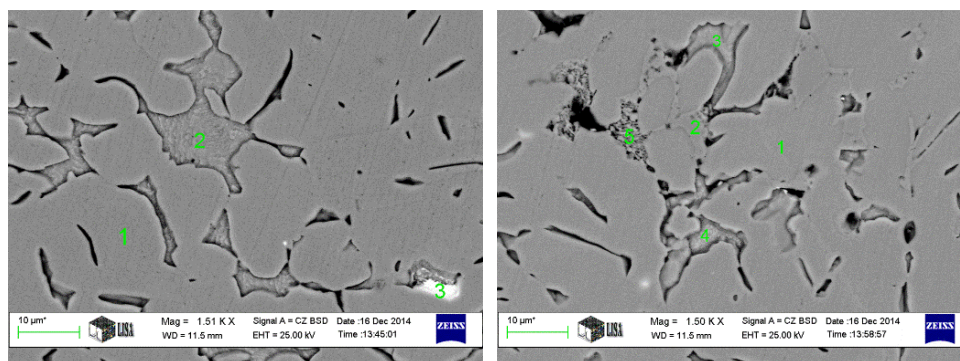
**Figure 5**

Next to the  $\beta$ , other phases-inclusions were revealed by the optical microscopic observation. Therefore, a detailed SEM-EDS analysis was performed. *Figure 5* shows the SEM micrographs, where the different analysed phases are marked with numbers. The left image shows the typical appearance of  $\alpha$  (1) and  $\beta$  (2) phases. The  $\alpha$  phase contains 35 w/w% zinc while the  $\beta$  contains 45.3 w/w% zinc. The right image

also shows the  $\alpha$  (1) and the  $\beta$  (3, 4) phases with the same composition. It is interesting that the microstructure contains pure copper (2, 5) which shows that the alloying of the raw material was not properly performed. Comparing the above information with the plausible manufacturing method, it is possible that the alloy was produced only for this object.

On the left micrographs of *Figure 5*, number 3 denotes the lead inclusion. It is white in the SEM micrographs due to the larger atomic weight related to the surrounding. These inclusions appear to be pure lead, the copper cannot solve the lead either in liquid or solid state. Therefore, the lead forms smaller or larger drops during solidification, and solidifies in this form at the beginning of the cooling of the melt. *Figure 6* shows this in larger magnification, and the analysed drops are denoted by 1. Number 2 denotes phases in both micrographs, where the local chemical analysis detected a high content of selenium.

*Different kinds of phases and the positions of the local chemical analysis in the microstructure of the sample from the burner*

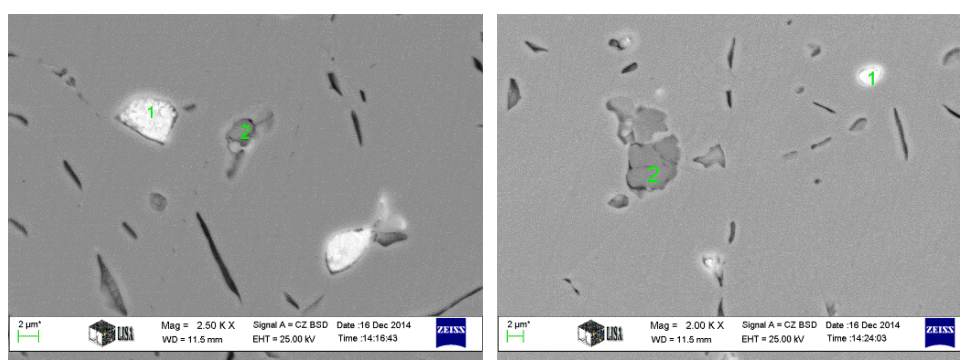
**Figure 6**

*Positions of the local chemical analysis of selenium containing inclusions, and their morphology*

These phases are basically copper-sulphide inclusions from the smelting process. Additionally, beside the sulphur these contain 9 w/w% selenium too. The sulphur and the selenium are chemically compatible and can substitute each other in the same chemical reactions. So, the sulphide copper ores can contain selenium, and the smelting process will be the same.

The copper-selenides are rare; therefore, they can be used as a trace of the origin of the ore. One typical place where selenides can be found is the Near-East, the estimated origin of the burner. Due to the large fossil deposition (oil basin) the selenium content of the copper ores can increase. This phenomenon and the inclusions show the origin of the burner next to the typology, the ornaments and the documentation.
