# THE BAROQUE RENOVATION OF THE MEDIEVAL FRANCISCAN CHURCH OF JÁSZBERÉNY

Olivér TURI

This study discusses the Franciscan church in Jászberény, originally built in the Middle Ages. The methods of Bauforschung/building archaeology were used in the attempt to create a theoretic reconstruction of the church's former appearance, involving laser scanning and point cloud data. The re-search focused mainly on the attic space, more specifically, on the question of the former vaults of the church.

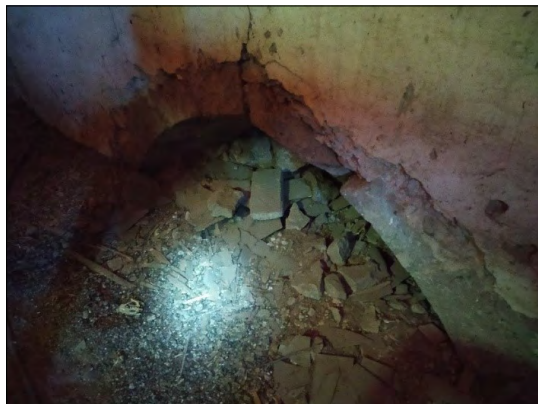
The most important observable trace in this regard is the plastering of the nave wall at a height of 2.15 m above the connection line of the current vault in the attic. We can treat it as a fact that in the Middle Ages, the church attics were not plastered. This leads to the conclusion, that the interior height of the nave was originally higher. This statement is also supported by the remains of a Gothic lancet window which was found on the South wall of the nave.

Moving towards the west side of the building the remains of two additional windows can be found. This makes it probable that the nave of the medieval church was illuminated by three windows from the southern side. Additionally, this makes it clear that the ceiling height of the church was indeed higher compared to its current state. Following this, a search was conducted for imposts and other signs on the wall that could indicate the past existence of vaults. However, there was no evidence to support the existence of these. Therefore, we can accept that the ceiling height of the church was 2.15 metres higher previously, but there are no indicators of former existing vaults.

**Figure 1.** *The remains of the walled-up Gothic lancet windows located in the attic.*

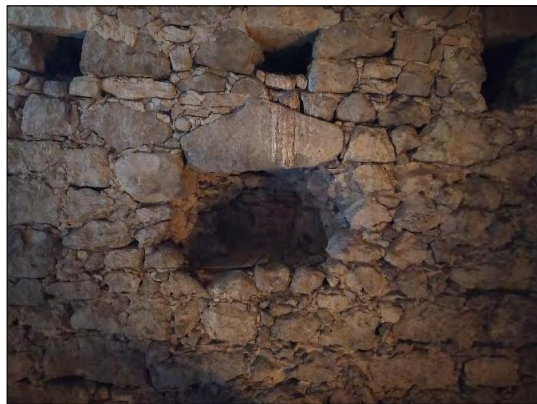
While observing the gable wall several remarkable things can be noticed. First, there were three holes where beams might have been previously on both ends of the wall. What is more interesting, two bigger holes can be found under these. Above one of these bigger holes, a typically carved stone can be seen, which at first glance, looks like a lintel. On closer inspection, a wooden beam can be observed running through both holes in the West wall's Southern side. It is possible, that the bigger holes in the walls functioned as light sources for the attic.

**Figure 2.** *The three smaller holes and one bigger hole with a stone functioning as a lintel in the attic's gable wall.*

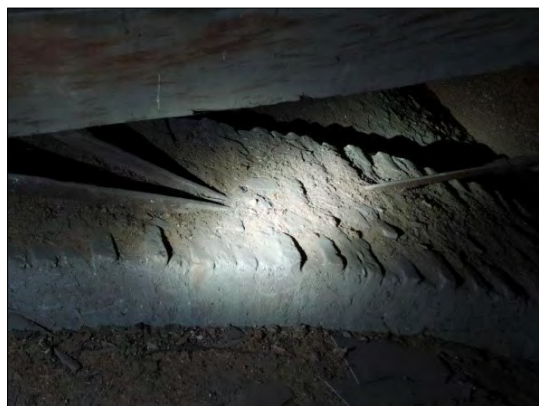
In the attic space tie rods can be observed, connecting the church's northern and southern walls and the transverse arches of the vault, to prevent the further outward shifting of the walls. On July

21<sup>st</sup> 1868 an earthquake caused immense damage to the building, then later in July, August and September further earthquakes shook the church.

According to contemporary descriptions, the building was on the verge of collapse. On the basis of the contract signed by the Franciscan order with the architect József Szódy, the installation of the tie rods began in October 1868, so repair of the suffered damages could begin with the contraction of the walls. These reparations were finished by the 10th of October.

**Figure 3.** *The tie rods connecting the walls, the vaults and the roof structure.*
