Restoring Art Nouveau

Architectural Decoration in the Danube Region

Proceedings of the international conference Restoring Art Nouveau,
Budapest, 6 November 2017

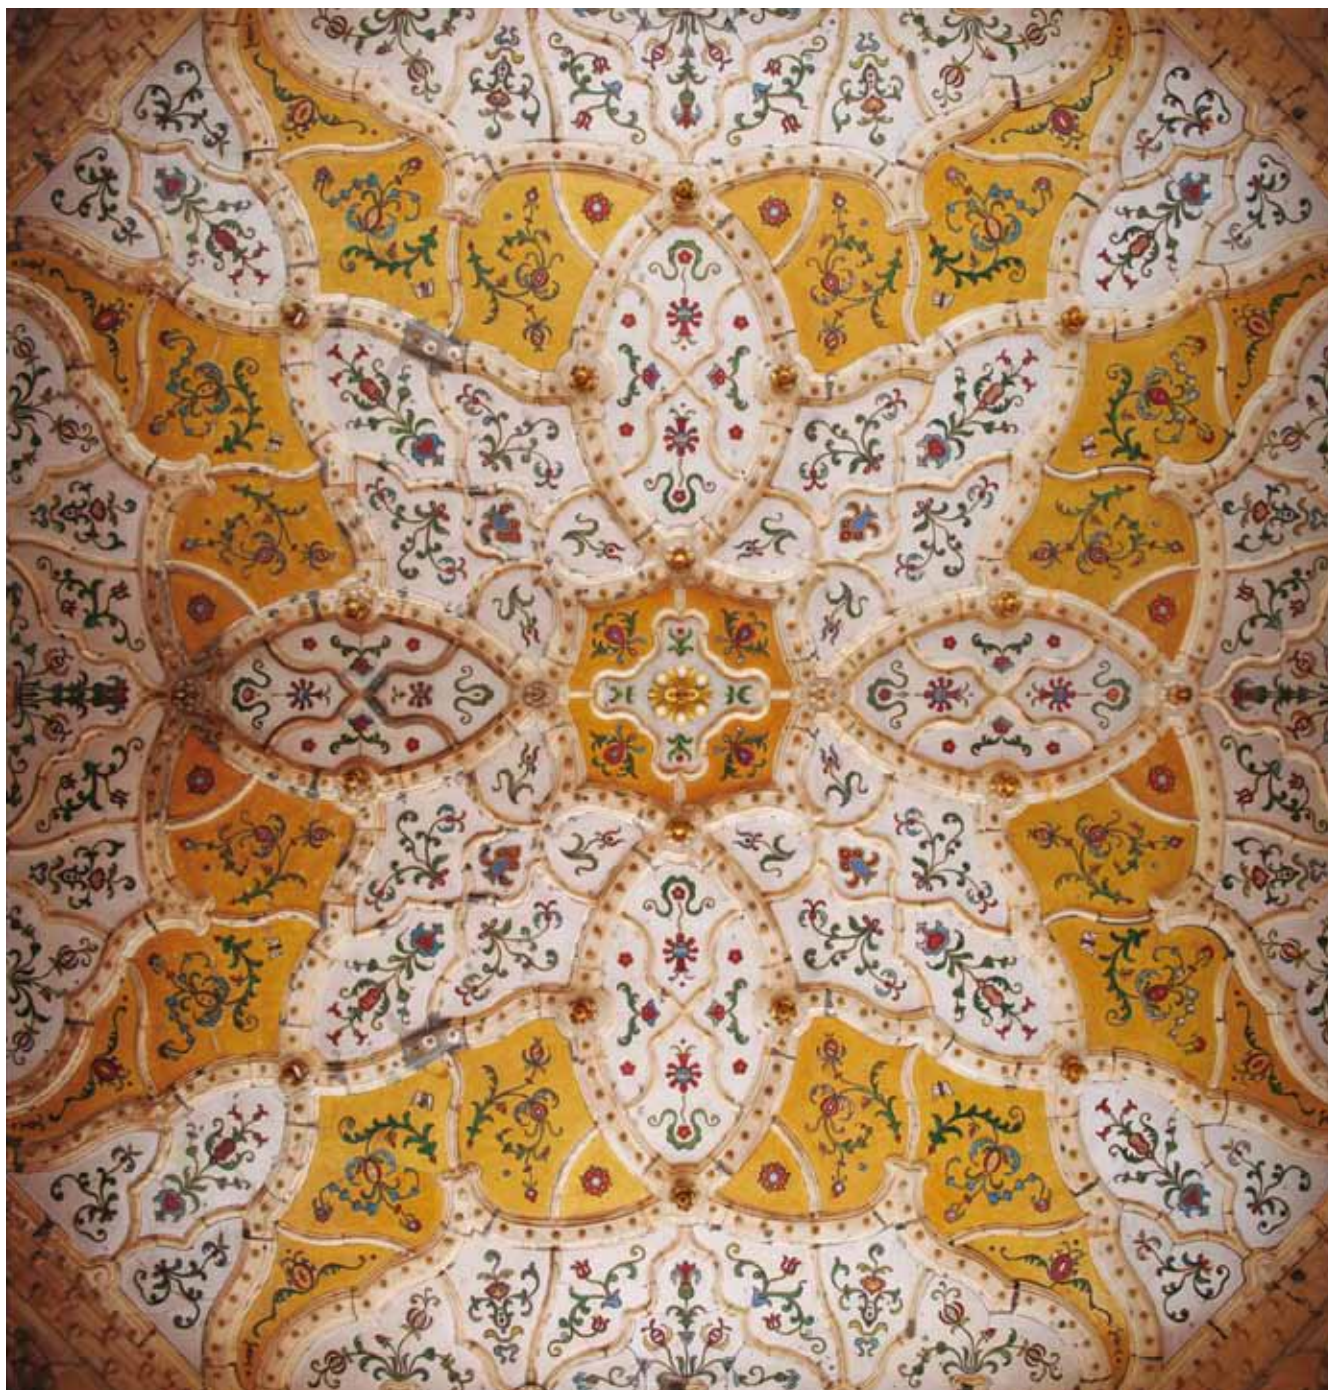
4. The ceiling in the main entrance hall, before restoration

In the second phase, in 2010, the ceiling of the lobby had to be restored. (Figs 8–9) In addition to structural damage, a great deal of mechanical decay had been caused on the surface of the ceramics during the Hungarian Revolution of 1956. This damage had been restored and they did not seem to be in a bad condition, but after up-close examination it turned out that the previous work and the ceiling were in a critical state. In addition to the natural signs of aging missing pieces and cracks were noted on numerous parts of the cladding of the columns in the lobby as well as on the ceiling.

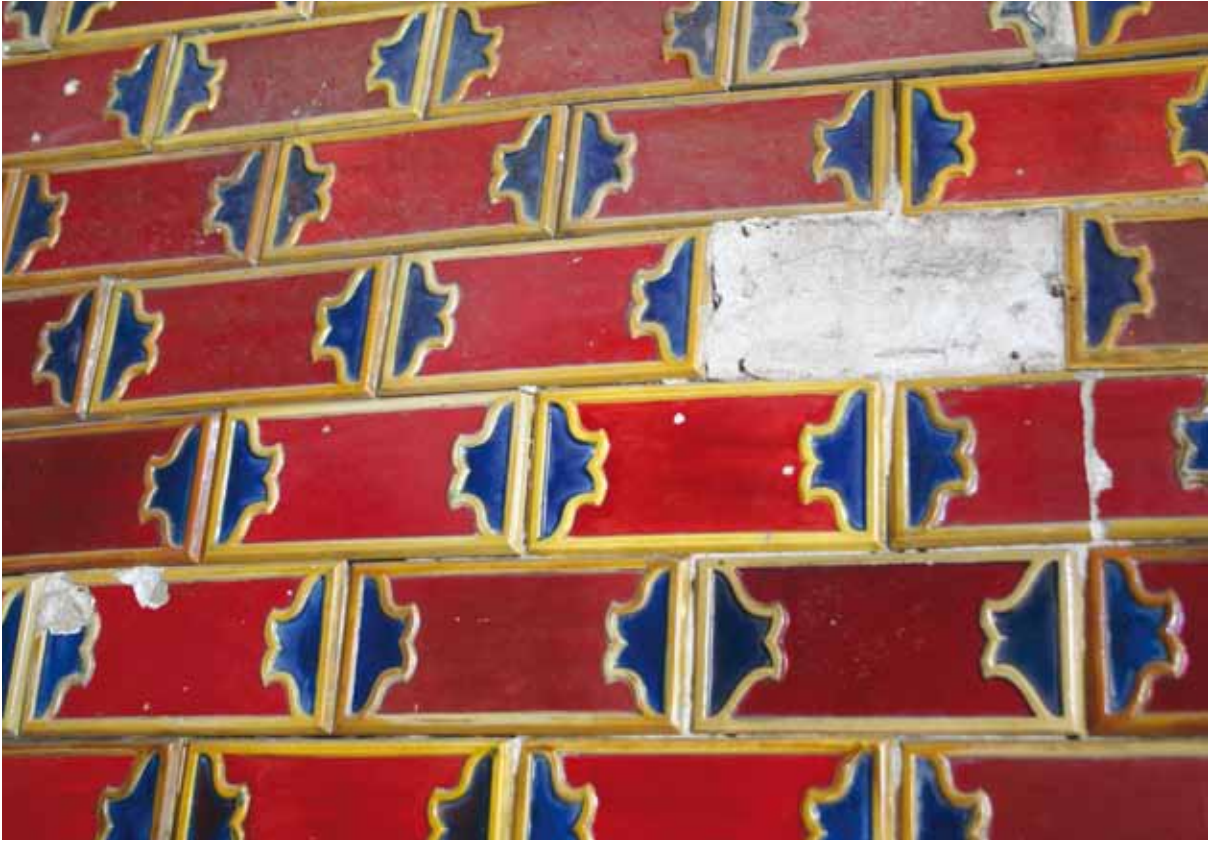
5. Decorative elements with ruby-colored luster glaze. The types of damage: gunshots, mechanical damage, damage due to leaks and fractures due to tension

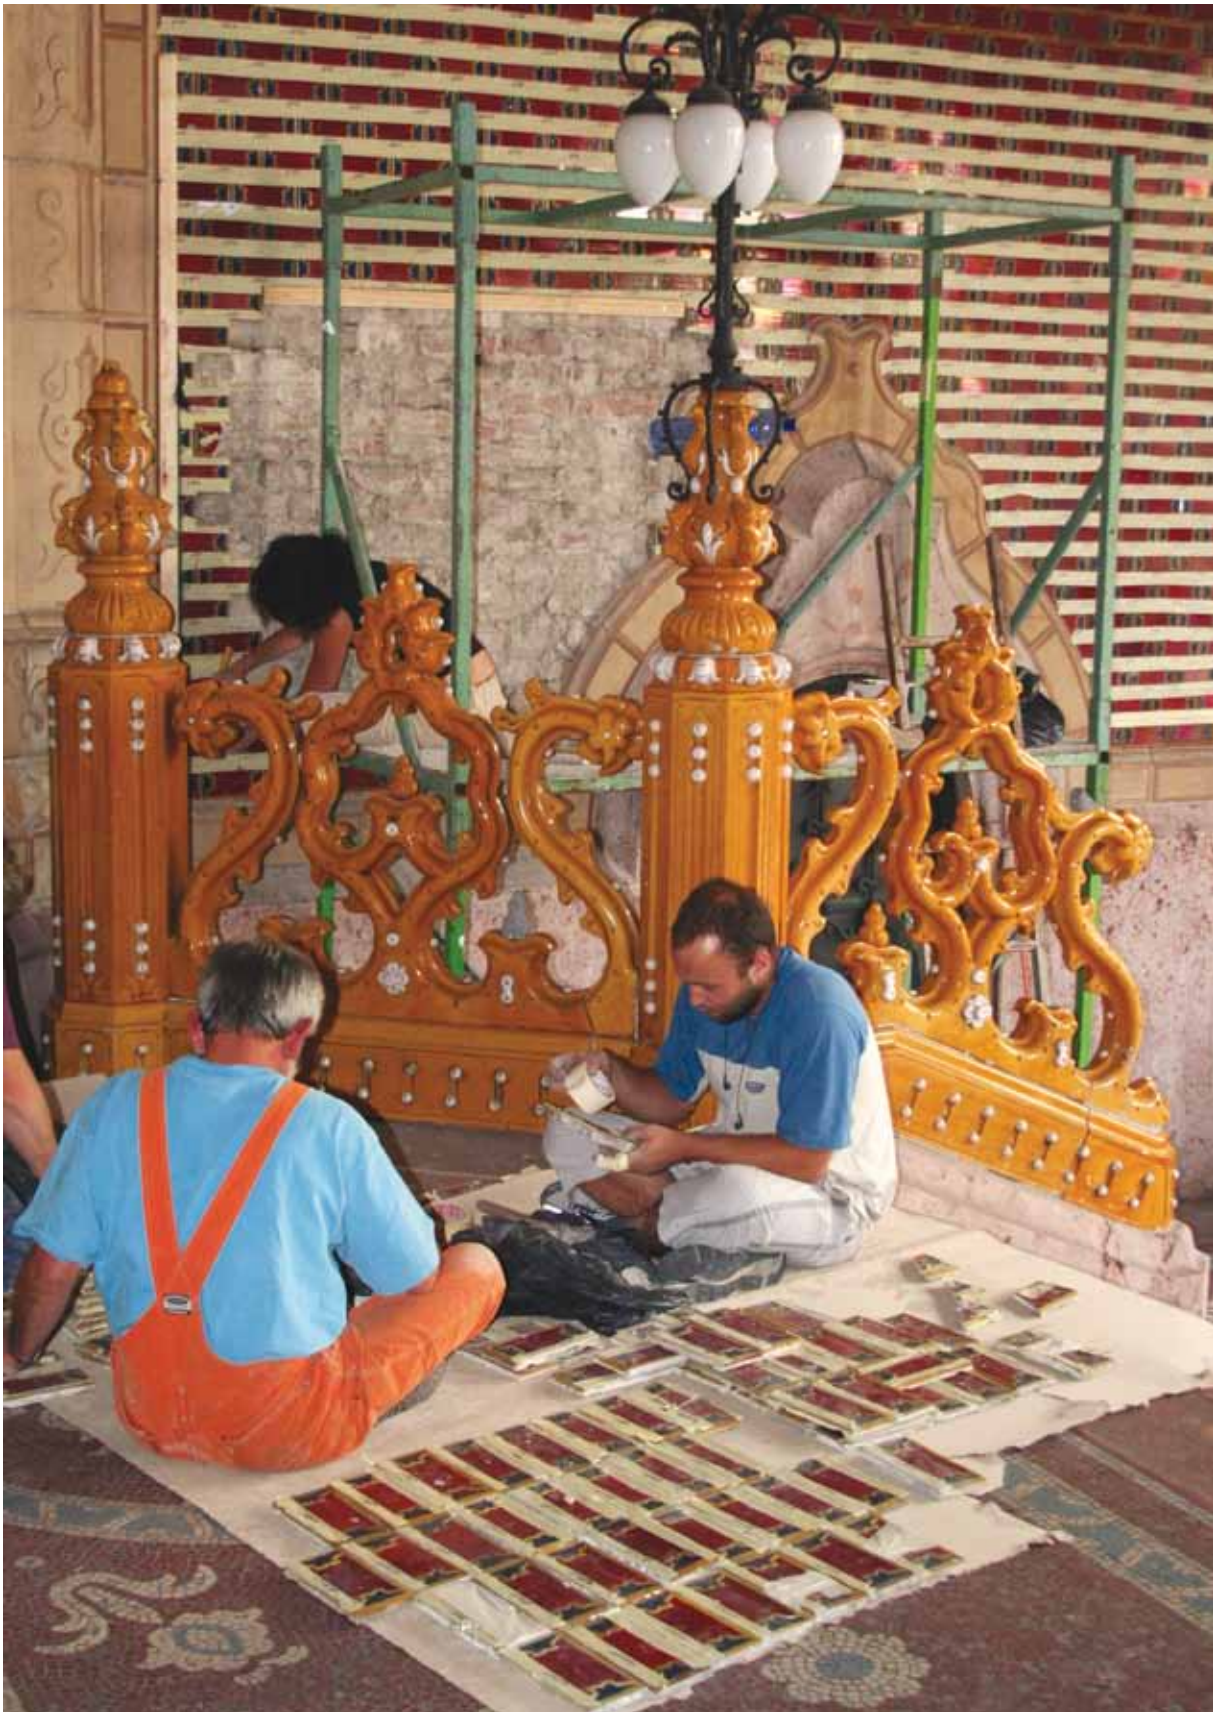
7. All the removed tiles were properly cleaned, and damaged tiles were taken to our workshop for further restoration processes

protective layer was a double component acrylic and polyurethane varnish. This layer is strong enough to stand up to mechanical and UV damage. After finishing the restoration of the damaged tiles in the workshop, we transported them to the building and replaced them in their original positions according to their numbers.⁷ (Fig. 7)

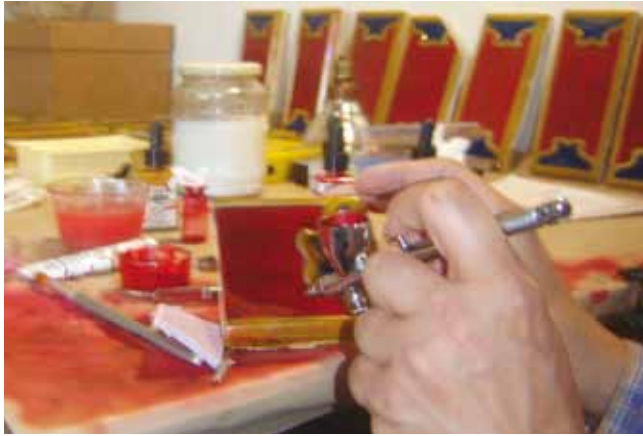
8. Broken pieces were glued together, and missing parts were recreated. Sometimes it was necessary to use an airbrush to create a thinner layer of paint

We continued the restoration process of the cleaned tiles with the adhesion and gluing of the broken pieces. We used Akepox 2010 epoxy glue to attach the broken pieces together. This provided adequate mechanical strength to the layers and is also durable over the long term against weathering as well as corrosive and harmful pollutants in the air and the environment.

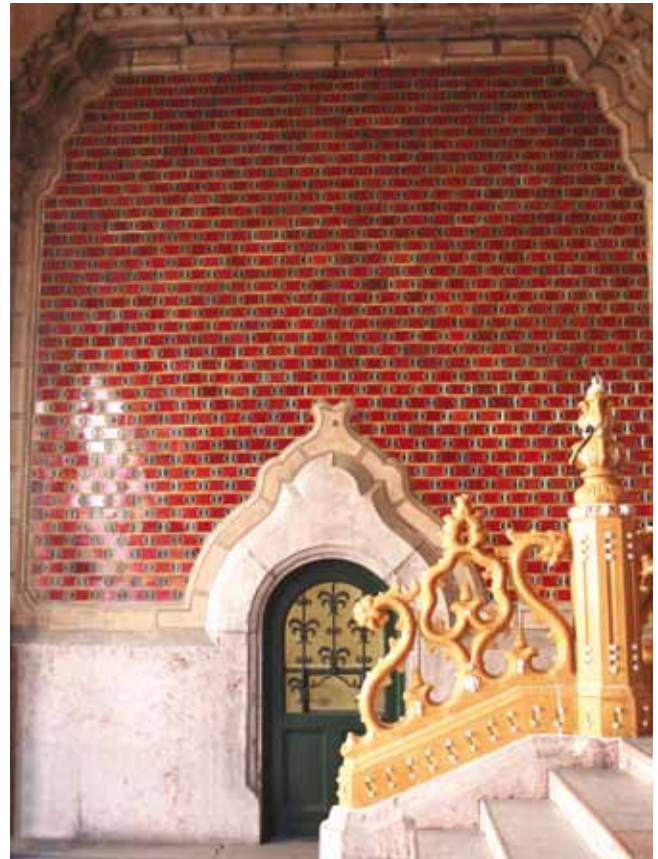
9. The wall covered with ceramics after their conservation and reinsertion

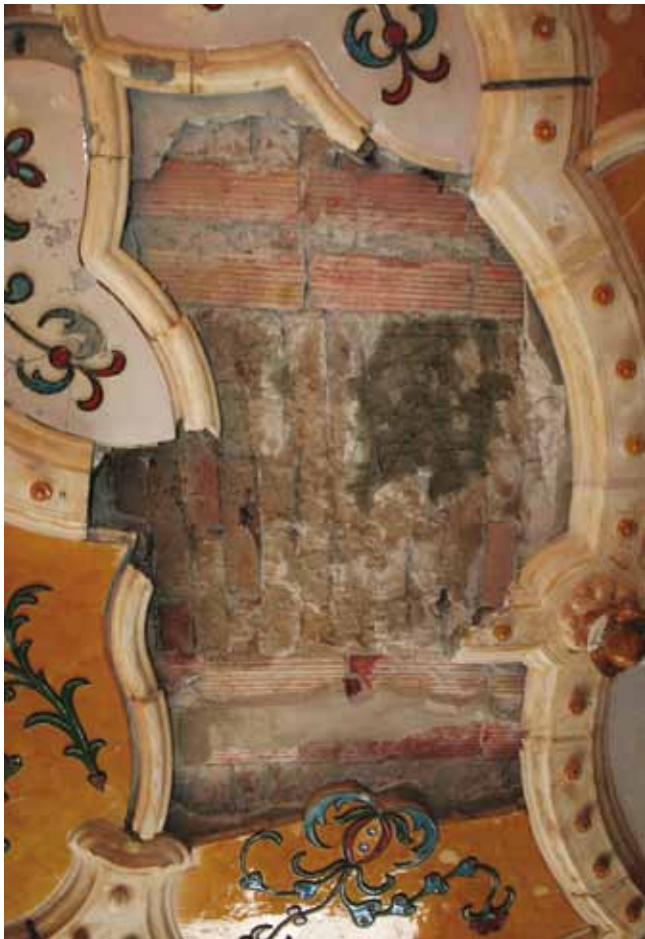
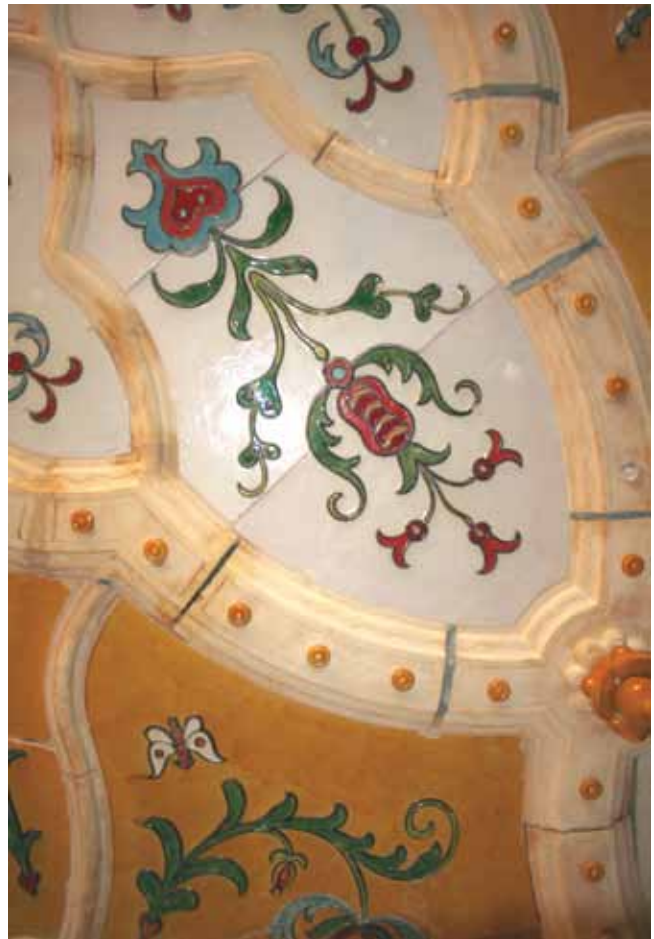
11a-b The damaged surface before dismantling and after restoration

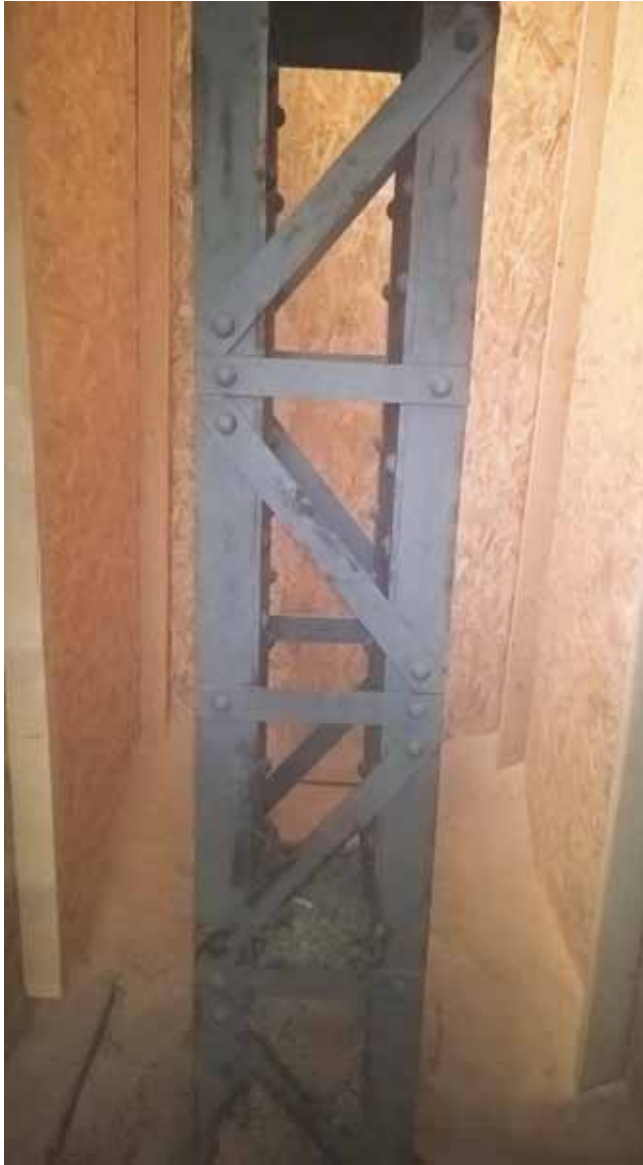
6. Cleaned iron pillar that supports the gallery and the dome, July 2017

Finally, the steel elements were covered with gypsum-lime mortar on top of 0.8–1.0 mm of wire mesh welded directly to the steel structure of the column and given a surface layer of plain plaster. The walls were rendered with two layers of mortar (the first rougher, with coarse granulation) while a single layer of lime-cement mortar was applied to the vaults (the aggregate is black stone with traces of quartz with granules of 0.5–7.0 mm). The segments of the apse were made with plaster painted to imitate stone. The decorative plaster

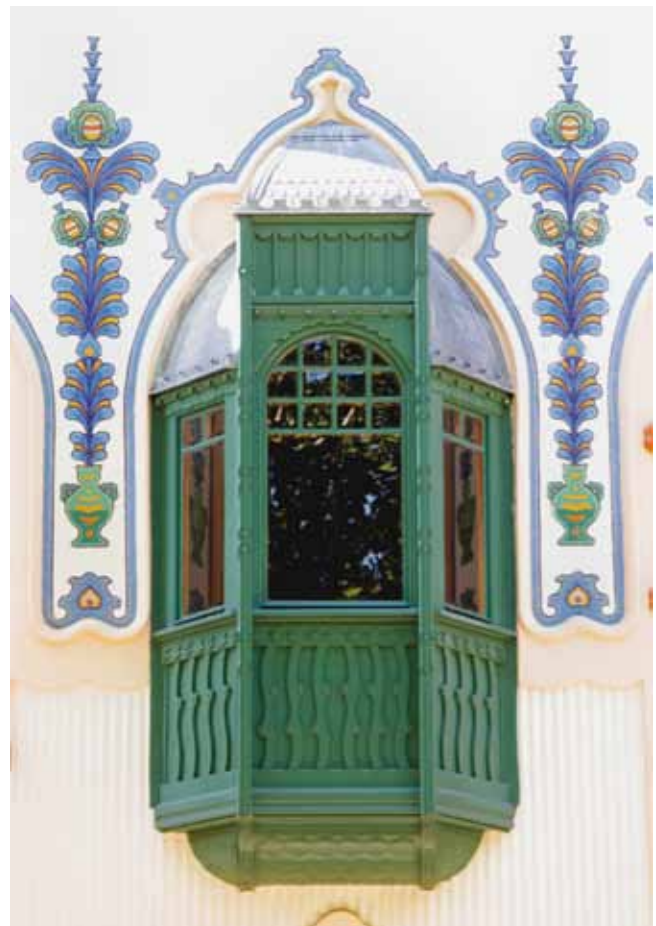
4. An oriel window after the restoration

Structural repairs to the oriel windows could no longer be delayed; their wooden structure was so rotten they had already begun to separate from the wall surface of the façade and threatened to fall on passers-by. Of course, the city's administration, which was the owner of the building, could not allow this danger to remain, so it agreed to finance the work. First, the experts from the Inter-municipal Institute for the Protection of Cultural Monuments of Subotica (hereinafter: the Institute) made a complete survey of the oriel windows, and all the details of their structures were carefully documented during the disassembly. The master carpenter was Ivan

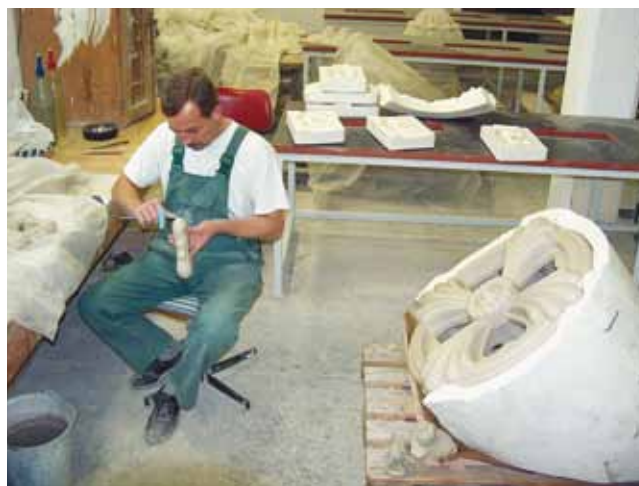
5. The production of the rosettes at the Zsolnay factory in Pécs, Hungary, 2003

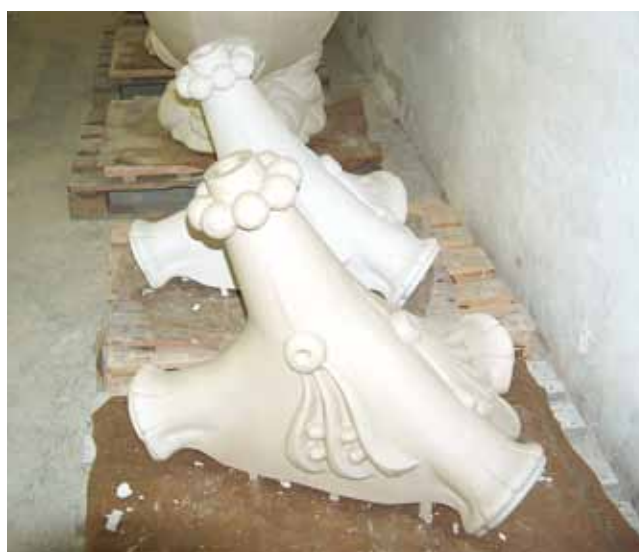
6. Special ridge tiles made of pyrogranite, before glazing

the old tiles and elements no longer met the demands of modern building regulations or standards (water absorption was 18–20% and the deformation resistance was 0.38 kN compared to the reference value of min. 0.6 kN). Therefore, they were no longer resistant to fracture and needed to be completely replaced with newly manufactured identical copies. A contract was signed with the Zsolnay factory in Pécs (Hungary) for this. Some molds were taken in situ and the samples were disassembled from the building and transported to the factory, where they started the production of the new tiles and decorative elements. (Figs 5–6) The production process was supervised by Gábor Dömötör. During

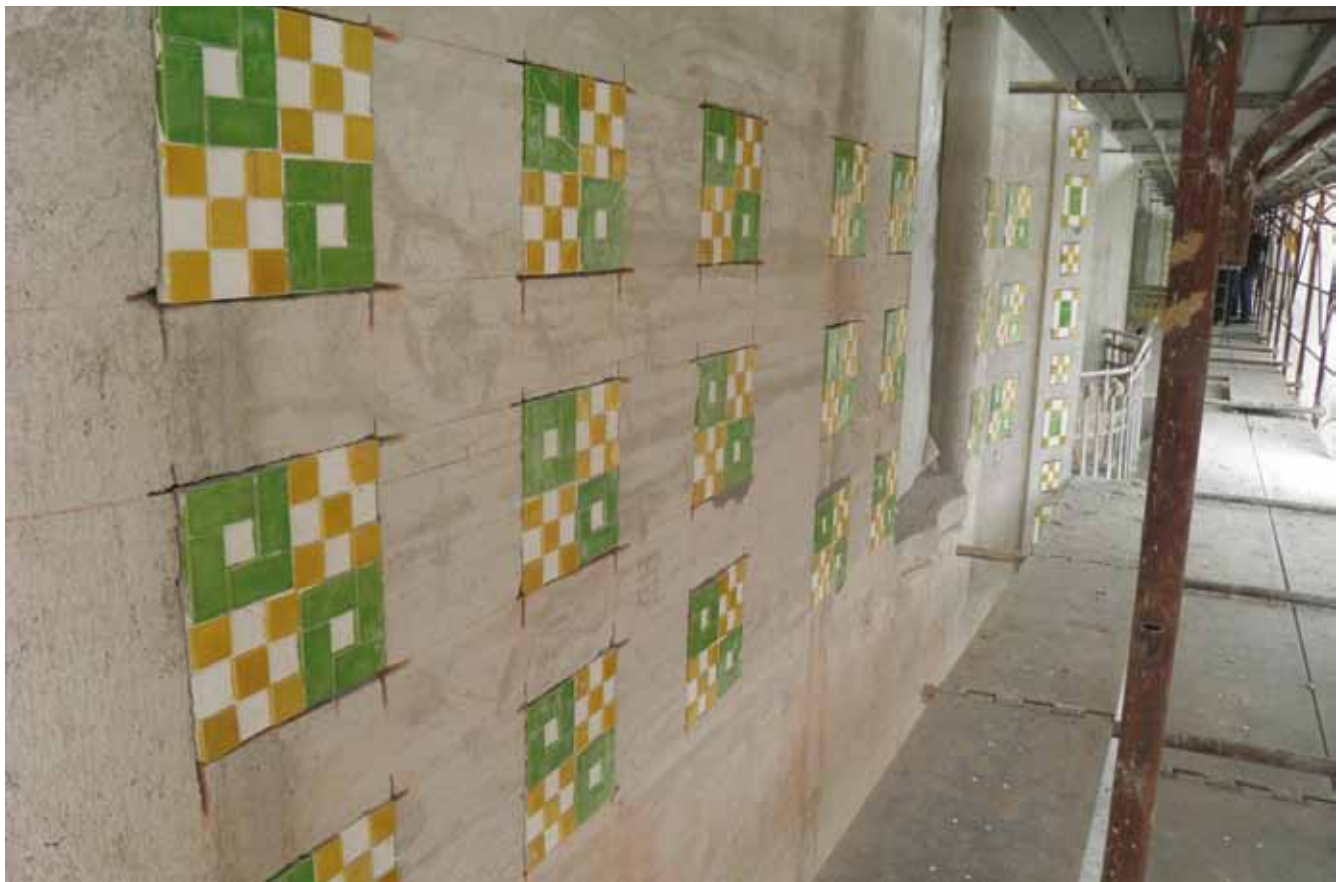
12. Adolf Moskovits Palace, the new plastering is made even with the slabs bearing the ornaments

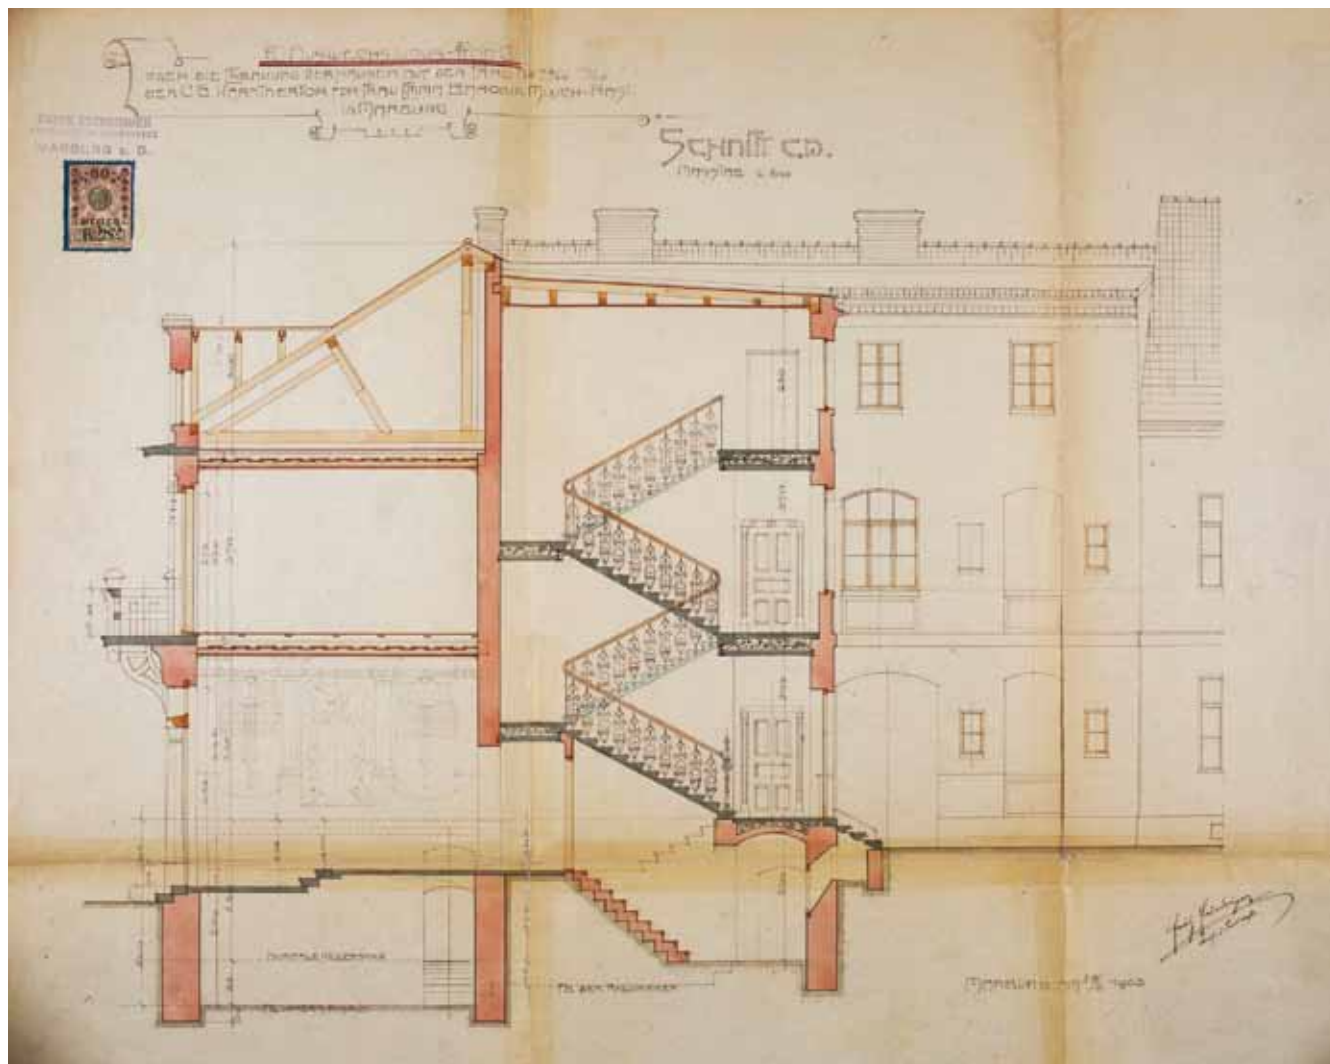
2. The Baroness house, section plan, 1902

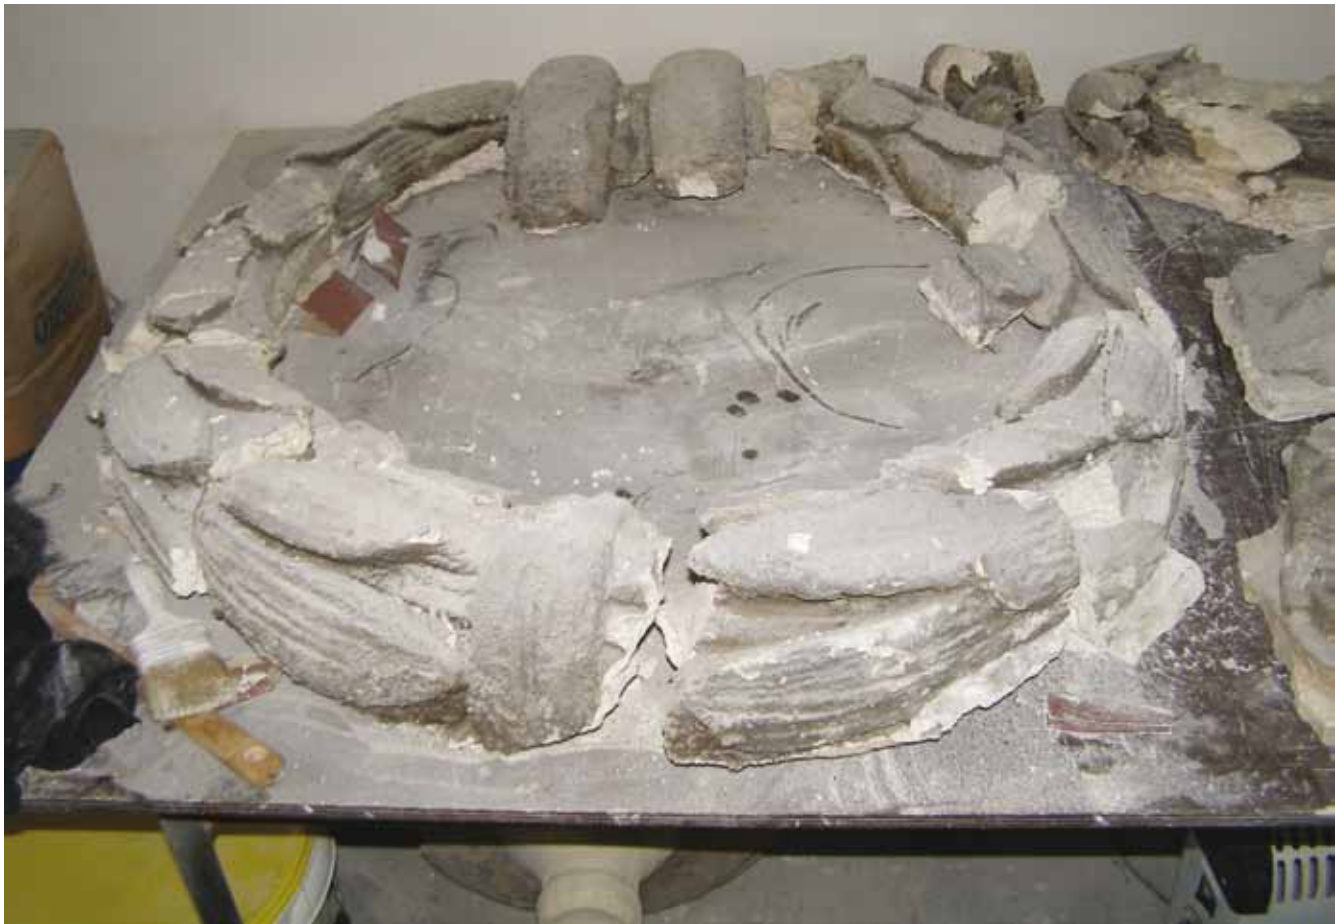
3. 20 Đorđićeva Street: Stucco laurel wreath after removal from the façade

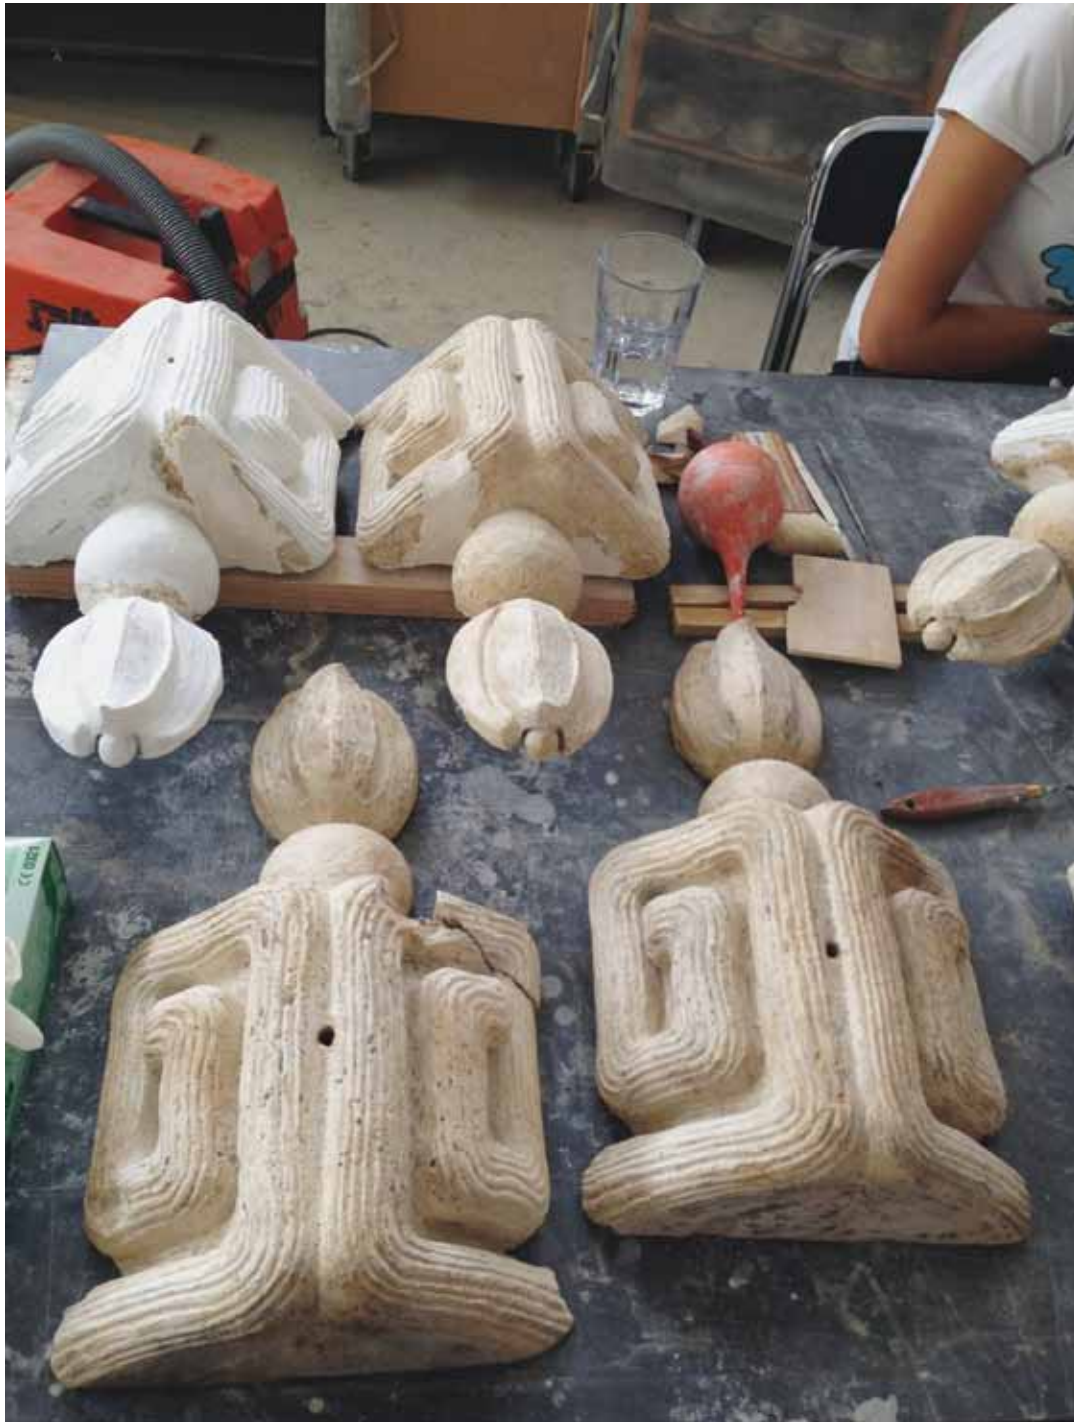
14. 80 Palmotičeva Street: Remodeled stucco elements of the entrance during the restoration

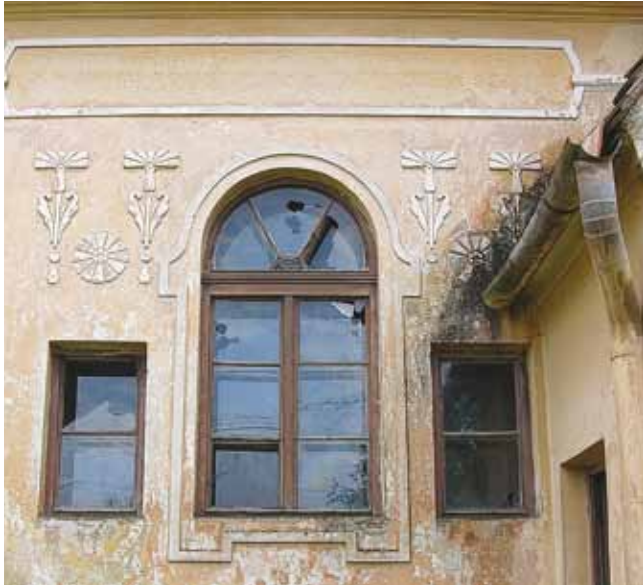
9. Former Lutheran School in Cincșor in 2008, detail of deteriorations

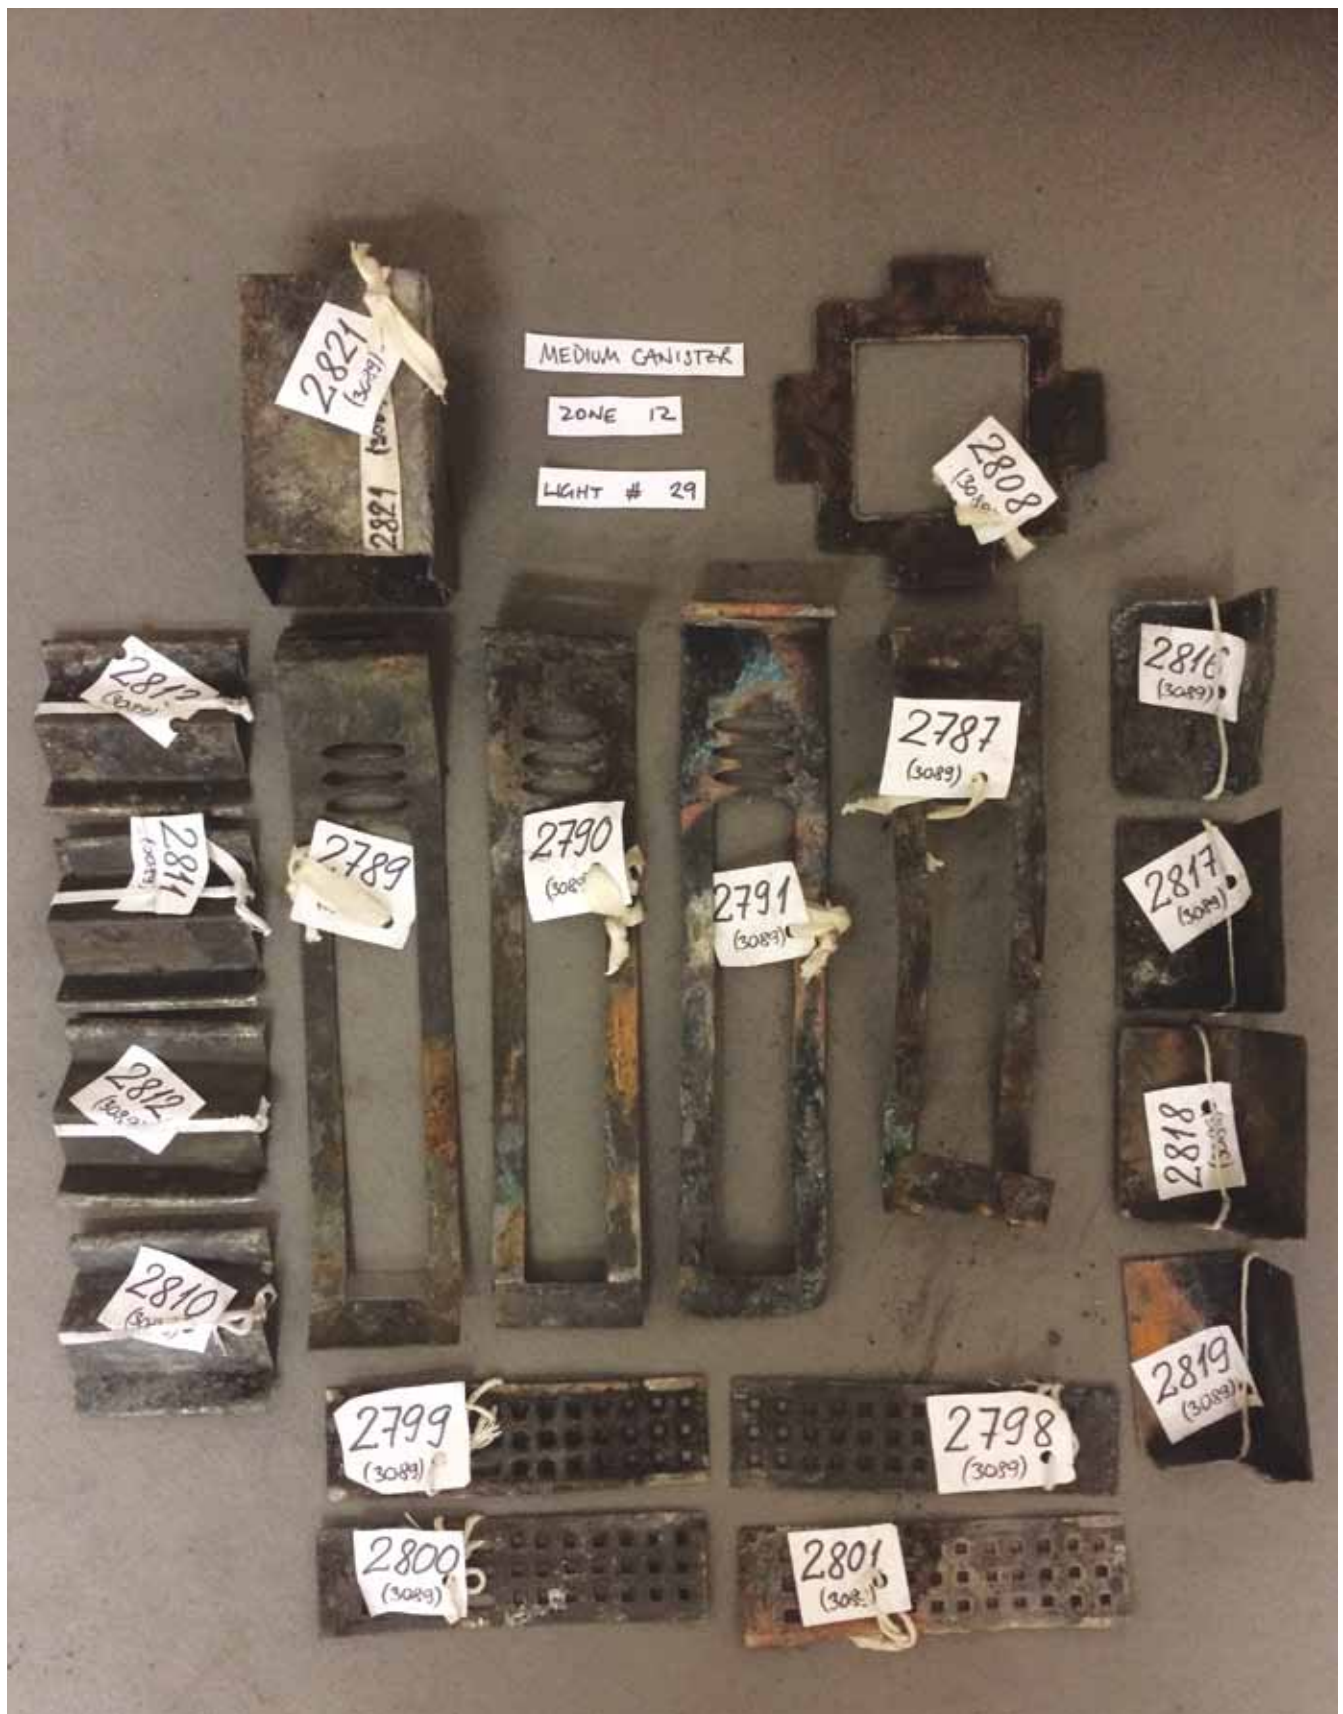
10. Fragments of the Mackintosh library lights, 2014
