# **Corrosion behaviour of low temperature carburized austenitic stainless steel**

**Abstract:** Austenitic stainless steels have low corrosion resistance in applications where strong acids and vapours attack the surface, typically in food and chemical industries. This drawback can be improved by surface treatments. Salt bath, gaseous or plasma-based surface treatments are a diffusion process for improving the hardness of the surface layer on stainless steels without significantly affecting their corrosion resistance. Low temperature carburising process can form crystal lattice distorting diffusion zone or/and compound phases. This research based on an industrial problem where corrosion patches could be formed on the surface after the using. Surface treatments were performed by derouging and passivating to clean the surface. Optical microscope and Vickers microhardness testing were used for the characterization of the surface and potentiodynamic tests were performed to determine the corrosion rate. The patches were formed only on the surface, it cannot affect the cross-section of the layer. The corrosion rates of the original and the derouged samples were similar.

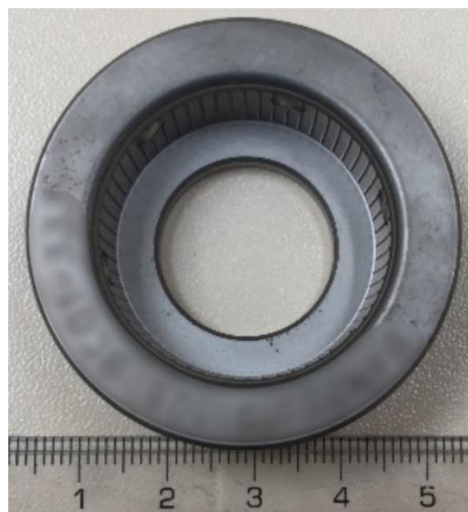
*Figure 1. The original part*

AISI 316L type austenitic stainless steel was used for the experiments. The chemical composition of the base material is (in wt.%): Cr (16.7), Ni (9.84), Mo (1.95), C (0.02), and Fe for balance. The low temperature carburising was performed by the industrial provider of the kolsterising treatment. The original part can be seen in Fig 1.

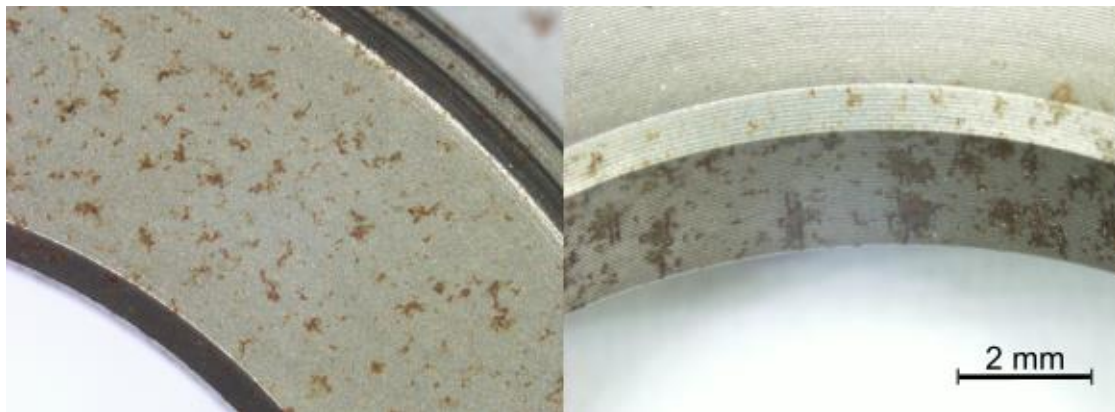
*Figure 2. Corrosion patches before the operational*

An operational test was made by the industrial provider who gave the samples for the investigation. Corrosion patches were formed on the surface of some parts which is seen in Fig 2.

These discolorations of the stainless steel and the iron oxide content on the surface is the typical form of the rouge. Rouge formation is a steady chemical process that is underway in all metallic, mostly piping systems in contact with water and all stainless steels corrode over time as minor ingredients are lost and electrochemical potentials rise [13]. The patches could remove by derouging. It is designed to remove the oxides of iron and/or other contaminants

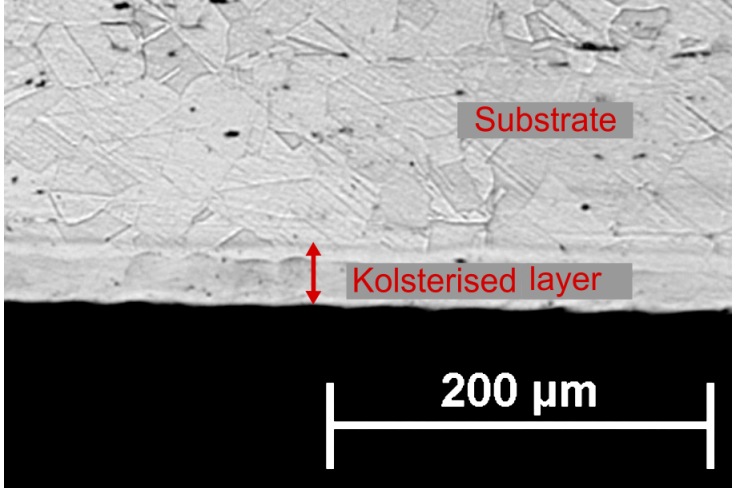
Figure 4. Cross-section optical microscopic images of the kolsterised layer

The microstructure of the substrate and the modified surface layer are presented in Fig 4. The kolsterised layer was homogeneous along the cross-section which approximately was 30  $\mu\text{m}$ . The base hardness of the substrate was 250 HV0.01 while the layer was 700 HV0.01. It was a significant increase in hardness which can improve the wear resistance of the surface. As it is seen, the rouging did not attack the cross-section of the layer.
