Electrochemical Migration of SAC305 Solders and Tin Surface Finish in NaCl Environment

Sándor Ádám, Bálint Medgyes, Dániel Rigler, Bence Szabó and László Gál

Budapest University of Technology and Economics

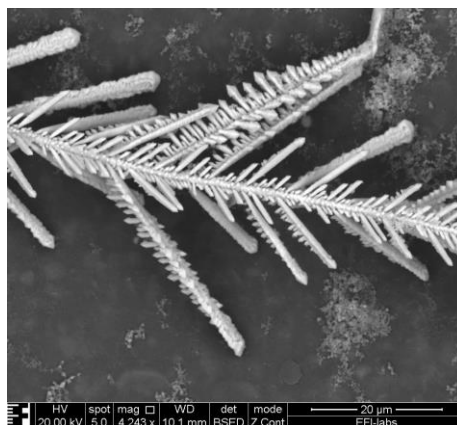
Fig. 1. Dendrite on a PCB.

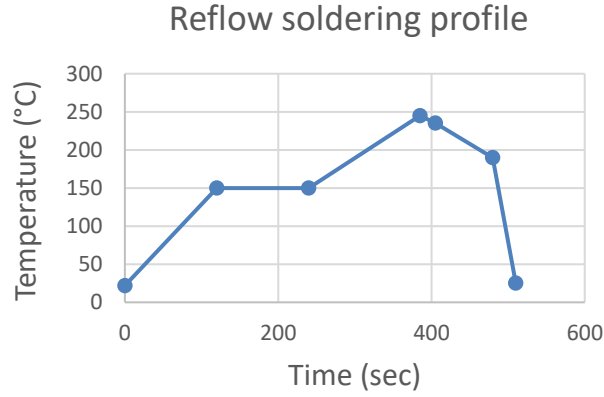
The gap size and the distance between the conductor pads on the test board was 0.3 mm in both cases, while the gap size was 0.3 mm. Fig. 2 shows the used reflow temperature profile for lead-free solder alloys in agreement with supplier’s recommendation (See Fig. 2).

Fig. 2. Reflow temperature profile for the test lead-free solder alloys.

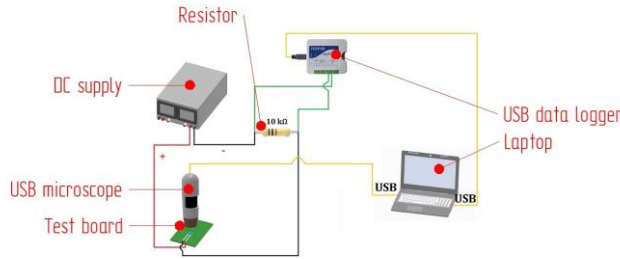
With the test set up (See Fig. 3.) real-time voltage data was recorded while in-situ optical inspection of ECM formation was performed as well. Based on the electrical data (voltage change), the ECM processes were followed, and MTTF was calculated as well.

Fig. 3. Schematic of the test set up for ECM investigation.

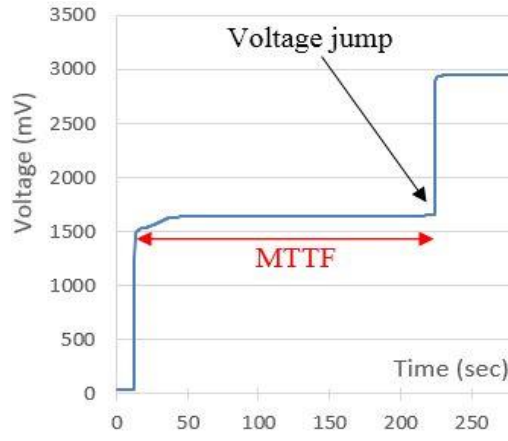
The time of the failure determination was based on the first voltage change using the voltage diagrams. According to this principle criterion of the failure was the first significant voltage jump (See Fig. 4.). ECM measurements were repeated ten times on each type of solder alloy, surface finish to get adequate repeatability. Based on the voltage diagrams MTTF was calculated in case of each solder alloy and surface finish.

Fig. 4. Time-to-failure determination by the first significant voltage jump.

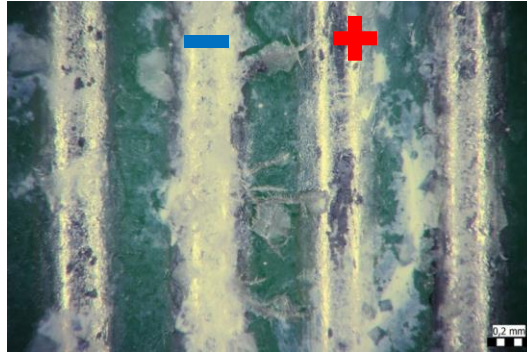
Fig. 5. Gray colored dendrites on the PCB in case of "A" type solder alloy.

Typically, right after the 3 VDC test voltage was loaded, 1500 mV value level was perceptible. The droplet was stretched, and H₂ gas evolution was visible at the cathode. After a short period of time white colored precipitate appeared, nearby cathode side. Outgassing and residue formation stopped after 2 minutes. Gray colored dendrites were grown from the cathode towards the anode (See Fig. 5.). In this case the MTTF value was 160 sec. Right after the measurement a typical test sample can be seen on Fig. 6. From the VDC test voltage was loaded, until the failure processes occurred and increased the voltage level with 300 mV.

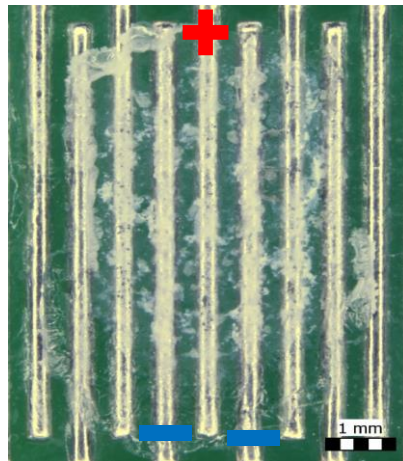
Fig. 6. White residue formation was observable in case of "A" type solder alloy.

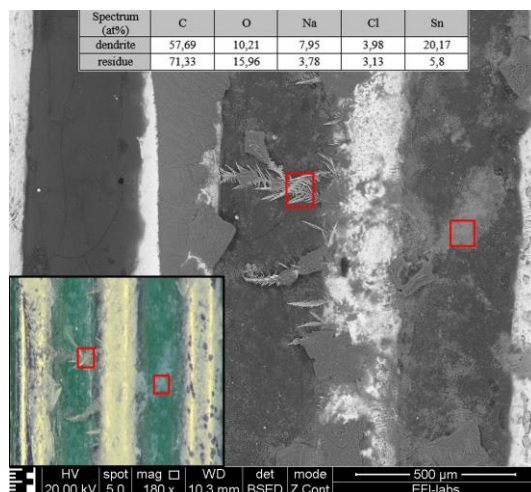
It was expected that the SEM-EDX results confirmed; the main element of the dendrites is tin, and precipitates primarily consist Sn and oxide (See Fig. 7.). Carbon, sodium, and chloride can be originated from the PCB material or from the NaCl electrolyte.

Fig. 7. SEM-EDX analysis in case of “A” type solder alloy.

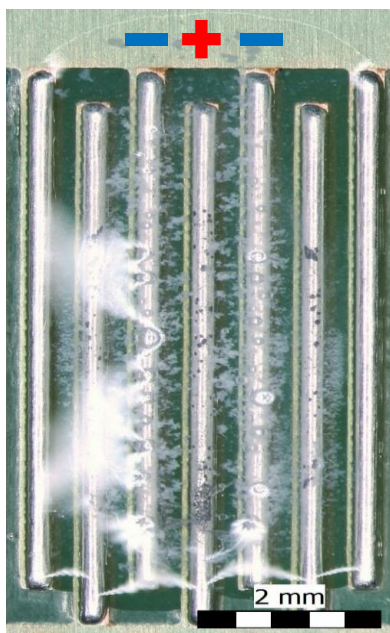
Fig. 8. Bigger amount of white precipitates was formed in investigations with “B” type solder alloy, than in case of “A” type solder alloy.

In case of “B” type solder alloys, after the 3 VDC test voltage was switched on, an initial voltage of 1500 mV was measured. The droplet started to stretch, and H₂ outgassing was observable at the cathode. After a half minute white residue appeared, near the cathode. Bigger amount of white residue was produced than in case of “A” type solder alloy (See Fig. 8). Outgassing and residue formation stopped after 2 minutes. Gray, metallic colored dendrites were grown from the cathode to the anode (See Fig. 9.), with different morphology than in case of “A” type solder alloy. Voltage increased with about 150 mV until the failure occurred. Failures typically happened after 178 sec.

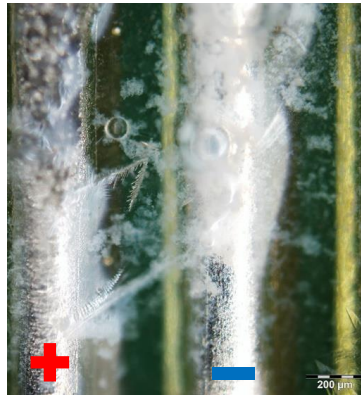
Fig. 9. Gray, metallic colored dendrites shown up in case of “B” type solder alloy.

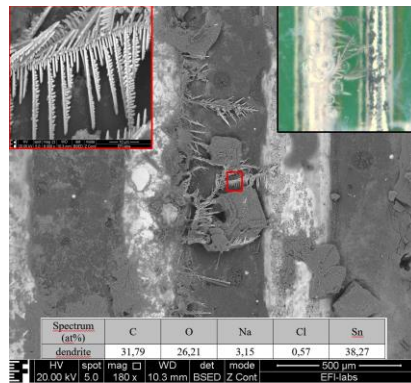
SEM-EDX results showed that dendrites are mainly composed by tin (See Fig. 10.), and in the residue tin and oxide are dominant (See Fig. 11.).

Fig. 10. SEM-EDX analysis in case of a dendrite by “B” type solder alloy.

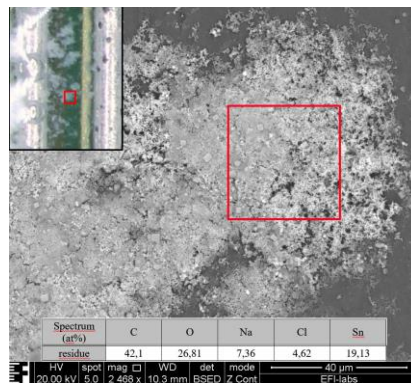
Fig. 11. SEM-EDX analysis in case of residue by “B” type solder alloy.

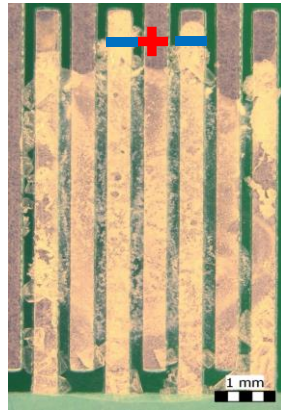
Fig. 12. White residue with bridging over the insulator layer was observed in case of galvanic tin surface finish.

WD test results with galvanic tin surface finish showed, that after the 3 VDC test voltage was loaded, voltage level at the resistor increased up to 1800 mV. After the stretching of the droplet the outgassing process was similar to the solder alloys. The color of the residue was white, but in this case bridging over the insulator layer was more typical (See Fig. 12.). Voltage at the resistor was not changed until the failure eventuated. MTTF was 99 sec. Gray, metallic colored dendrites were grown from the cathode to the anode, with similar morphology as in the case of “B” type solder alloy (Fig. 13.).

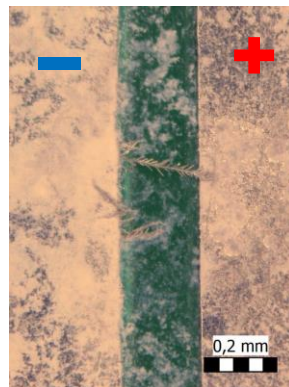
Fig. 13. Gray, metallic colored dendrites in case of galvanic tin surface finish with similar morphology as in case of "B" type solder alloy.

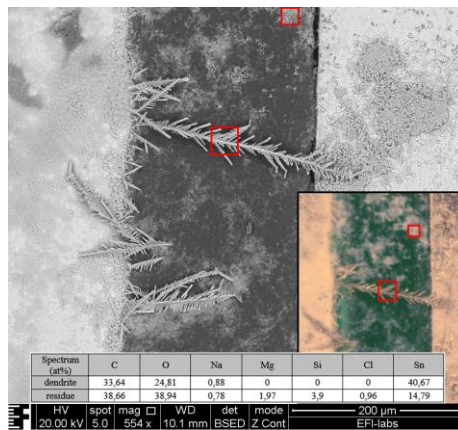
Fig. 14. SEM-EDS analysis in case of galvanic tin surface finish.

According to the results of SEM-EDX analysis, similar to the other cases dendrites mainly contain tin, and the residue consists of tin and oxide (See Fig. 14.). In the residue Si, and Mg were also detectable, presumably these elements were originated from the PCB material.

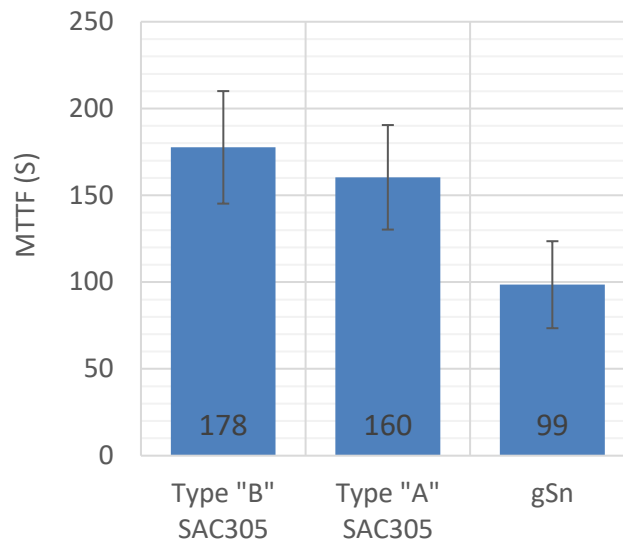
According to the MTTF data (See Fig. 15.) it was confirmed, that "A" and "B" type solder alloys with different rosin&acid/flux paste ratio have closely the same migration susceptibility with 160 and 178 sec. On the other hand, in case of galvanic tin surface finish, failures happened after a shorter period of time, the ECM mechanism was faster, MTTF was 99 sec.

Fig. 15. MTTF values between SAC305 solder alloys and galvanic tin surface finish (with 1σ deviation), in case of WD tests with 3,5 wt% NaCl solution.

Two-sample t-tests were also made in each pair. It was proven that on 95% significance level, the MTTF values by “A”, “B” type solder alloys are the same, however t-tests also confirmed that MTTF value of gSn is different from the MTTF values of solder alloys on 95% significance level.

Based on the MTTF results no significant difference was demonstrated between the “A” and “B” type lead-free solder alloys. In case of galvanic tin surface finish the migration susceptibility was higher than by the solder alloys.
