Ecocycles, Vol. 5, No. 2, pp. 44-73 (2019)
DOI: 10.19040/ecocycles.v5i2.149

CASE STUDY

Evolution of Water Quality of Lake Balaton

Károly Kutics

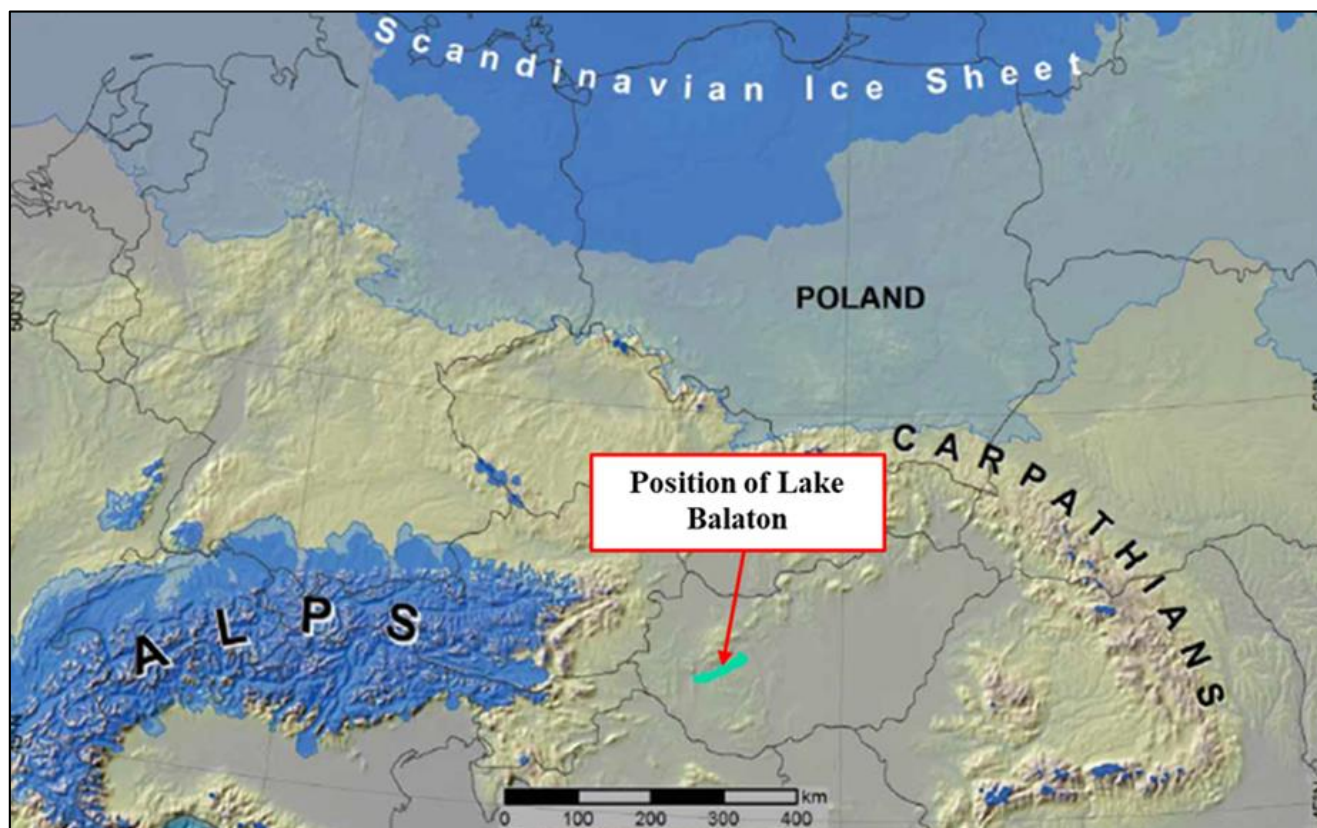
Figure 1. Ice cover at the last glacial maximum, approx. 20,000 years ago (blue), and at its maximum during the Quaternary epoch (light blue) . based on Zasadni & Klapyta(2014) .

(Fig.1) so the lake is not of glacial origin. Therefore, Lake Balaton is a rather young lacustrine formation, as compared to ancient lakes such as Lake Ohrid, Lake Skadar or Lake Baikal that are estimated to be 4 to 25 million years old. According to a review and synthesis by Virág (1998) of geological and paleolimnological research, at the beginning of the Holocene several smaller, separate lakes existed² (Fig. 2). Due to level fluctuations, wave erosion and deflation these lakes merged about 7 to 5 thousand years ago resulting in the present shape of the lake. In the merging process of the proto-

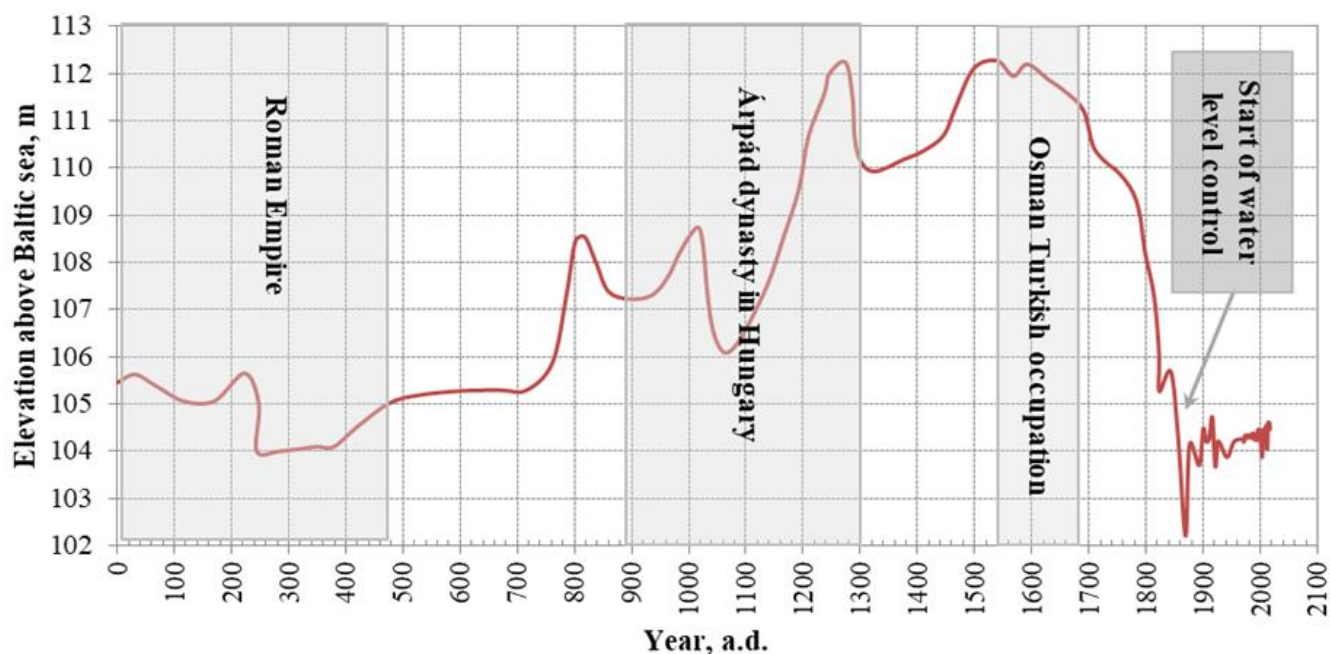
Figure 3. Reconstruction of historic water level changes of Lake Balaton. (Developed on the basis of Bendeffy, 1968. and www.hydroinfo.hu)

Level fluctuations are well documented from other studies, such as Chohnoky (1936), Bendeffy (1968)⁵. On Fig. 3 the data of Bendeffy referring to the A.D. period completed with recent water level measurement data are shown. Water level (and so lake volume and surface) of the lake changed within wide limits. Systematic regulation of the lake level started in 1863 with the commencement of the outlet sluice on the Sió canal in the town of Siófok. Direct reason of the introduction of level control was the construction and operation of a railway line along the southern shore of the lake, since high water level with wave action resulted in damage to the railway tracks. Water level dropped considerably, resulting in a host of problems that emerged since then.

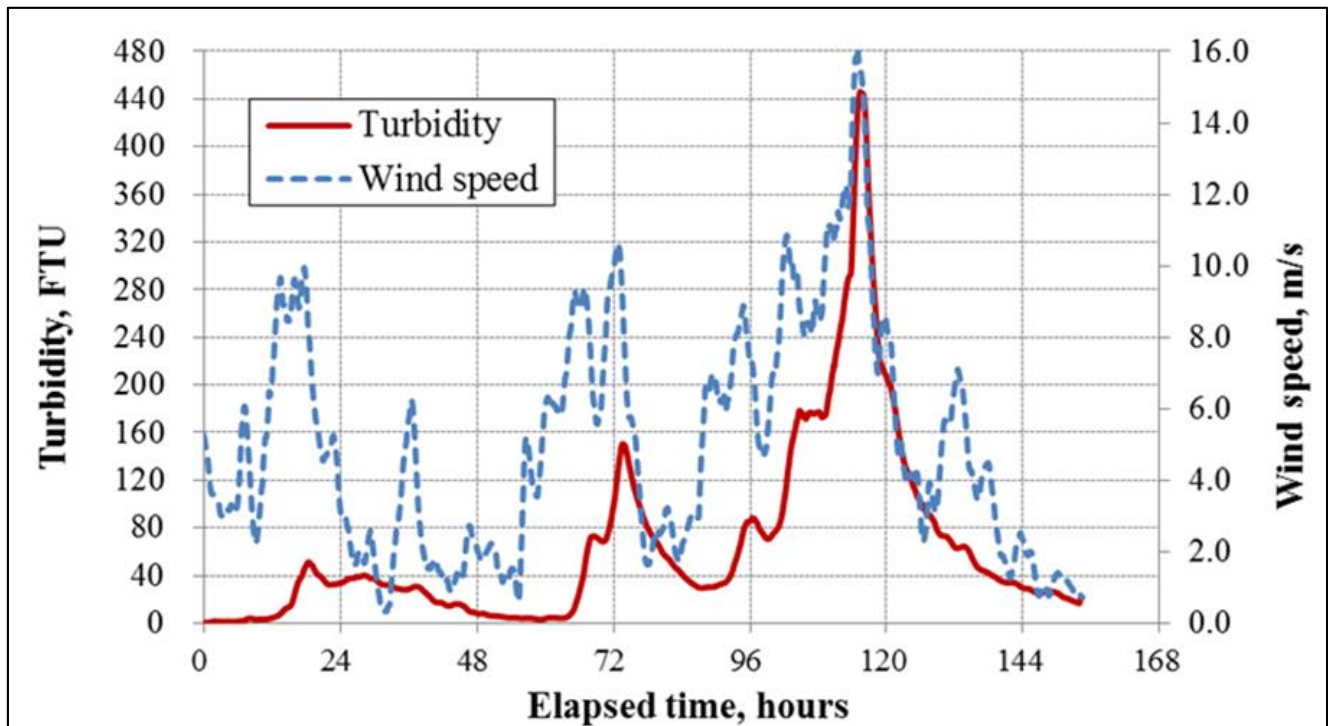
Figure 5. Wind induced changes in turbidity in the water column due to bottom sediment resuspension (Basin 4 centre, Siófok, from June 1, 2012, 0:00 hour; 10-minute frequency of measurement, 7-order smoothing, baseline-corrected. Raw data were provided by the BIR monitoring system of LBDCA).

An example of wind induced sediment resuspension is shown in Figure 5, where 4 wind events are shown for the Siófok Basin (deepest and widest one). Wind speeds of up to some 6 m/s did not result in any significant resuspension of bottom sediment. Resuspension was triggered by winds of 8 to 9 m/s, and a medium storm of up to 16 m/s wind speed resulted in extremely high turbidity values in the water column. The most important implication of this behaviour is the high mass transfer rates between the sediment surface and the water column. As a result, phosphorus exchange with the sediment intensifies, and the sediment may serve as a source of phosphorus at almost any time of the year, as opposed to deeper monomictic or dimictic lakes. Simulations conducted for the Siófok Basin at fetch distance 6.24 km (NW wind, midpoint of basin) by the shallow lakes wave equations (CERC, 1977, US-ACE, 1984) showed that at a reference wind speed of 8 m/s the resuspension depth equals to 84% of the mean depth (3.81 m) of the basin at 75 cm gauge level (i.e. recent conditions), but it would be reduced to only 45% of it when the mean depth was doubled (roughly the conditions before interventions to reduce lake level started in the 19th century). This indicates that sediment-water mass transfer was less intensive before lake level reduction and lake-wide sediment resuspension was a rather rare event limited to extremely high wind conditions (i.e. storms) exceeding 25 m/s.

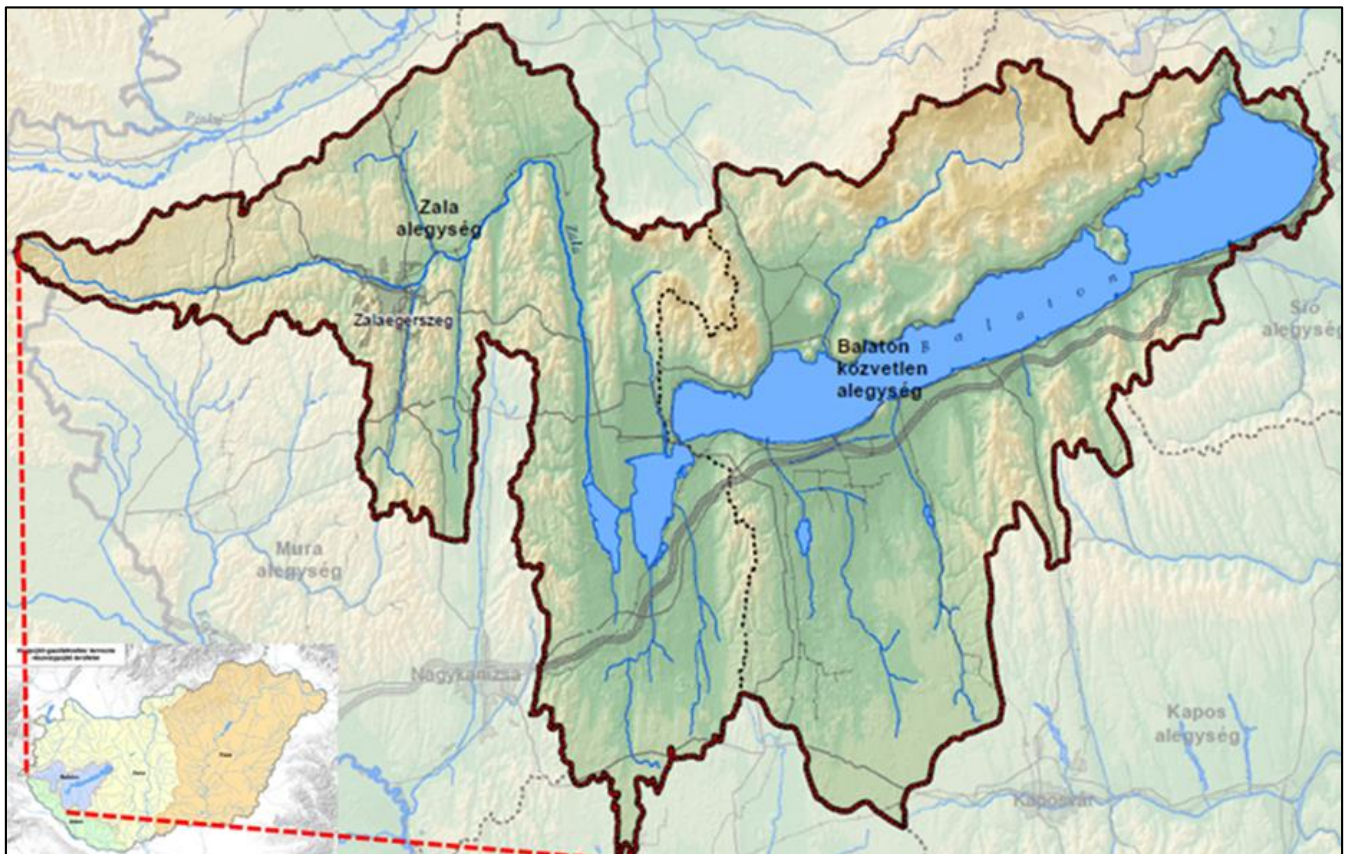
Figure 6. Lake Balaton watershed is one of the 4 separate “river basins” in Hungary defined in accordance with the EU-Water Framework Directive (Based on: KDT VIZIG: Lake Balaton River Basin Management Plan, 2016 www.vizeink.hu)

The present – day Lake Balaton and its watershed with its tributaries are shown in Figure 6. Zala river on the west side is by far the largest tributary constituting roughly half of the discharges into Lake Balaton.

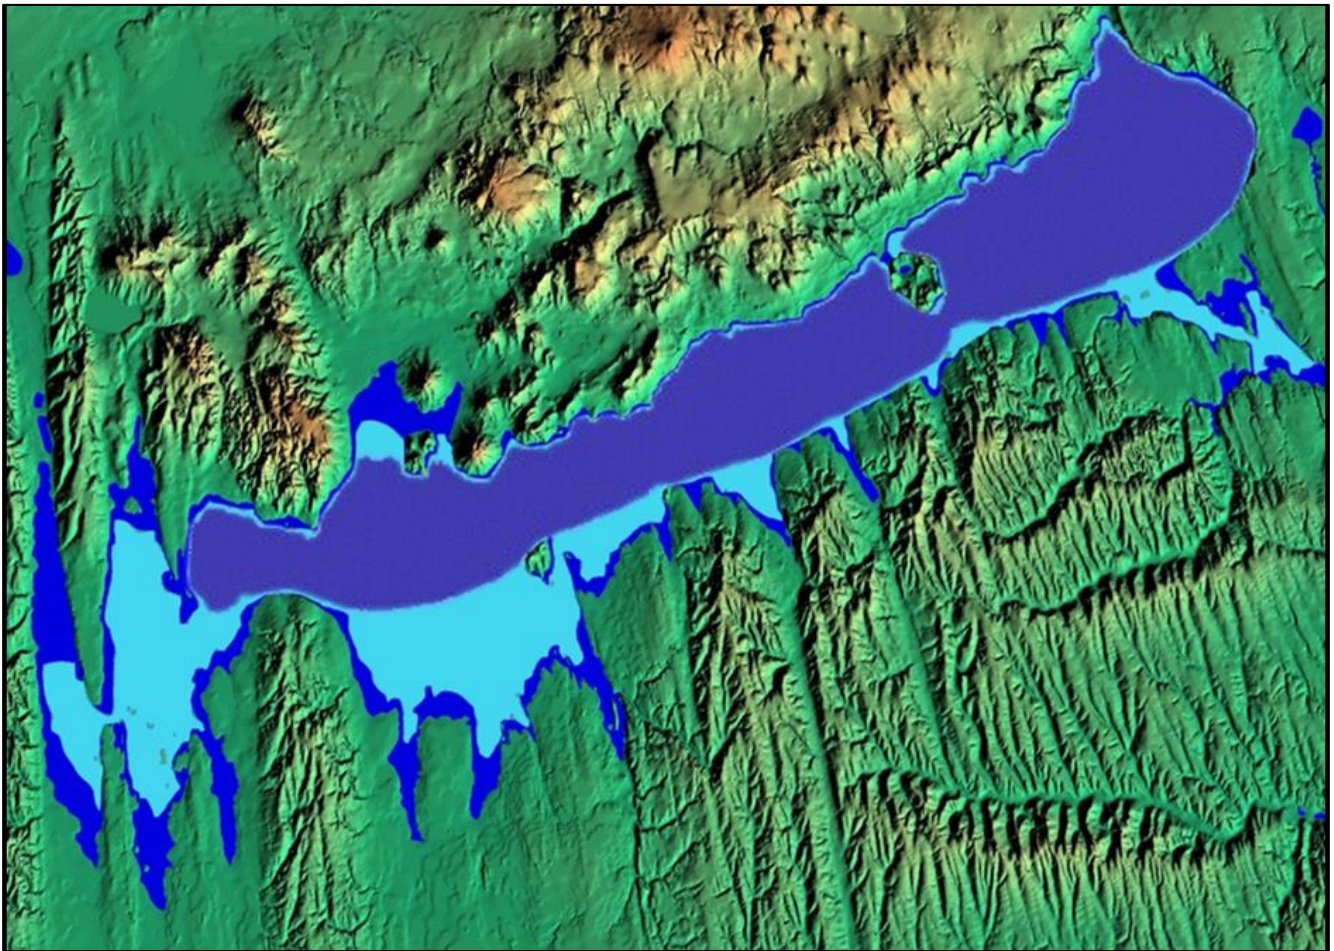
Figure 7. Lake Balaton surface at different water level elevations. (104 m above Baltic Sea level represents recent situation, 105 m is immediately before the opening of the Siófok sluice, while 110 m level is typical of the 18th century.

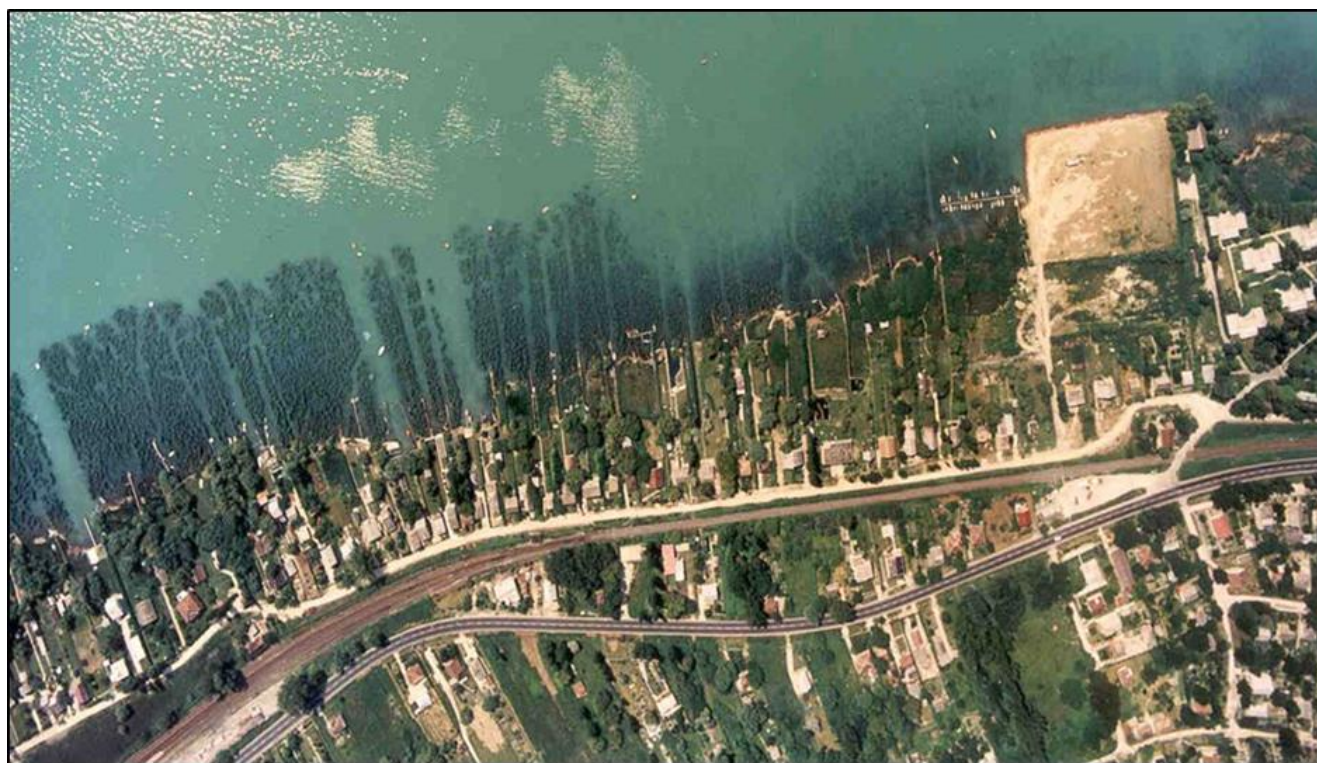
Figure 9. Summer houses on the lake shore. Private entrances to the lake destroyed reed stands and resulted in direct water pollution and loss of habitat. (Source: Google Earth, 2005, shoreline of Balatonkenese township)

Reed degradation occurred due to the construction of ca. 2000 „private” passages and boat piers along the southern shore amounting to some 10 hectares direct loss of reed stands and much more due to wave action, etc. damage (Fig. 9) (Pomogyi P. (2015))

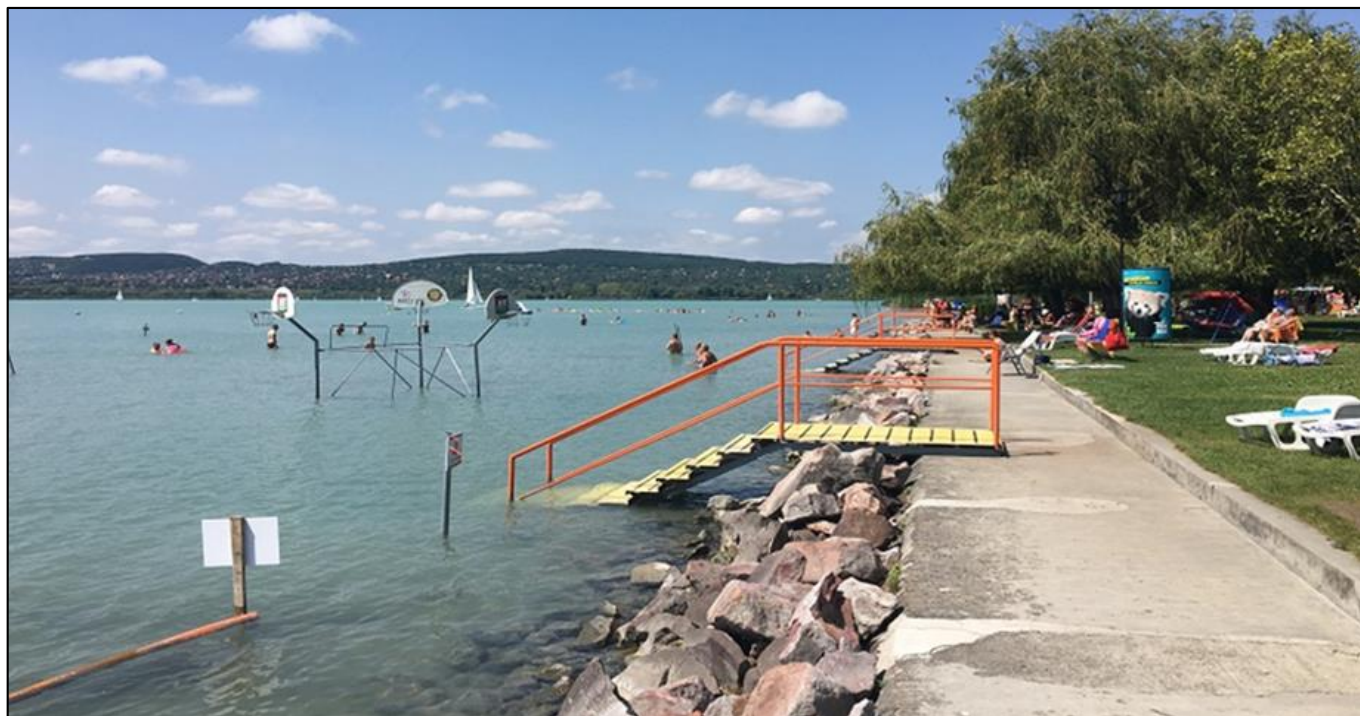
Figure 10. Concrete and stone rip-rap shore protection at Lake Balaton. (Source: www.google.hu)

Concrete walls and stone rip-rap were constructed along about 45 % of the shoreline of Lake Balaton. Such constructions started at the end of the 19th century and accelerated after 1945. The purpose of shoreline protection structures was to prevent the potential damage to buildings, railways, roads and other artificial structures/property by wave erosion and ice dilatation/drifts (Figure 10). The impacts of the intervention include the loss and interruption of habitat in the littoral zone, loss of about 4.3 to 6.9 km² of reed stands and loss of spawning areas for certain indigenous fish species. It was found (Kutics, 2008) that there is a close correlation ($R^2 = 0.78$) between the length of concrete shore protection structures and the annual fish catch in Lake Balaton. In addition, self-purification potential of the lake was reduced since the floating debris cannot be removed by wave action due to the almost vertical concrete walls. Sandy beaches apparently disappeared and there are great efforts (and huge costs incurred) now to restore some negligibly small sections into “original” conditions. It is apparent that all these changes had a strong and harmful influence on water quality and biodiversity (Herodek S. et al, 1988)

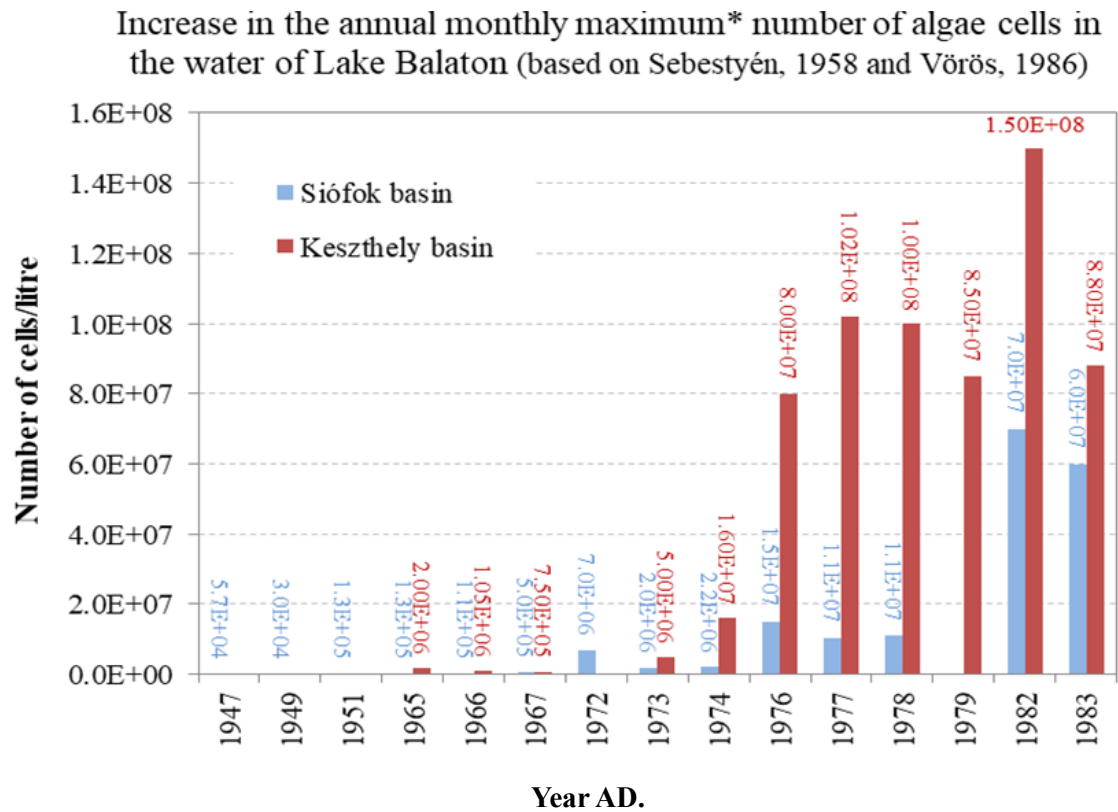
Figure 13. Changes in the concentration of phytoplankton cells in Lake Balaton (*for the 1949-1951 period summer half-year maximums are shown)

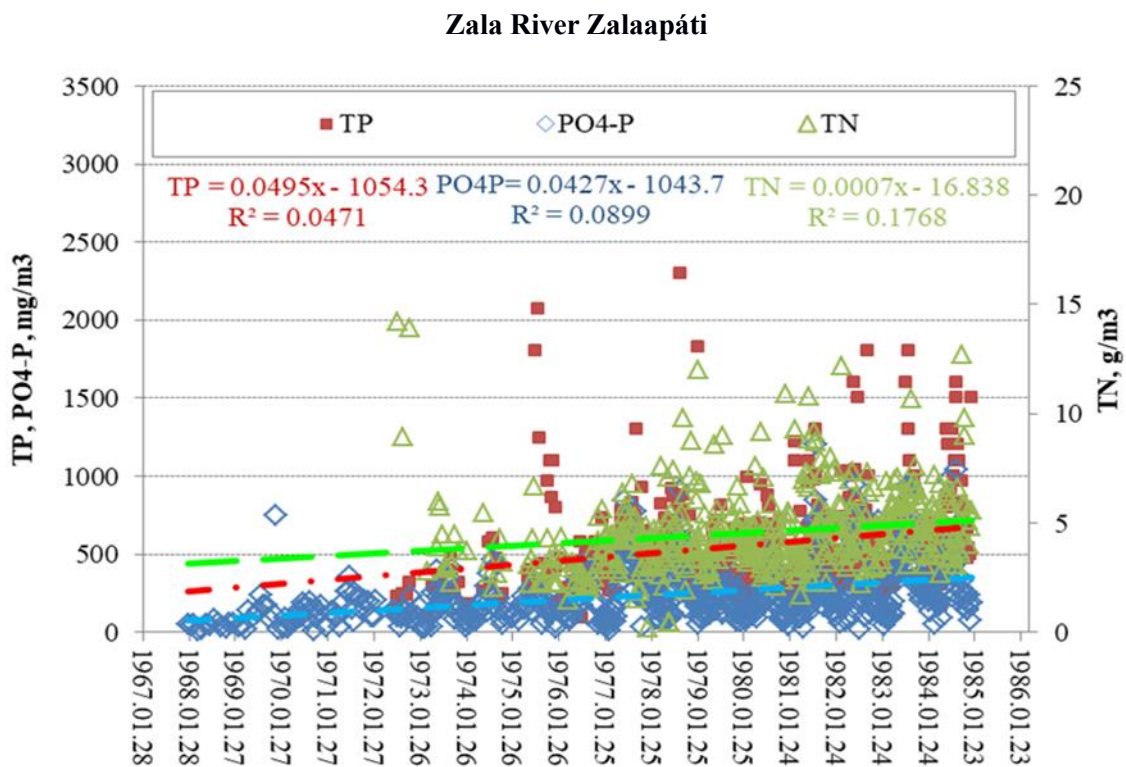
Figure 14. Trends in nutrient concentrations in Zala river at the standard water quality monitoring point in the village of Zalaapáti during the period of the development of eutrophication (Analysis by the author based on raw monitoring data of KDT KÖFE)

All the above described human interventions resulted in an increase of nutrient (phosphorus, nitrogen) load to the lake. In Figure 14, nutrient concentrations of total phosphorus (TP), phosphate phosphorus (PO₄-P) and total nitrogen (TN) in Zala river a few km from the river mouth are shown from the start date of systematic water quality monitoring to the time when full-blown eutrophication was observed. The large number of data scatters considerably, but the statistics in Table 4 clearly show the increasing trends in nutrient concentrations. (Mean and SD values are mg/m³ for phosphorus, and g/m³ for TN.)

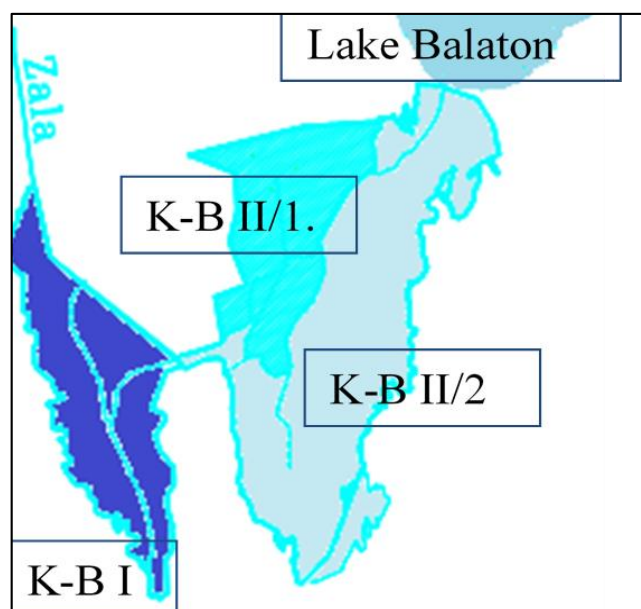
Figure 15. Zala river and the Stages of the Kis-Balaton reconstructed wetlands at the SW end of Lake Balaton (based on <http://www.nyuduvizig.hu/index.php/vizrajz/kis-balaton-tavmero-rendszer-vizmerleg>)

Described in Section 2, the vast wetlands along the downstream section of River Zala were drained and the original habitat destroyed. The sedimentation and filtering function of the wetland was eliminated resulting in fast siltation and eutrophication of the Keszthely Basin. By the end of the 1970s, scientists recognized the need to restore (or rather, construct a new wetland, since the original conditions could not be reproduced) Kis-Balaton (Herodek S. et al., 1988). Immediate planning started. The original, mechanistic plan (with little consideration of ecological aspects or sustainable operation) consisted of Stage I (upper lake of 18 km², and 1.16 mean water depth) and Stage II (lower lake of 51 km² and 1.25 m mean water depth). Stage I would serve as a sedimentation basin and conversion of dissolved phosphorus (DP) to particulate P (i.e. algae) and Stage II as a “filter” of algae with huge reed stands. Stage I was inundated in 1985. Due to lack of finances and concerns about the credibility of the operational hypothesis, only a 16 km² part (Stage II/1) of Stage II was inundated in 1992. A long debate and several re-designs of Stage II followed, resulting in a huge delay in the implementation. Eventually, Stage II was finished at the end of 2014, with significant modifications of the original plan (www.nyuduvizig.hu). The modifications include the separation of Stage II/1 from the other water bodies and assigning priority to nature preservation functions, reconstruction of the short-cut possibility of River Zala, and considerably lower water levels in the rest of the Stage II area (Stage II/2). In spite of the delays in implementation and changed priorities of its function (i.e. nature conservation over water quality improvement of Lake Balaton) the reconstructed wetland removed 81 % of suspended solids, 37% of total phosphorus and 42% of total nitrogen during the 1993-2006 period as compared to the average values of the 1976-1985 period (www.nyuduvizig.hu).

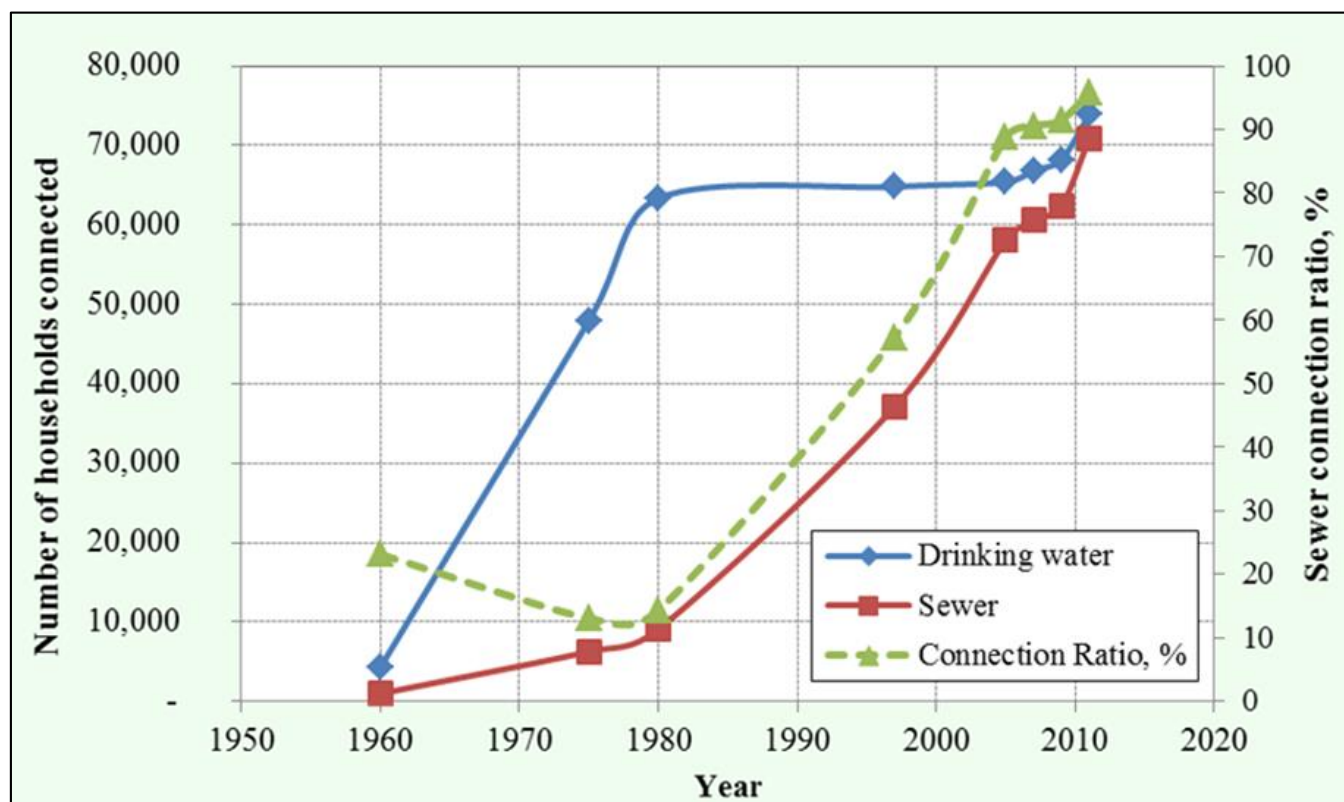
Figure 16. Evolution of drinking water and sewer connection of households as well as the sewer connection ratio in the lakeshore communities of Lake Balaton (Processed data of Koltay J., 2001 and KSH, 2013)

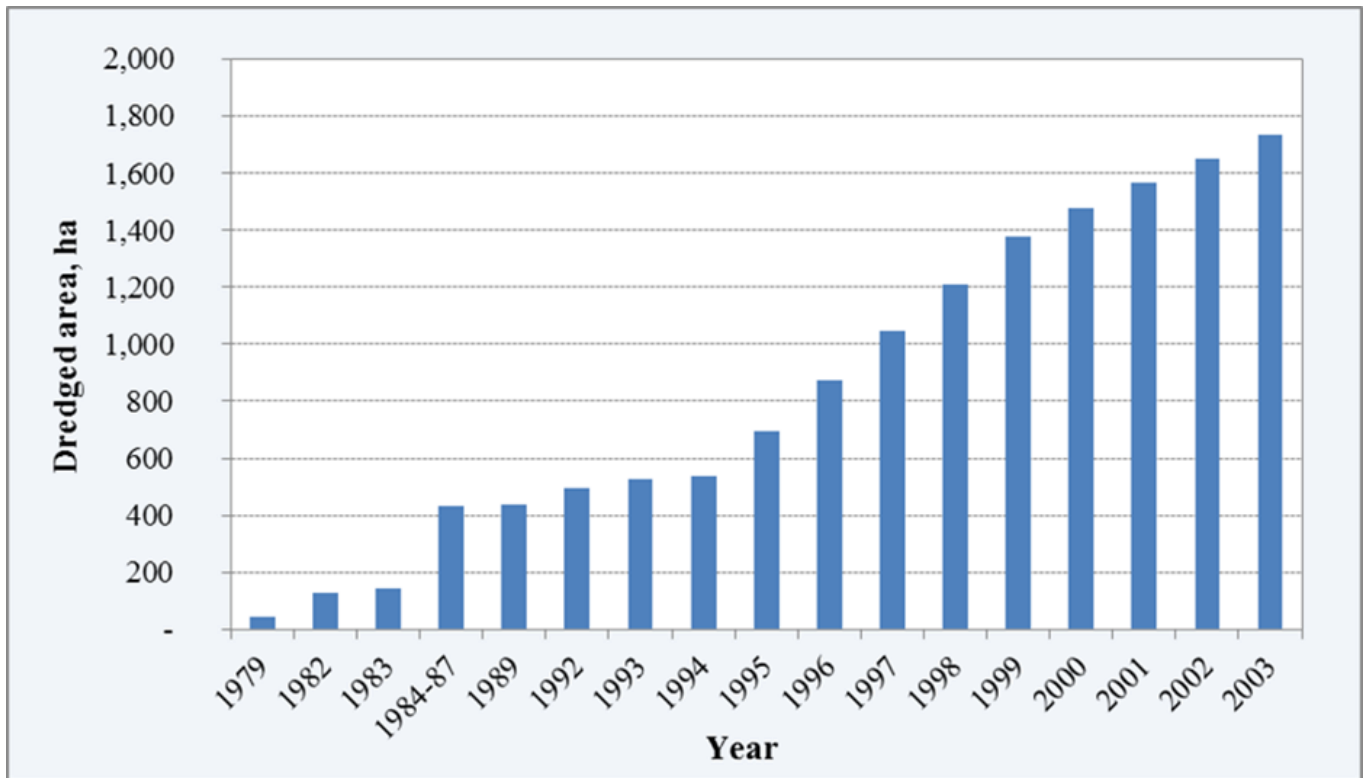
Figure 18. Cumulative lake area where sediment was dredged in the Keszthely Basin of Lake Balaton (Source: Papp F., 2005)

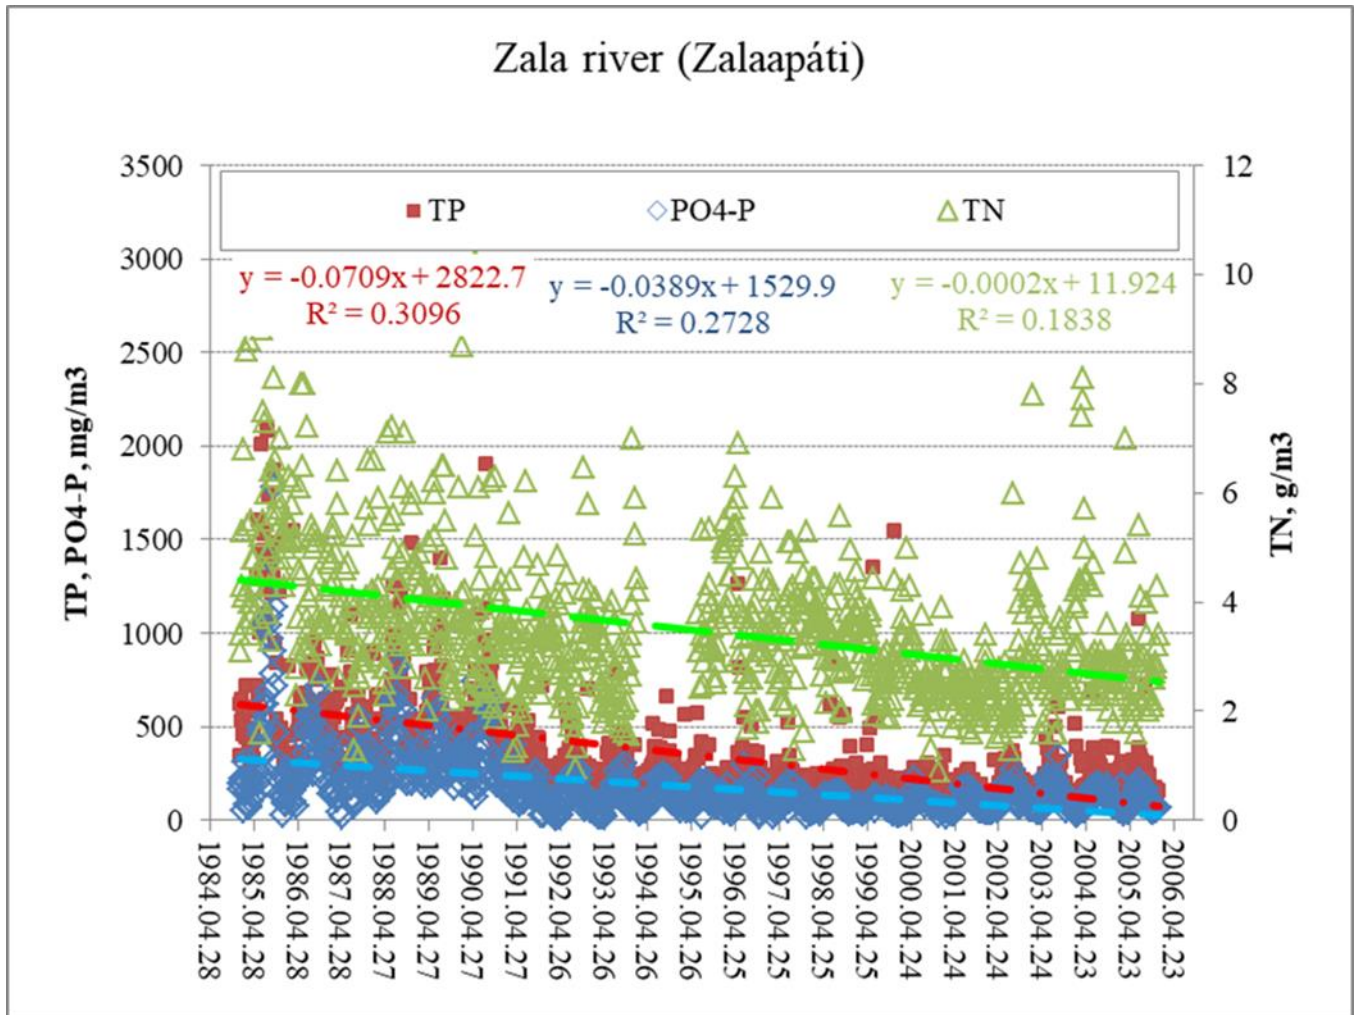
Figure 20. Trends in nutrient concentrations in Zala river at the standard water quality monitoring point in the village of Zalaapáti during the period of the implementation of WQ control measures.

as shown by the water quality monitoring data of e.g. Zala river (Fig. 20).

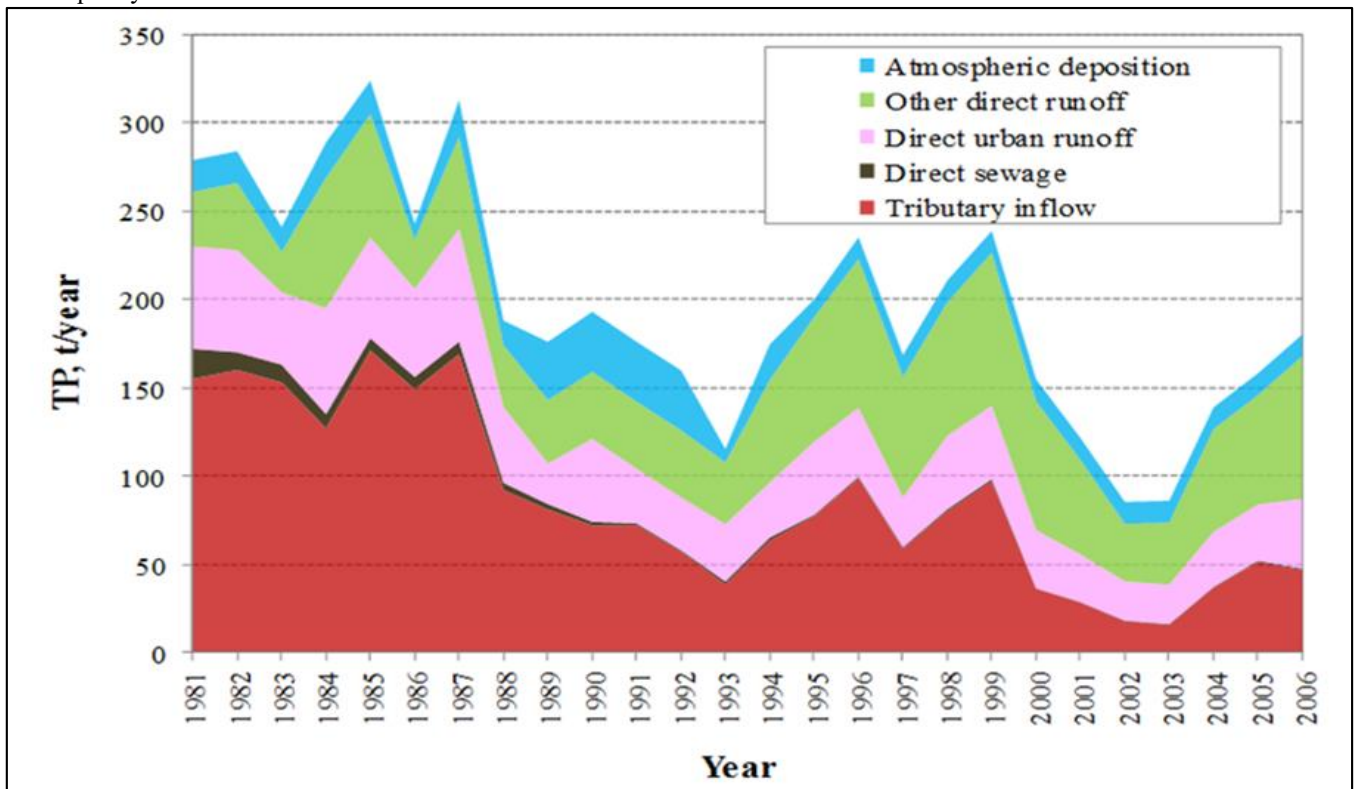
Figure 21. Change of total phosphorus load of Lake Balaton (after Jolánkai G., 2007 and Kutics K., 2011)

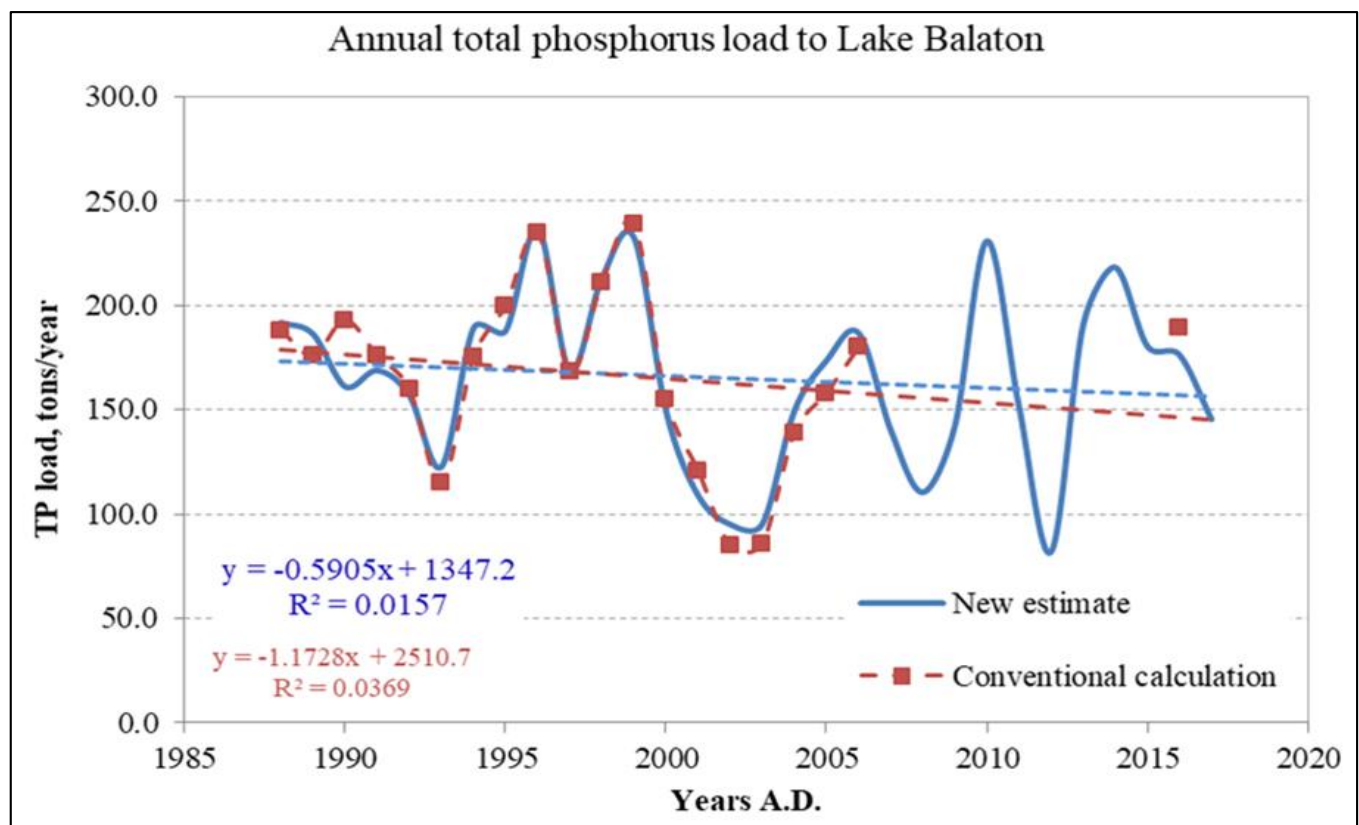
Figure 22. Recent trends in phosphorus load to Lake Balaton (Jolánkai, G. (2007) and author's own analysis of monitoring data)

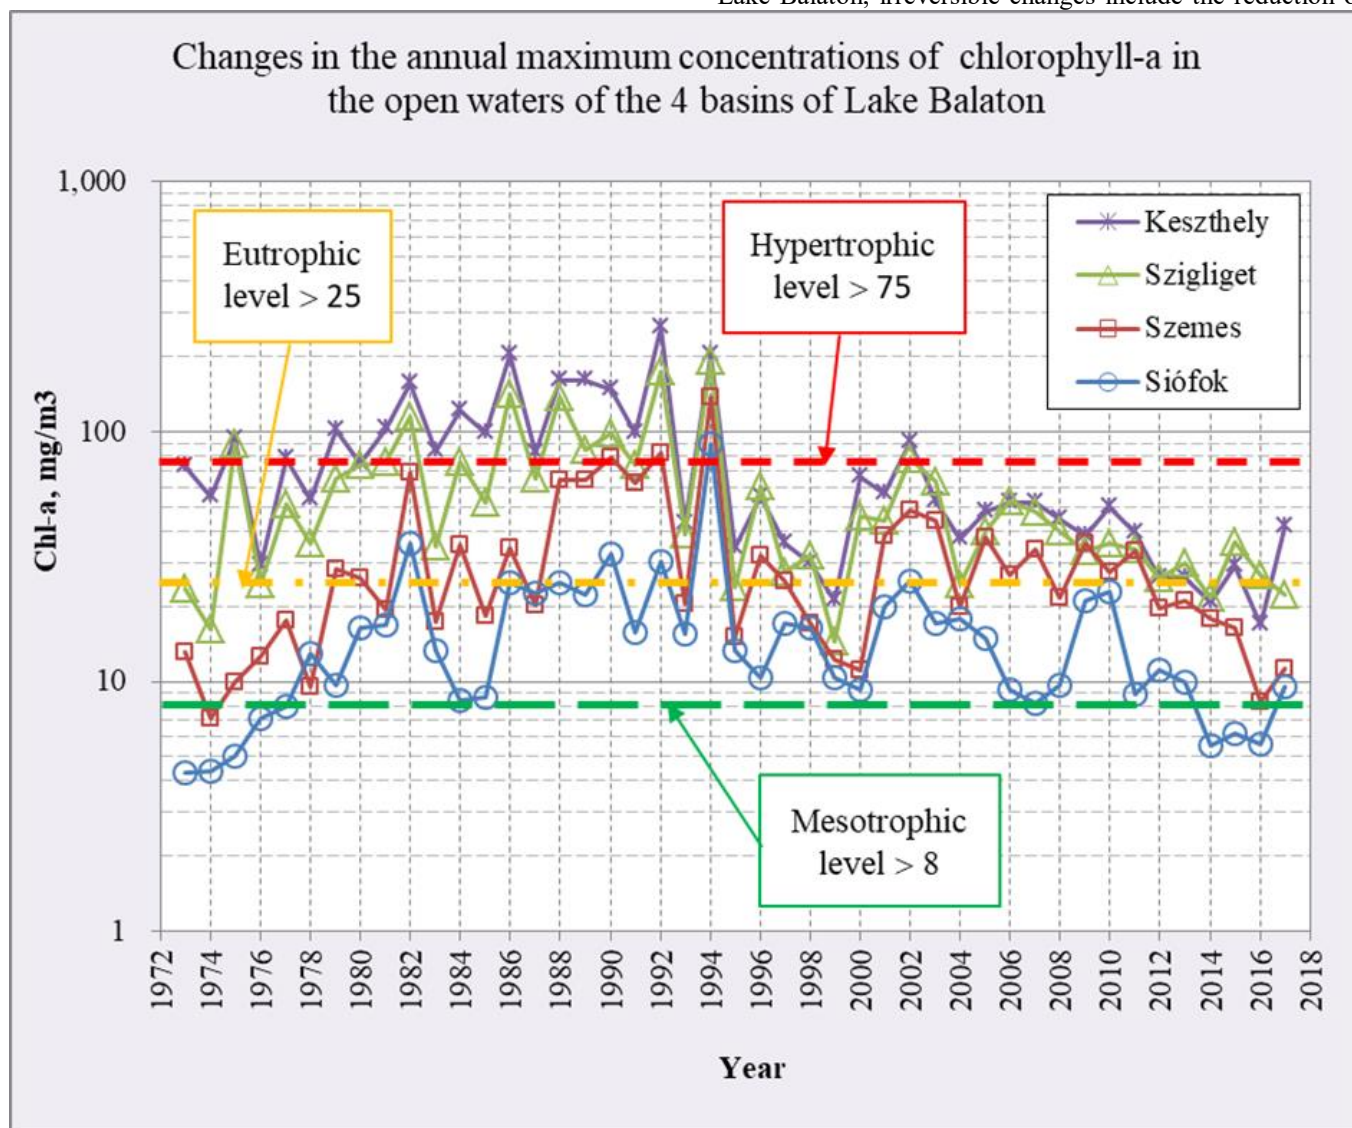
Figure 23. The time series of measured chlorophyll-a maximum concentrations in the four basins of Lake Balaton

As a result of former TP load reduction interventions, eutrophication of the lake was stopped and even reversed. Years after 1994 showed significant reduction in algal biomass (in terms of chlorophyll-a), as shown in Figure 23 and Figure 24. The trophic status of all the 4 basins of the lake improved significantly and hypertrophic conditions were almost completely eliminated. However, a dry spell from year 2000 to 2003 with extreme drought and very low lake levels (some 24% of lake volume was lost by the end of 2003)

Data shown in Figure 23 and 24 indicate that chlorophyll-a concentration, a measure of phytoplankton abundance shows a decreasing trend (with the exception of the period of extreme drought and associated lake level drops from 2000 to 2004). However, during the period of extreme low lake water level – some 80 cm below normal (meaning some 24% loss of lake water volume) mass growth of filamentous green algae (*Cladophora glomerata*) occurred in the shallow water (Figure 27).

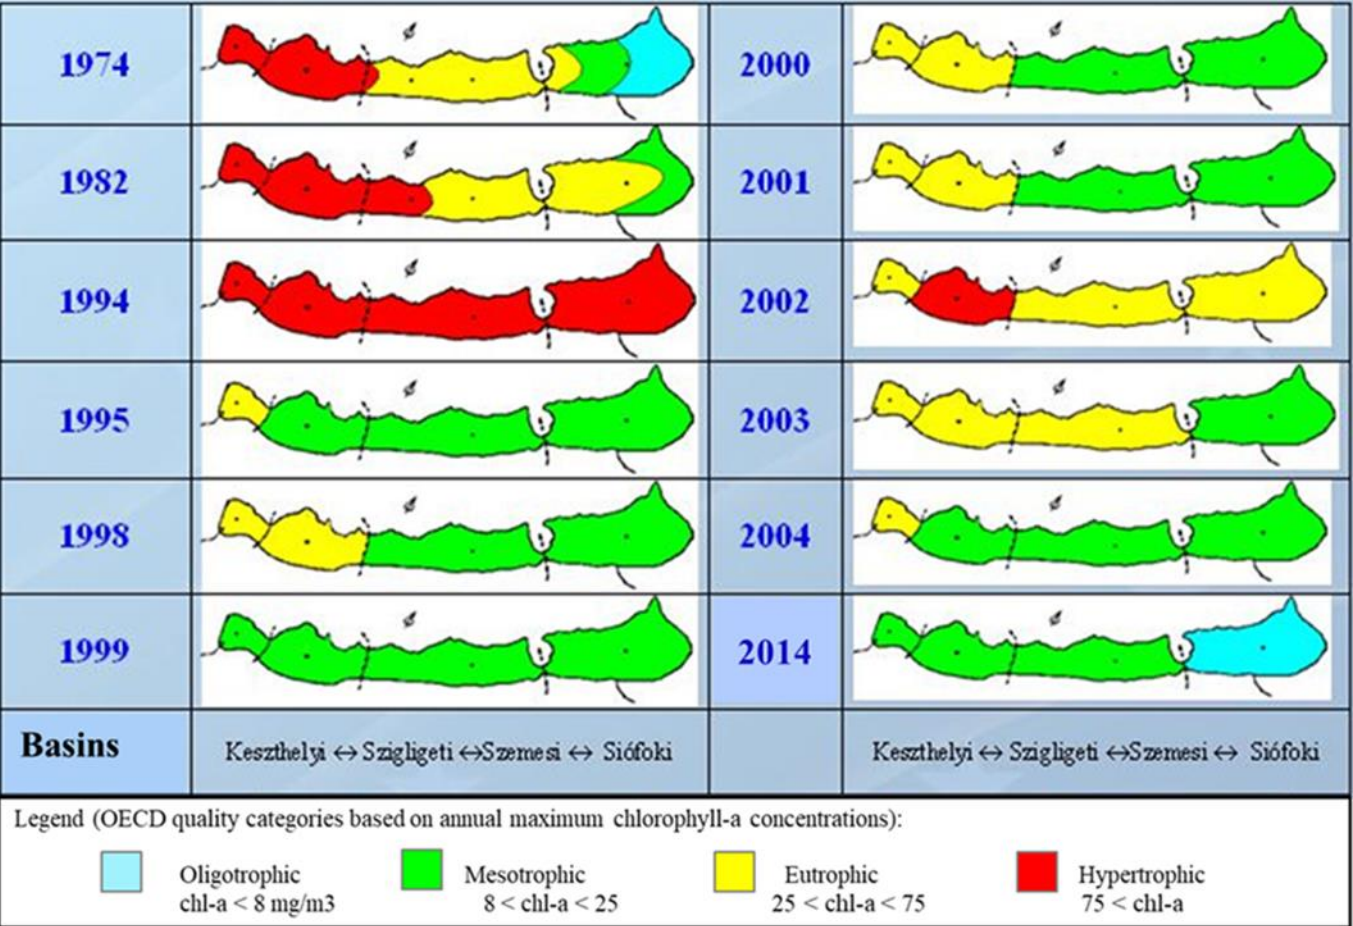
Figure 24. Trophic categories of the 4 basins of Lake Balaton based on annual maximum chlorophyll-a concentration (data source: KDT KÖFE and <http://web.okir.hu/sse/?group=FEVISZ>)

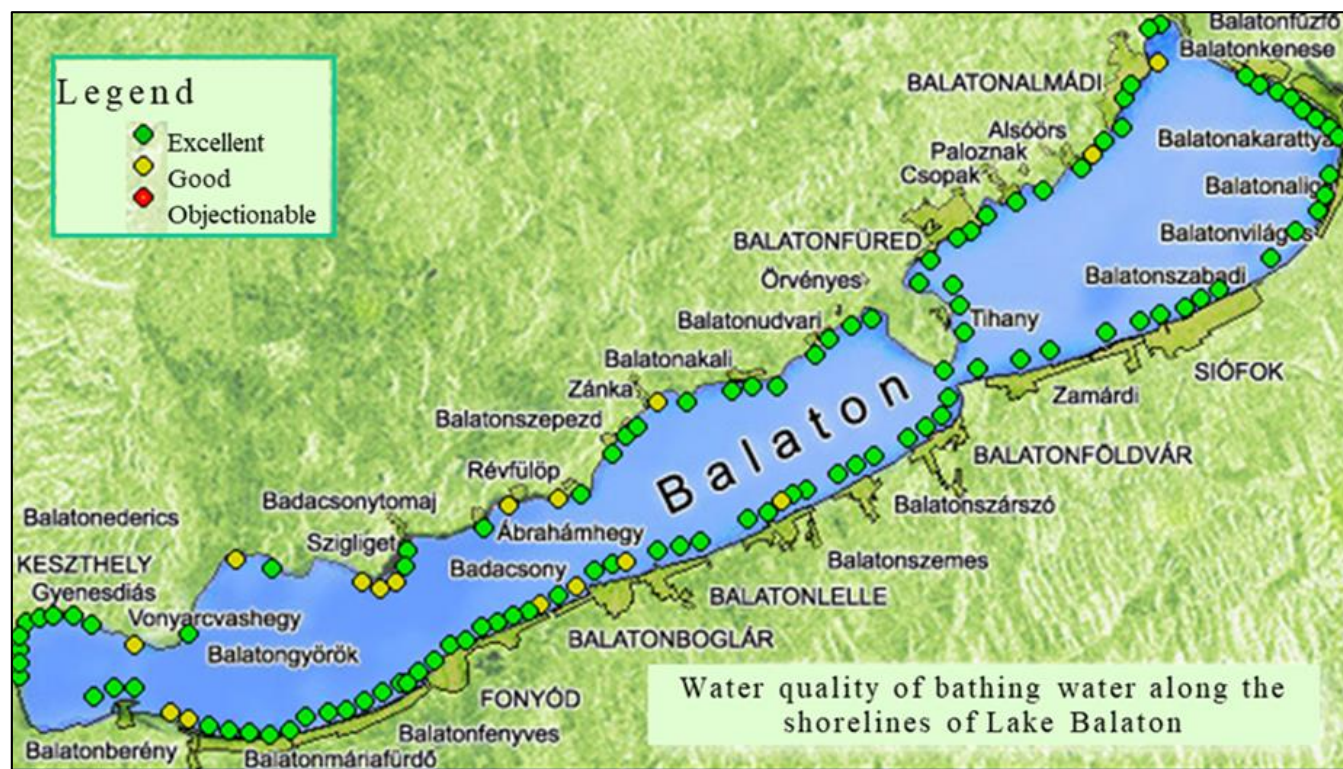
Figure 25. Example of water quality report of bathing sites (“beaches”) along the shores of Lake Balaton (source:

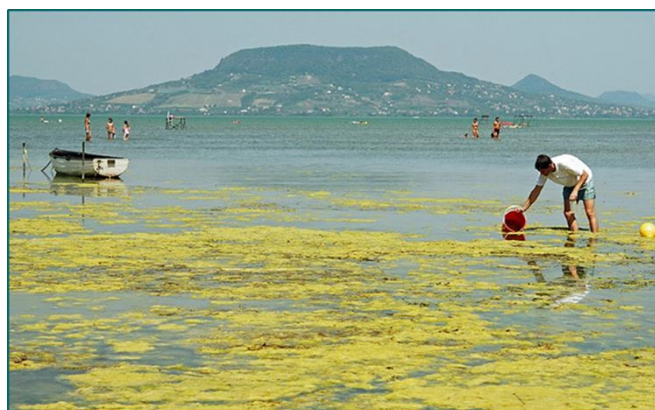
Figure 27. Mass growth of filamentous green algae (*Cladophora glomerata*) in the extremely shallow parts of Lake Balaton (<https://ilovebalaton.blog.hu>)
