Ecocycles, Vol. 5, No. 2, pp. 44-73 (2019)
DOI: 10.19040/ecocycles.v5i2.149

CASE STUDY

Evolution of Water Quality of Lake Balaton

Károly Kutics

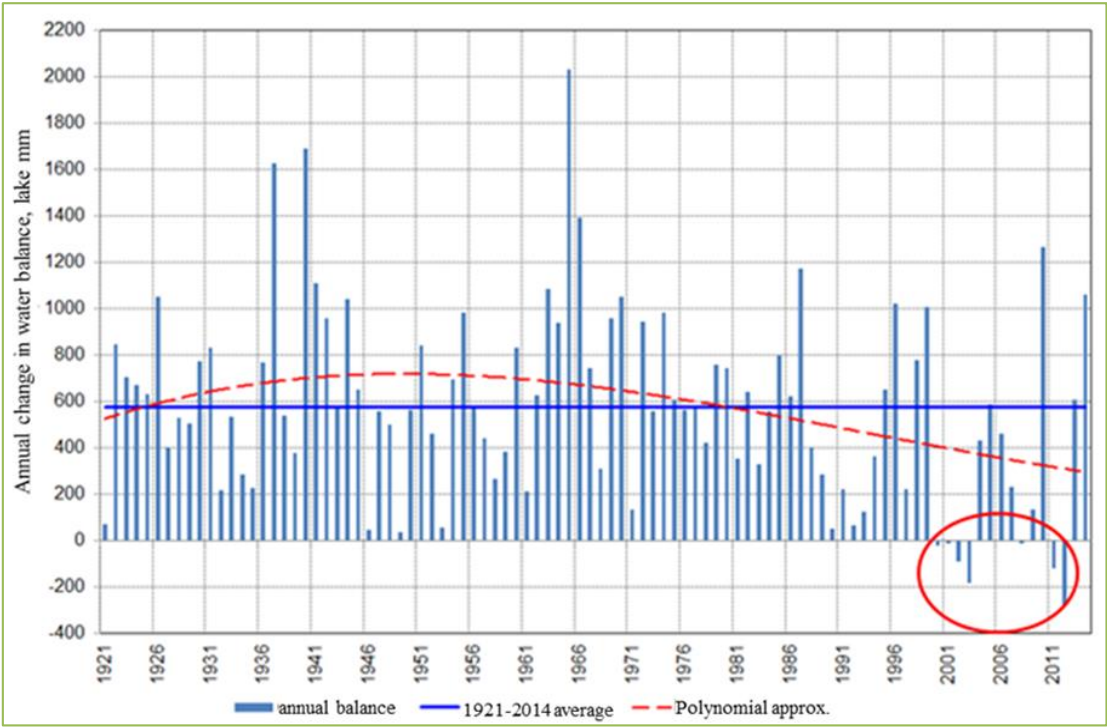
Figure 29. Long-term changes in the annual natural water balance of Lake Balaton (Kutics K. et al, 2016)

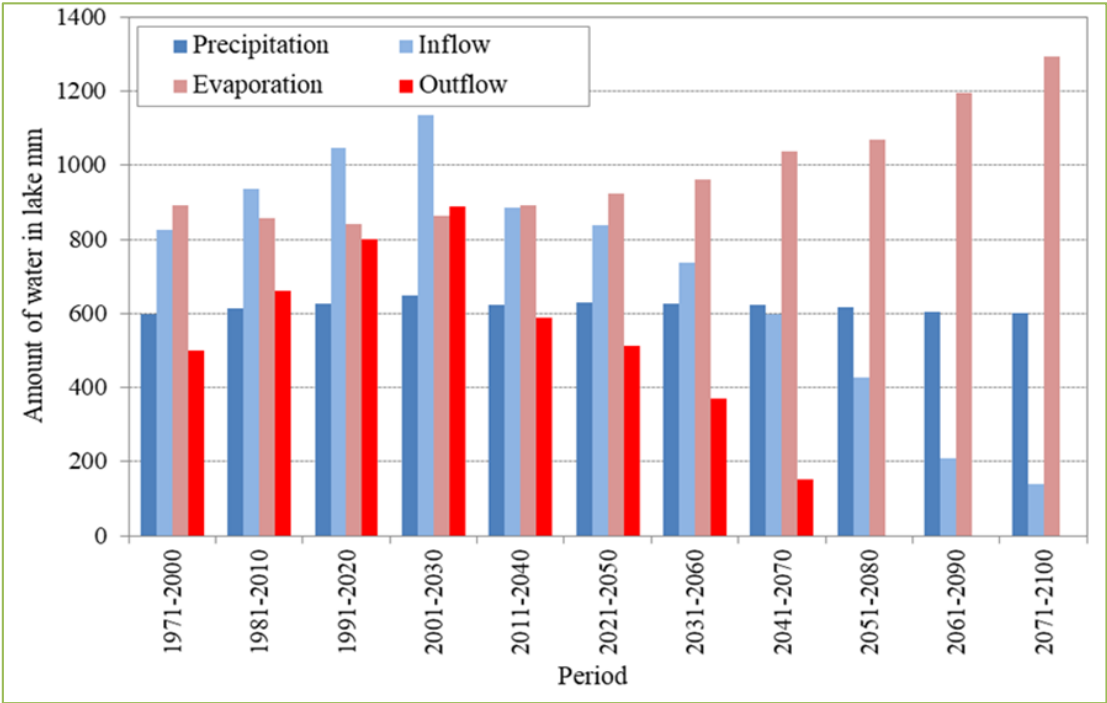
Figure 30. Prediction of the change of water balance elements of Lake Balaton based on regional A1b climate scenario (Kutics K. et al., 2016)

in the natural water balance of Lake Balaton were predicted for the 21st century (Figure 30). According to the predictions, water balance of the lake deteriorates, water outflow decreases, and the lake turns to an endorheic one in the second half of the century. The consequences might be quite serious with level drop, area contraction, salt concentration growth and general deterioration of water quality.
