EFFECT OF FIRE ON NATURAL STONES

András Biró, Viktor Hlavička, Éva Lublóy

Budapest University of Technology and Economics, Department of Construction Materials and Technologies, H-1111, Budapest, Műegyetem rkp. 3. Hungary

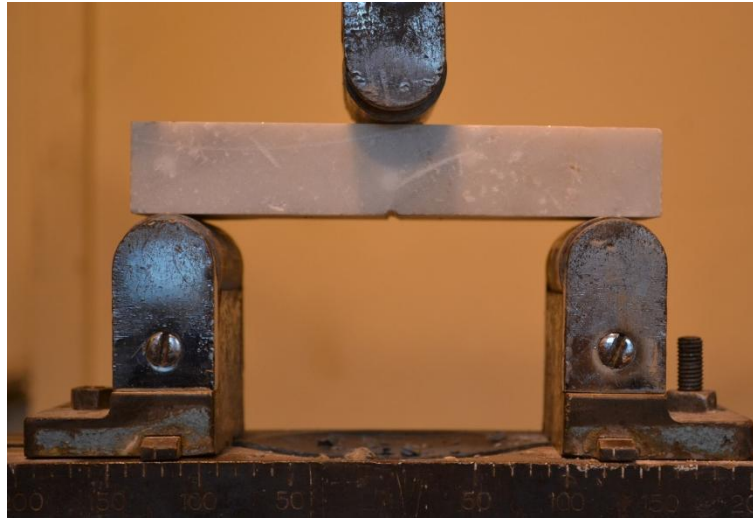
Figure 3: Experimental setup for flexural strength test

Flexural strength was also measured. The geometry of the specimens was: 25×50×150 mm. The applied support distance was 125 mm. The experimental setup can be seen in *Figure 3*. The force which caused the failure of the specimen was measured. The device used for this test was force controlled. The loading speed was 0.5 MPa/s.

There was small groove on the specimens (*Figure 3*). These grooves made sure that the failure happened at the middle of the specimen and made possible to also evaluate the results by fracture mechanics methods. This evaluation is not the subject of this research.

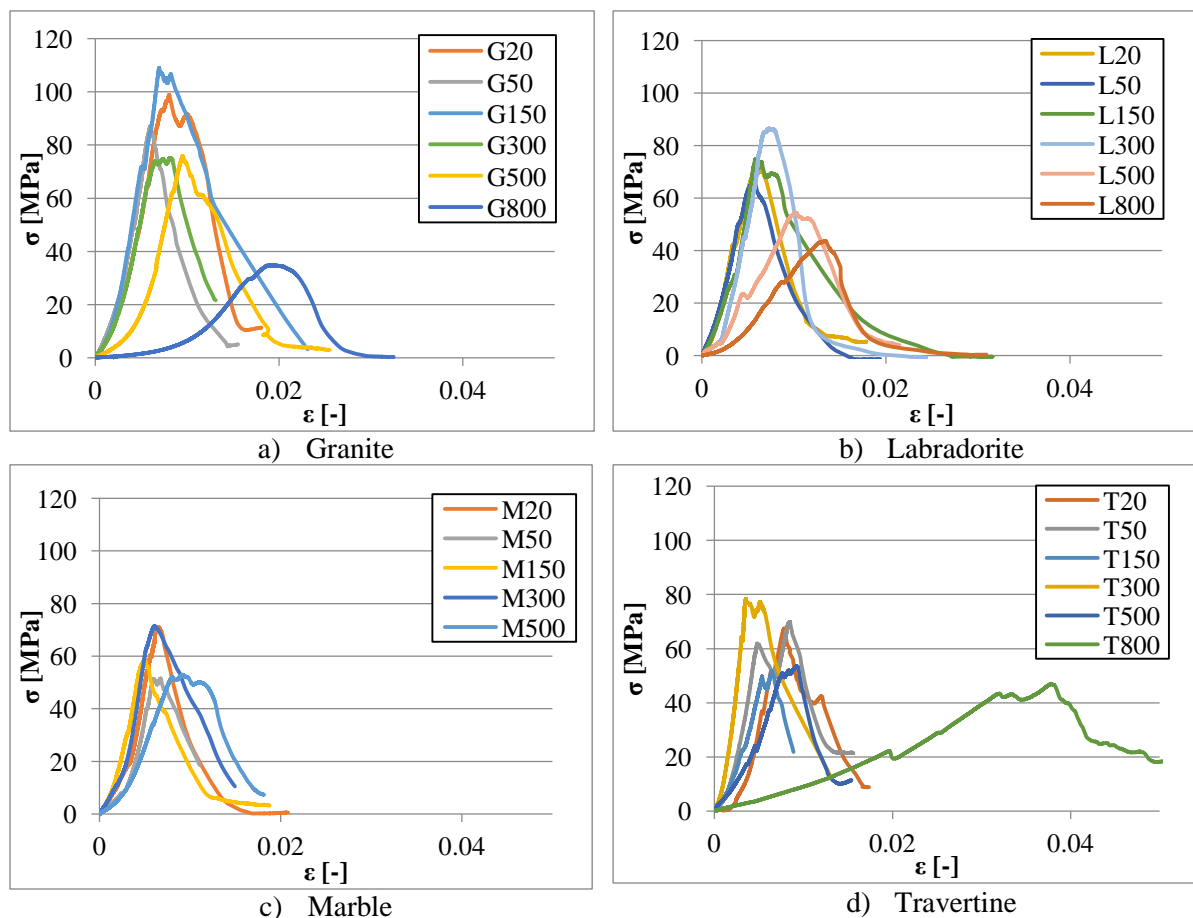
Figure 8: Typical stress-deformation curves by rock type and temperature

The recording of the lateral and axial deformations made it possible to make the stress-deformation curves, some of the typical ones for each rock at each temperature are shown on *Figure 8*. The decrease of the stiffness of the rocks was significant only after being exposed to 500 °C and above. At these high temperatures the initial deformations were also bigger, and the typical linear phase was delayed. There were more cracks after high temperature loading which had to close first. Furthermore, it can be stated that during the load, with the increase of heat-load, the curves were much more unevenly formed, there were more breakpoints on them. At 800°C the failure of the specimens (except for the marble because measurement results were so low that they could not be considered after temperature loading with 800 °C) happened with a larger deformation.

In the case of the two igneous rocks the linear slope of the curves varied only slightly up to 300 °C, but both the stiffness (Young's modulus) and the strength decreased, and the deformations increased significantly at 500 °C and 800 °C. These were true for both igneous rocks, although the decrease in stiffness was bigger for the labradorite after temperature loading with 500 °C, and the decrease in strength was bigger for the granite after temperature loading with 800 °C.

The travertine had the biggest deformation of the specimens heated to 800°C, and it had the highest number of breakpoints on the curves out of all the rocks at all temperatures. These breakpoints can be explained by the pores in the travertine. The marble specimens suffered so much damage after temperature loading with 800°C that their stress-deformation curves were useless. After temperature loading with 500°C the initial deformations and the stiffness decreased. At lower temperatures however, only small changes occurred because of the homogenous microcrystal structure.

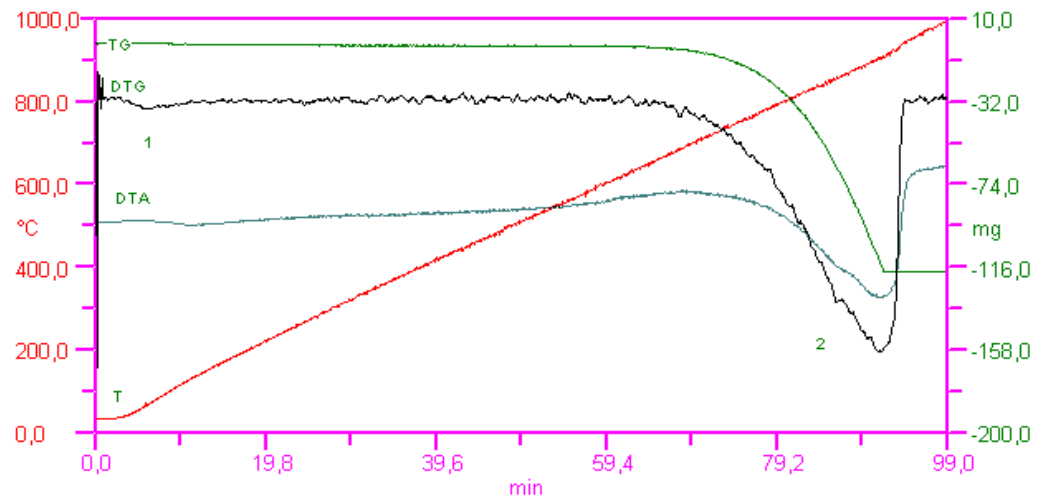
Figure 14: Derivatogram of the marble

The marble and the travertine showed similarities on their derivatograms. The derivatograms of the marble and of the travertine had two thermal decomposition peaks each:

- Peak 1: Release of absorbed water
- Peak 2: Decomposition of CaCO_3 ($\text{CaCO}_3 \rightarrow \text{CaO} + \text{CO}_2$)

According to the weight evaluation of the marble and the travertine, the emission of CO_2 was higher for the travertine, suggesting that the CaCO_3 content of the travertine sample was higher. This was predictable because marble may contain MgCO_3 as well. The decomposition of MgCO_3 only happens at higher temperatures. The same result was shown by the weight of the spalling material after the 800 °C heat-load.
