## TRACES OF A CHURCH AND FORTRESS BUILT PRIOR TO THE HUNGARIAN CONQUEST FOUND IN A BENEDICTINE MONASTERY

### New Discoveries in Kaposzentjakab

ISTVÁN MOLNÁR<sup>1</sup>

Hungarian Archaeology Vol. 9 (2020), Issue 3, pp. 13–26. doi: <https://doi.org/10.36338/ha.2020.3.1>

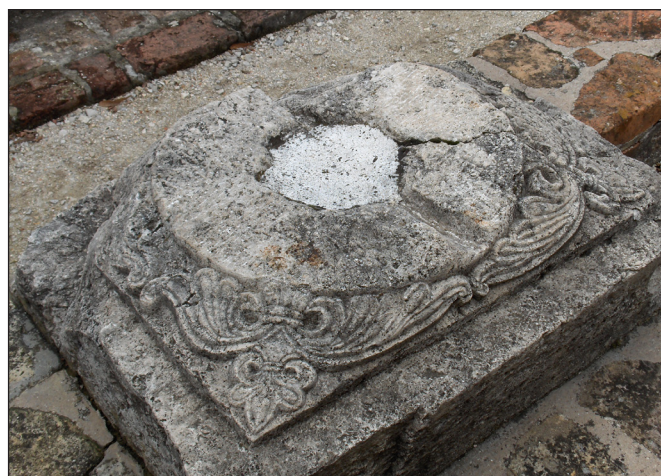
Fig. 3. Carved column base preserved in its original location in front of the sanctuary of the church

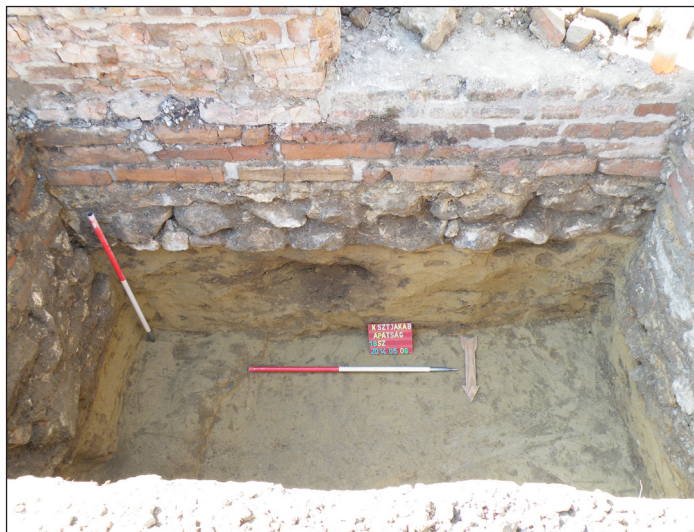
Fig. 4. The foundation wall of the early church

When excavating in the monastery church in 2014, we found the remains of the church that was already at the site when the abbey was established and was also mentioned in its deed of foundation. The structure's foundation was easily distinguishable. It was comprised of two to three rows of raw stones of 20 to 60 cm that were set using little or no mortar, and three to four rows of masonry consisting of large bricks that were 40 to 50 cm long and 8 to 10 cm thick (Fig. 4). The rows of bricks must have been used to construct the foundations in the 1060s, but it is also possible that they were located above the surface in the past. Foundations such as this could be observed on the inner walls of the monastery church, and thus on the inner side of the side galleries on the north and south sides, and on the adjoining part of the eastern wall. The walls of the sanctuary of the monastery church had destroyed the foundations there, which were made in a similar way with slightly more mortar. The west wall of the early church was inside the monastery church, and therefore it was damaged by the digging of later graves. However, we did manage to find the location where the wall began in the north and south, as well as a short wall section in the middle. From the remains, the form of a 7.5×12–13 meter large, single-nave church with a straight apse emerges. The wall sections of this church were used in the construction of the monastery church. On the northern side of the church interior, the remains of the ascending walls of the early church that were laid with large bricks can still be seen today (Fig. 5).

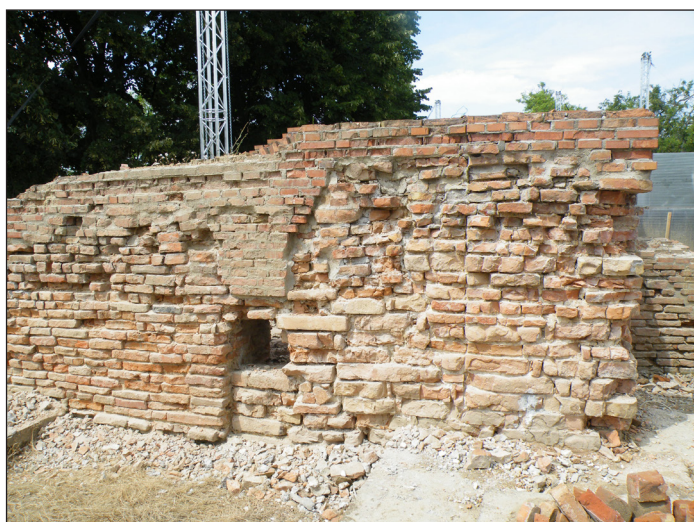
Fig. 5. The reused wall sections of the early church can be easily distinguished in the picture taken during the renovation of the monument

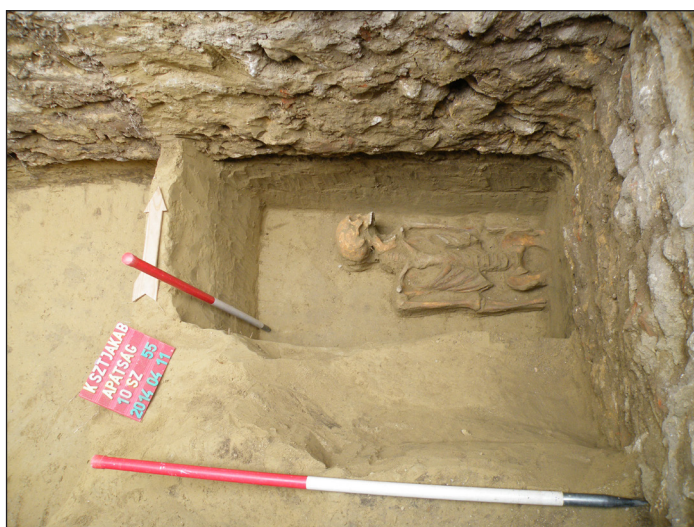
Fig. 6. An early burial intersected by the foundation walls of the monastery church

The age of the first church is indicated by the graves excavated next to it, which were then intersected by the foundation walls of the monastery church built in the 1060s (Fig. 6). Obviously, a significant portion of the early cemetery was destroyed by later burials and constructions projects. In addition, only those graves without finds that were destroyed by the 11th-century walls can be identified with certainty. It is important to emphasize that the early church was certainly not built on an even earlier cemetery, as its foundation walls do not intersect burials anywhere, and

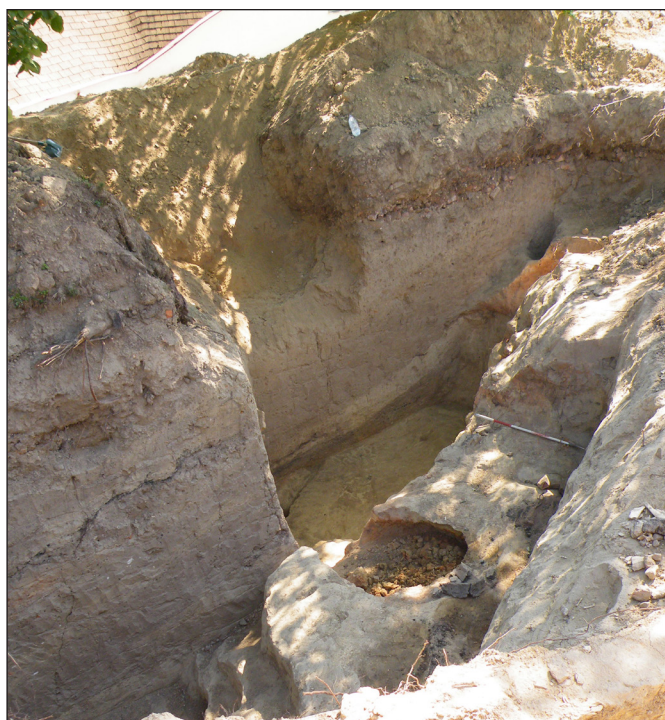
*Fig. 7. Remains of berms dug into the hill during the construction of the early rampart*

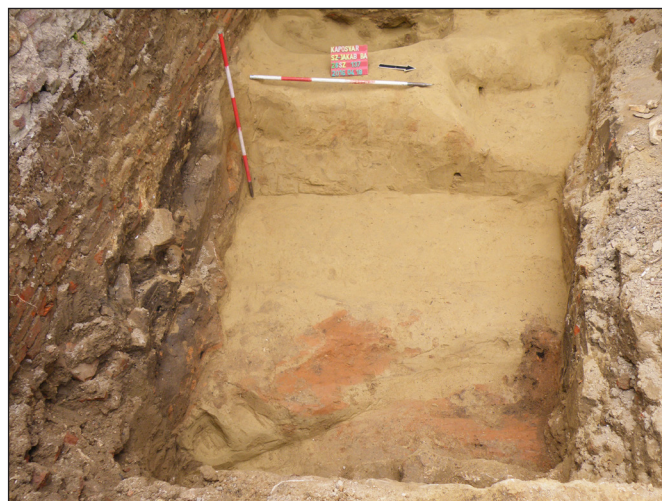
*Fig. 8. Evidence of charring on the wooden structure on the lower berms*

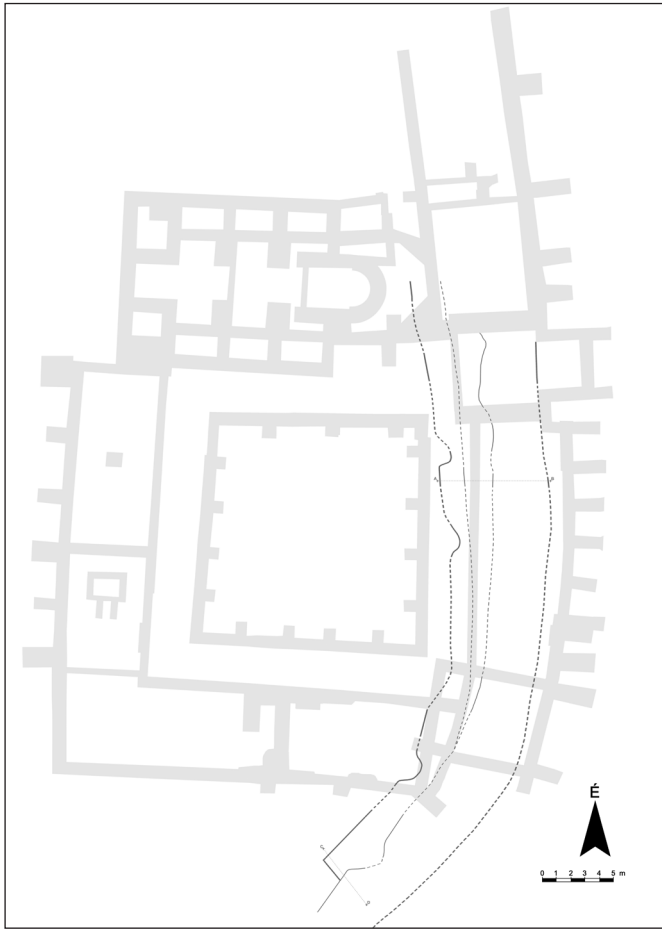
Fig. 9. Presumed location of the fortress on the east side

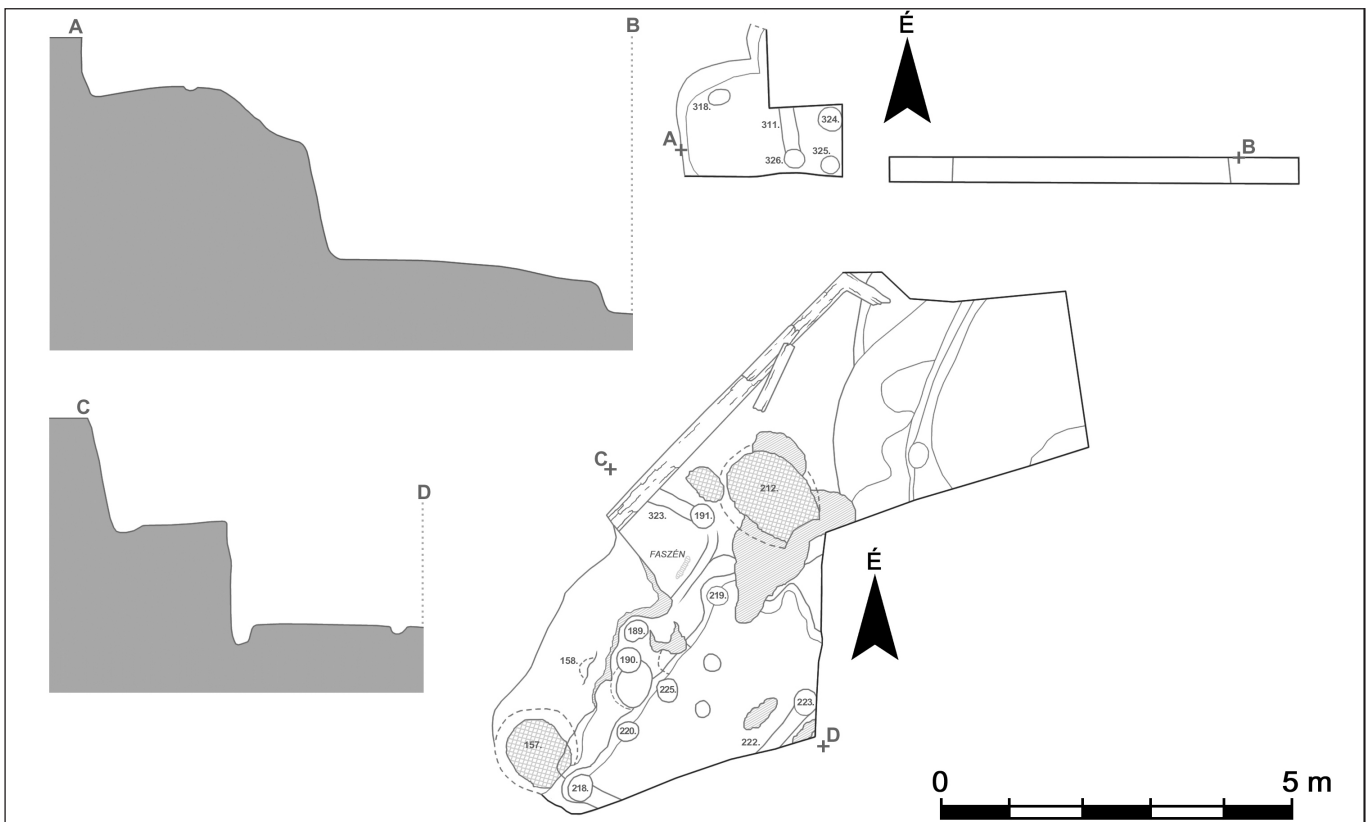
Fig. 10. Surface and segment of the elements of the ramparts excavated in sections No. 22, 26 and 32

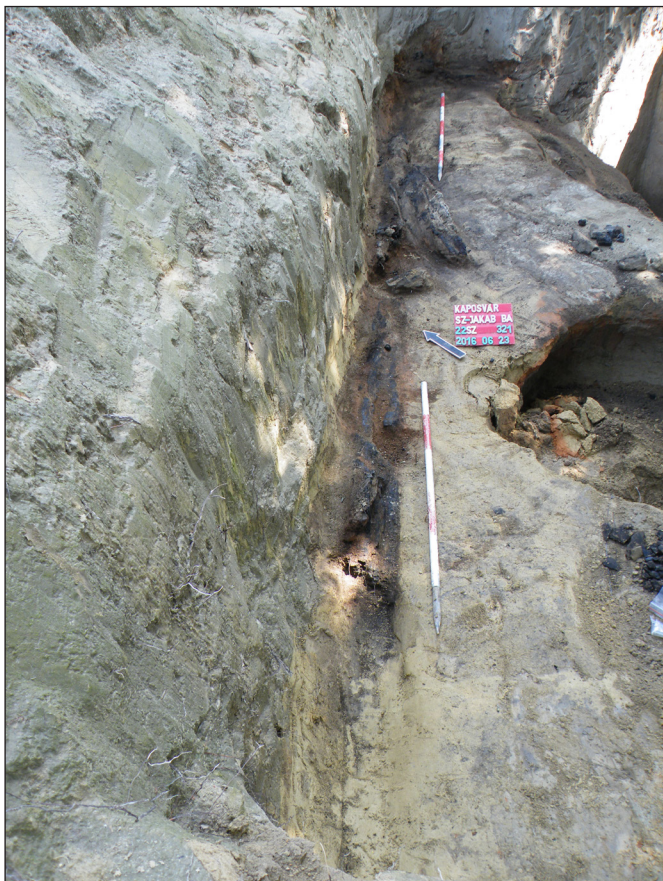
*Fig. 11. Charred remains of the wooden structure of the rampart*

There were a few charred beams left of the wooden structure itself (Fig. 11). The fact that the beams are pressed into the loess soil and the sides of the berms in several places aids in reconstruction. Due to this, the beams that lie horizontally are indicated by long, small ditches with curved bottoms, while the standing beams are indicated by shallow, circular depressions or by curved remains on the sides of the berms. The constructed panels were approximately 1.8–2 meters wide and approximately 3.5–4 meters long. There was only one row of these on the upper level, while two panels could fit on the lower level, but we found clear evidence of only one panel that stood against the wall in the area that was investigated. The wooden structure was connected to the bottom and sides of the berms in several places, the former being indicated by postholes with a diameter of 25–40 cm, and the latter by horizontal pole slots carved 30–40 cm deep into the wall (Fig. 12). In addition, rows of horizontal beams that lay atop one

Isotoptech Ltd - HAS Atomki Laboratory performed carbon isotope dating (DeA 9495) on a sample from one of the charred beams (Fig. 11). Based on the examination, the sample dates back to 694–861 with a 95% probability. According to this, the structure (or the part of it that was examined) cannot be earlier than the 8th century. The time at which the ramparts were destroyed is determined by the plants that were burnt at the time of destruction. Remains of a significant portion of processed millet and a pear (seeds, charred residue of the core and fruit pulp) were found in the destruction layer (the plant remains were identified by Ferenc Gyulai, and I would hereby like to express my gratitude to him). The carbon isotope measurement was performed by Isotoptech Ltd – HAS Atomki Laboratory (DeA 10089, 10091). There is a 95% proba-

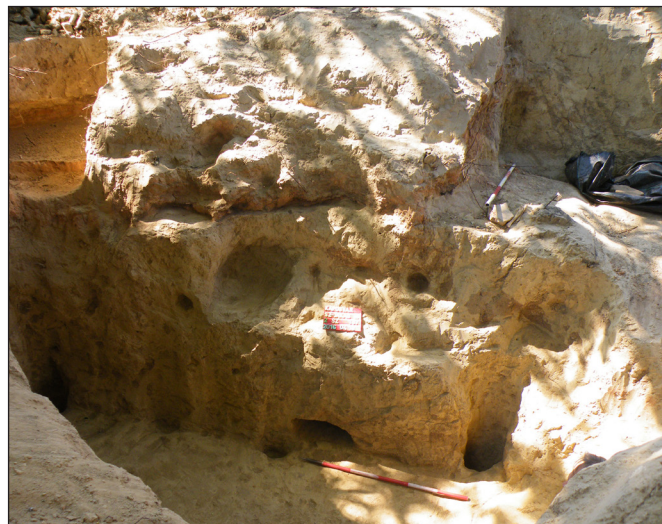
*Fig. 12. Traces of the wooden structure standing on the lower berm*

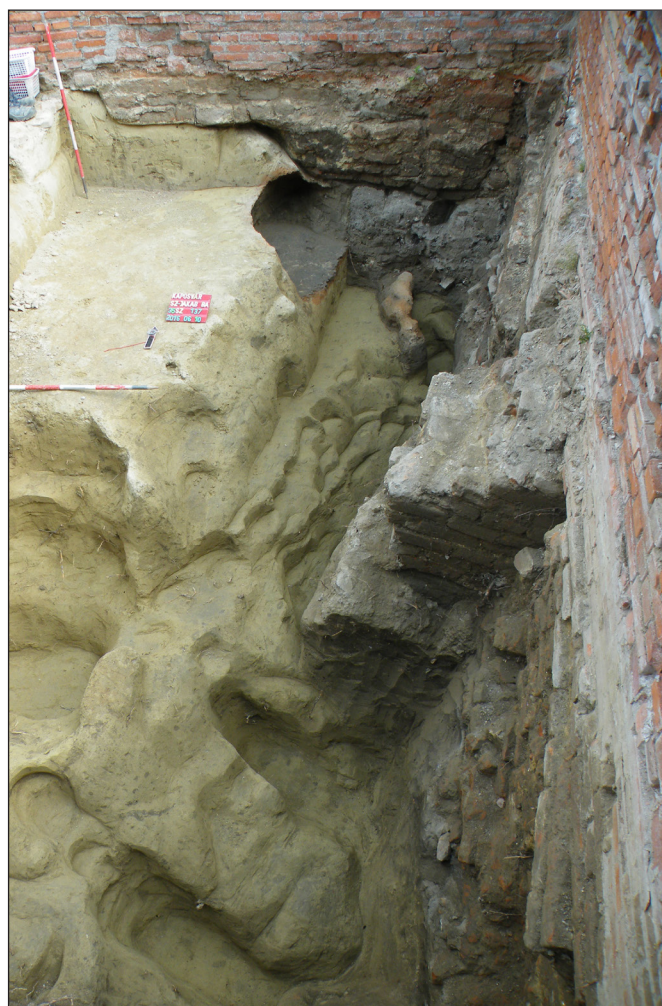
*Fig. 13. Traces of horizontal rows of paired beams that were used to connect the wooden structure to the hillside*

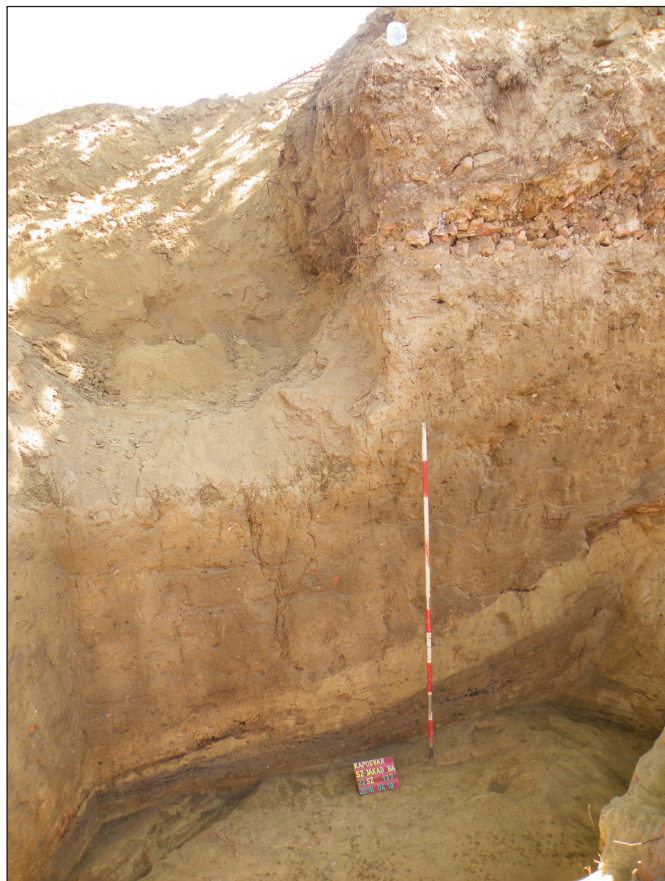
Fig. 14. Layers of the fill in the berm deposited after the destruction of the rampart. The imprint of the horizontal beam of the wooden structure can be seen on the left side

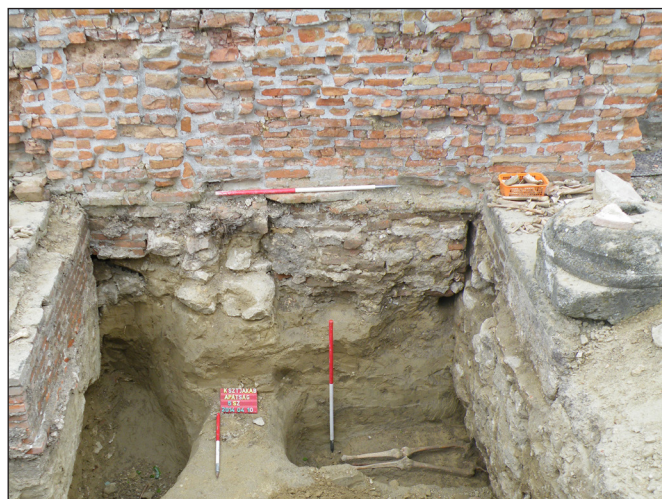
Fig. 20. Walls of the monastery church from different periods. On the left, the pillar foundation of the monastery church is visible, to the right are the remains of the early church, and then the wall section added during the Gothic reconstruction. On the right, the wall of the monastery church and the early tomb that was destroyed by its construction can be detected

The walls on the northern and southern sides of the old church were used for the building that was consecrated in 1067. The 1–1.4-meter-deep foundation of the newer walls was easily distinguishable, consisting of mortar-covered stone and brick elements, on top of which there are three rows of horizontal or one row of oblique bricks. An 18.5×12.5-meter building with a semi-circular apse divided by lesenes was erected atop its walls and had entrances on the west and the south. Inside the building, galleries were built on the northern and southern sides and a tower or a pair of towers probably stood above the west gallery. In the center of the building, four deep columns standing on foundations made of ashlar supported a tower above a vaulted area. The column bases with palmette decorations in front of the sanctuary may have been a part of the chancel arch, and the shallow foundation between the two large pillars in the west may have belonged to a choir screen (MOLNÁR, 2015, 189–191). Gergely Buzás concluded that the building most closely resembles the contemporary architecture of Dalmatia, while also highlighting that the building shares similarities with the nearly contemporary Benedictine monasteries of Szekszárd and Feldebrő in Hungary (BUZÁS, 2018).
