ARCHAEOSEISMOLOGY OF THE AD 1545 EARTHQUAKE IN CHIANG MAI, NORTHERN THAILAND

Abstract (Archaeoseismology of the A.D. 1545 earthquake in Chiang Mai, northern Thailand): The A.D. 1545 Chiang Mai earthquake in northern Thailand was studied by historical and archaeological sources. The temple Wat Chedi Luang has lost about half of the original 80-metres height due to southward-directed collapse. Twenty-one temple sites – out of 74 visited – has tilted pagodas, up to 5° in various directions, dominated by a SE trend. All damaged temples were built before the 1545 earthquake. We suggest that a city-wide liquefaction event caused tilting. The responsible earthquake possibly occurred along the Doi Suthep Fault within city limits. Possible activity of distant faults is assessed.

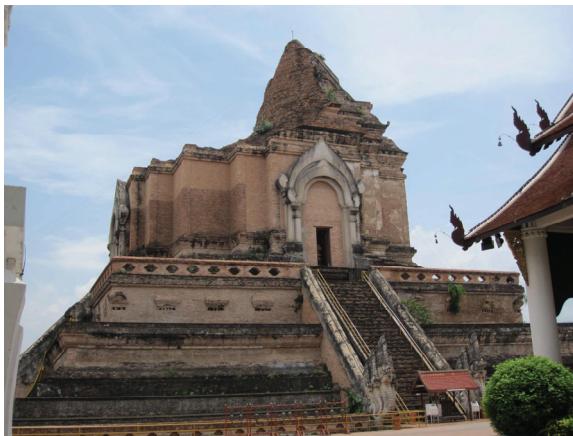
Fig. 1: Wat Chedi Luang in Chiang Mai, Thailand, seen from the southeast. Damaged during the AD 1546 earthquake, the upper half of the stupa fell to the south.

The largest chedi (stupa, pagoda) ever built in what is Thailand today is the Wat Chedi Luang, standing in the monastery of the same name in the centre of old Chiang Mai city (Fig. 1). Built in 1391, it has been reconstructed and enlarged several times. A huge chedi, 56 x 56 m rectangular basement, approx. 80 m

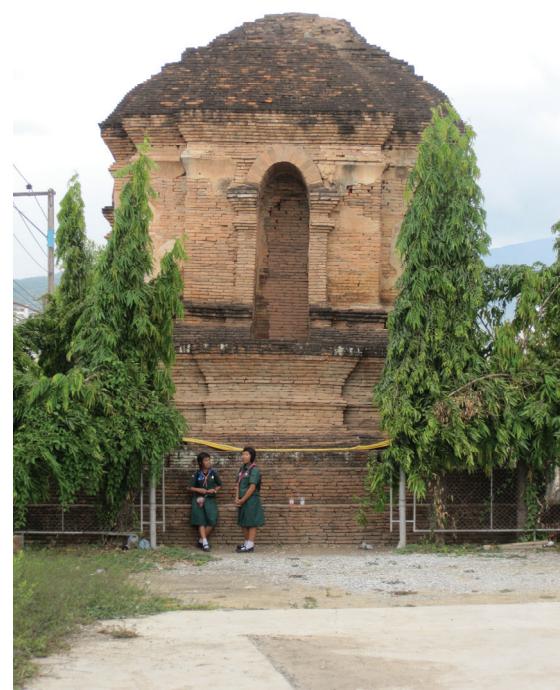
Fig. 3: Tilted buildings citywide

In addition to the famous damaged chedi, numerous religious and secular monuments in and around the old city bear evidence for some kind of earthquake damage. The most obvious evidence is tilting of chedis: the pointed top part of the monument clearly deviates from the vertical by a few degrees (Fig. 3). (The lightweight metal decoration at the very top is almost always heavily tilted; we did not take these into account, only the brick portion below.) Historical data on construction time of the chedis indicate that all of them were built in the 14-15th century AD, before the A.D. 1545 earthquake (Fig. 4). Locations and tilt directions are mapped on Fig. 5.
