**ACCEPTED FOR PUBLICATION IN COMPOSITES SCIENCE AND  
TECHNOLOGY**

**DOI: 10.1016/J.COMPSCITECH.2014.05.020**

**DAMAGE DETECTION AND SELF-REPAIR IN HOLLOW  
GLASS FIBER FABRIC-REINFORCED EPOXY  
COMPOSITES VIA FIBER FILLING**

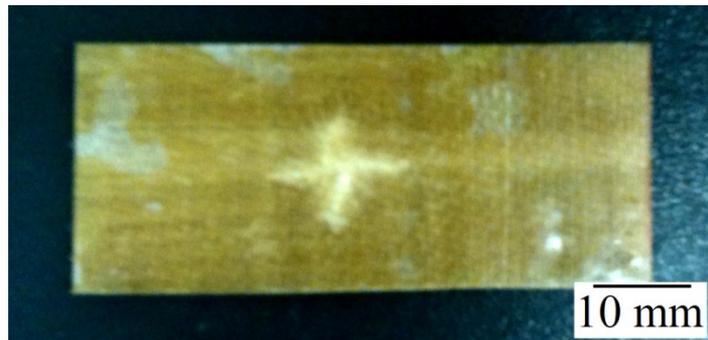
**Figure 4**

**Figure 4.** The formation of the impact damage

HGF reinforced composites were prepared by the HLU technique as described above. They were filled with the components of a polyester resin system, and the self-repairing ability was examined. The nominal size of the specimens was 24×1.25×60 mm. The energy of the impact was adjusted so that after the impact the residual strength and modulus could be measured in three point bending. The bending strength and the bending modulus were compared on different types of specimens: unfilled – undamaged, unfilled – damaged, filled – undamaged, filled – damaged, filled – healed. During the preliminary fracture tests it was observed that the filled specimens can absorb more energy than the unfilled ones. The energy of the incident impact was selected so that the residual strength remained well measurable. The weight of the falling dart was 3.62 kg, the falling height of the unfilled specimens was 40 mm (1.42 J), whereas the falling of the filled specimens was 110 mm (3.91 J). The filling of the hollow fibers increased the energy absorbing property of the composite specimens; the low impact energy did not result in fracture in the specimen, so the impact energy had to be increased so the healing could be measured. The formation of the impact damage on a specimen is seen in Figure 4.

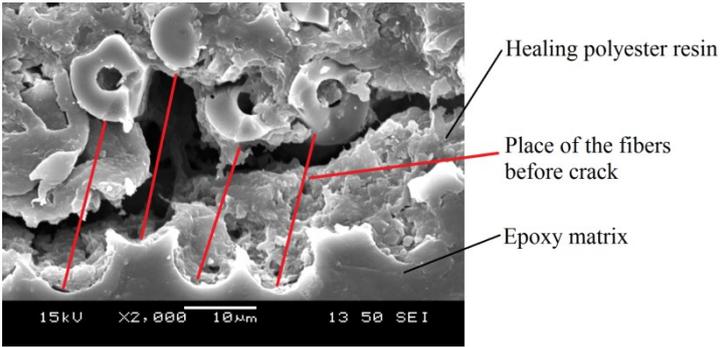
Figure 11

**Figure 11.** Scanning electron micrograph of the healing agent that has flowed into the crack

Healed specimens of the hollow fiber reinforced composites were embedded into resin, and it was polished to examine the traces of self-repair with a JEOL JSM 6380LA scanning electron microscope (Japan). An electron micrograph can be seen in Figure 11.

In the SEM picture in Figure 11, the locations of the fibers before they were separated by the crack are well visible – cf. arrows. Under the effect of the impact load delaminations with fiber fractures occurred. The healing agent flowed out from the fibers and filled the cracks. The cross-linked healing agent is observed inside the crack. Thus, the integrity of the structure was restored, and because of this, the bending properties improved after the healing phase compared to the damaged state.
