An inventory to the requalification of the Ex European city in Biskra

Pollack Periodica •
An International Journal
for Engineering and
Information Sciences

Fig. 1. Conceptual framework: towards the requalification of the Ex European city in Biskra
(Source: Author)

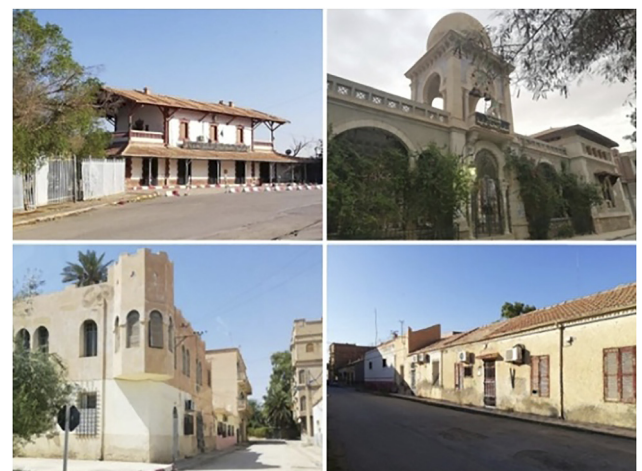
Fig. 3. Overview on some constructions in the site
(Source: Author)

The first step in this investigation process starts with the division of the study area into several blocks (Fig. 3). As follows, each block is coded according to its related series

3.1.2. The esthetic styles. The historical emergence of the French styles, introduces a variety of designs when it comes to the ornamentations and the aesthetics of the buildings [6, 7] (Fig. 3). The approach adapts the post-revolution style for most of the constructions known with the Neo-classical and the Neo-Moorish design styles, mostly used in the larger scale constructions that require attractive exteriors and façades, and other details of private residences. Some examples of the Eclecticism style, especially in the former city hall's features, construct one of the crucial landmarks in the Checkerboard.

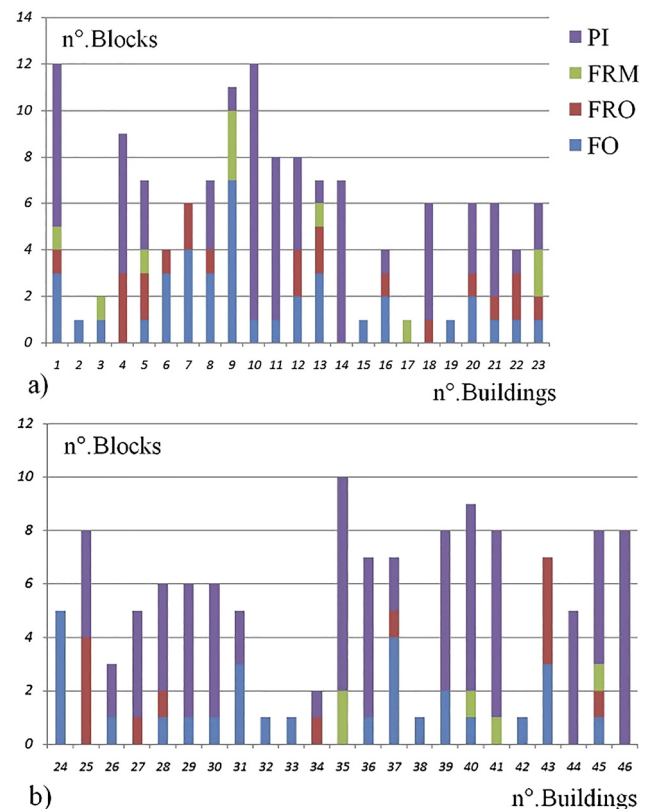
Fig. 4. Classification of the buildings in the site: a) Blocks 1 to 23; b) Blocks 24 to 46

The essential findings of the assessment and the diagnosis phase (Fig. 4) were directly conducted by the criteria of the research, revealing the global condition of the French Checkerboard. The modern innovations of the constructions; resume an influential time-lapse for architectural and urban mutations in the site. As stated in the preliminary observations on the 46 blocks; the majority of the built heritage in the center is in an extreme state of disrepair, while there are an important number of valuable monuments; some are standing in a moderate state against a lot more that are in danger; neglected and called for action. Three general categories were classified during the study, regrouping the total of the evaluated constructions:

- A. French buildings in the original state;
- B. French buildings in a reconstructed state, two sub-categories were defined:
 - B.1. Reconstructed state, where most parts are remaining French (French character);
 - B.2. Reconstructed state, where most parts are renewed (modern character);
- C. Post independent buildings in a new state.

The interpretation of the results in the data collection phase indicates the analysis of 273 plots. However, ten terrains are found demolished or in ruins, decreasing the built space's total to 263 constructions, 147 of which are entirely renewed in the post-colonial periods, with modern architectural style, 49 properties are partially reconstructed, where 34 buildings preserve a French character; 15 are rebuilt with a contemporary styles, but still indicate the effects of the French design. Lastly, 67 constructions stand in the original

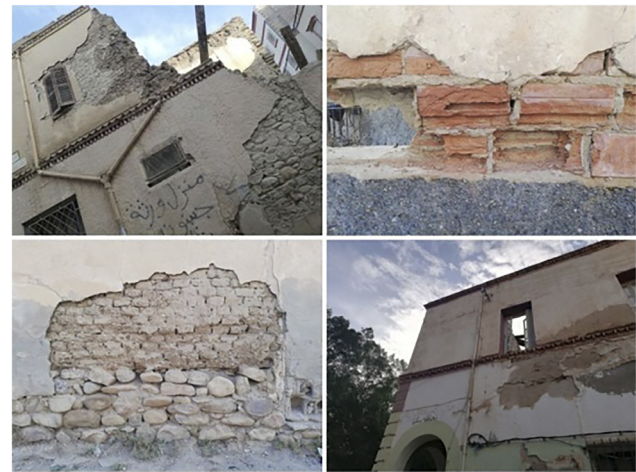
Fig. 5. Major problems affecting the construction materials (Source: Author)

On the micro-level, the architectural envelope analysis affirms that deteriorations are encountering the bad condition of the buildings. A generation of the alterations resumes the leading causes of the degradation, where the majority of the structure suffers from the effects of humid deteriorations, caused by infiltrations from the terrain; many

parts sustain superficial and deep cracks, which affect the structural system and the foundations; threatening the stability of the constructions. In general, the same types of pathologies were repetitive and revealed during the study (Fig. 5), including: physical pathologies: from different types of cracking, to the collapse of the old parts, along with the crumbling of earth material and the detachment of the mortar. Moreover, the humid pathologies: presented with water infiltrations, condensations, humidity stains, and capillary effect are the essential issue of the terrain, and is probably justified with the historical disposition of the Checkerboard along the Seguias channels [8], presenting the dangerous effect of water on the traditional system using earth as the primary material of construction.
