10  
11 Destruction of the royal town at Visegrád, Hungary – historical evidence and  
12 archeoseismology of the 1541 AD earthquake at the proposed Danube dam site

33 The Danube Bend is the site of the proposed Nagymaros dam, part of the Gabčíkovo-Nagymaros  
34 hydropower complex in Slovakia and Hungary. The dam was designed in the 1970s to resist  
35 intensity VI seismic events. We present historical and archaeological evidence for an intensity  
36 IX earthquake on 21 August 1541, which destroyed buildings of the royal town of Visegrád.  
37 Evidence includes vertical fissures cutting through the 30 m high, 13th century donjon Salamon  
38 Tower, built on hard rock. Some parts of the adjacent 15th century Franciscan friary, built on the  
39 alluvial plain, collapsed due to liquefaction of the subsoil. The date of a potentially responsible  
40 earthquake on 21 August 1541 was recorded in a sermon of the eyewitness Lutheran minister  
41 Péter Bornemisza, living at Pest-Buda, 35 km away. Taken by the Ottoman army in 1544, the  
42 royal town and the fortress lost strategic importance, never to be rebuilt. Photographs and

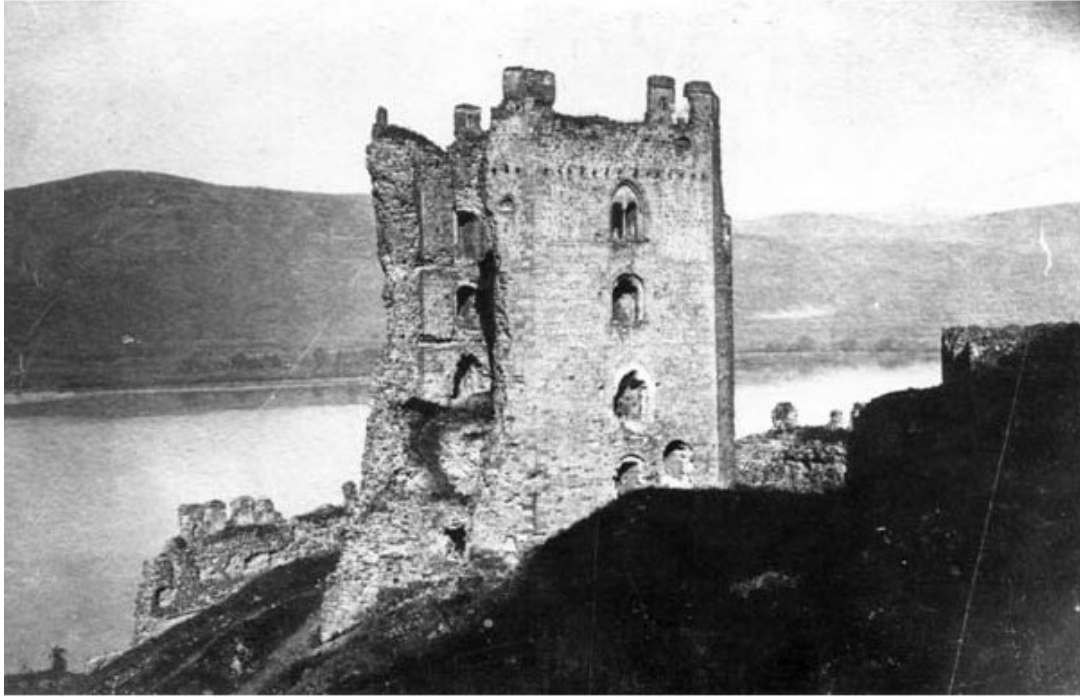
**Figure 2.** V-shaped collapse damaged all six floors of Salamon Tower as seen in 1870. View from east. The collapse scar on the left was caused by cannonfire on 12 October 1540. Note the vertical fracture along the vertical row of windows – this is an indication of severe seismic shaking. Photograph by Sándor Beszédes (*FKF 52495N*) (Bozóki 2014, fig. 2).

123 The siege in 1540 made the southern corner collapse due to four days of cannonfire (left side in  
124 Fig. 2). The lower castle complex and the tower, occupied by the Ottoman army four years later,  
125 lost its strategic importance, never to be rebuilt to its original purpose. Still remembered as a  
126 royal residence in the 19th century, it has been subject to various restoration attempts, some of  
127 them applying stone materials in the 19th century, as well as concrete on the damaged and  
128 destroyed facade parts, a widespread restoration method in the 1970s. Plastering and inserting  
129 new stones in the facade effectively covered all damage features (Bozóki, 2005, 2014), but they  
130 can be studied on the architectural surveys and documentation of this historical monument  
131 created before the restoration projects. Nineteenth-century images (drawings and photographs)  
132 reveal the condition of the buildings right before 1544, the year of Ottoman conquest (Figs 2-3).

136  
137 Besides the obvious collapsed southern corner, victim to the 1540 siege (Iván, 2004), there are  
138 further features of destruction, which cannot be related to cannonfire. The western facade bears a  
139 conspicuous vertical fracture, connecting the weak zone of windows, across all five floors (Fig.  
140 3). Earthquake-hit towers, like donjons or church towers, often bear similar fractures, located  
141 halfway between opposing walls. The fractured towers of the *kasbah* of Sousse, Tunisia  
142 (Bahrouni et al., 2020, their fig 4.2), of St. Peter's church, Broadstairs, England (Musson, 2007,  
143 his fig. 10), and of San Agustín church, Manila, Philippines (Saita *et al.* 2004, their fig. 5) are  
144 good examples. Often one half of the tower collapsed, while the other half remained standing  
145 (e.g. the clock tower in Finale Emilia in Italy; Acito *et al.*, 2014). While the collapsed southern

146 corner is historically proven to be victim of cannonfire on 12 October 1540, all other fractures  
147 developed in places protected from artillery. We suggest that these were formed by seismic  
148 shaking.

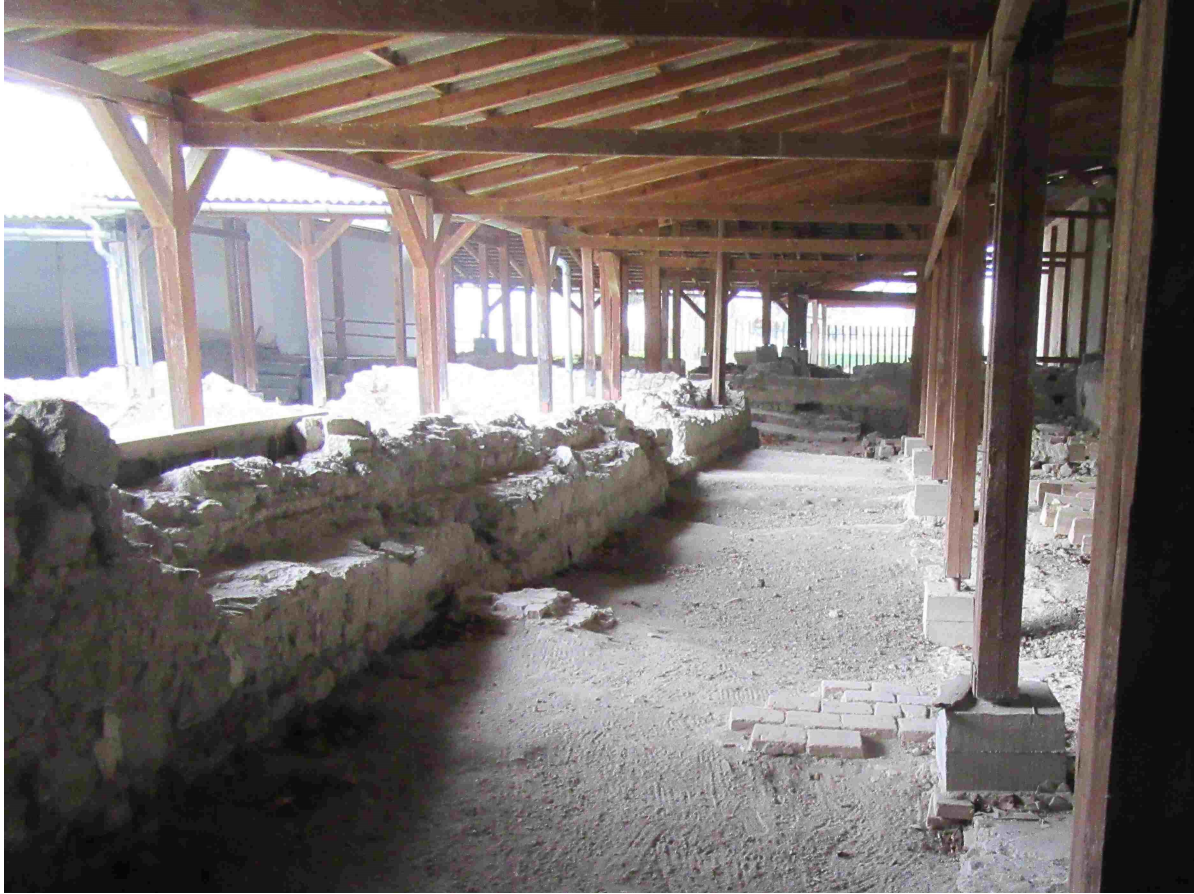
**Figure 6.** Undulating floor in the southern sector of the cloister walk. Originally covered by bricks, now the underlying plastered surface is visible. View to east. Site 5 on Fig. 4. Archaeological Database (ADB) photo #6699.

176 The cloister walk (a covered corridor with four wings surrounding the rectangular cloister garth)  
177 was floored with bricks embedded in mortar. The floor, originally horizontal and flat, displays an  
178 undulating surface today (Fig. 6). Various parts of the floor are 10 to 80 cm below the original  
179 level, marked by the top of the foundation walls (Fig. 4, Site 5). There is a distinct depression in  
180 the northwestern corner, ~40 m<sup>2</sup> in area, up to 80 cm deep (Fig. 4, Site 6-7, and Fig. 7). A 3D  
181 model was created to show the shape of the otherwise featureless floor. The calculated volume of  
182 the depression is 14 m<sup>3</sup> (Fig. 8).

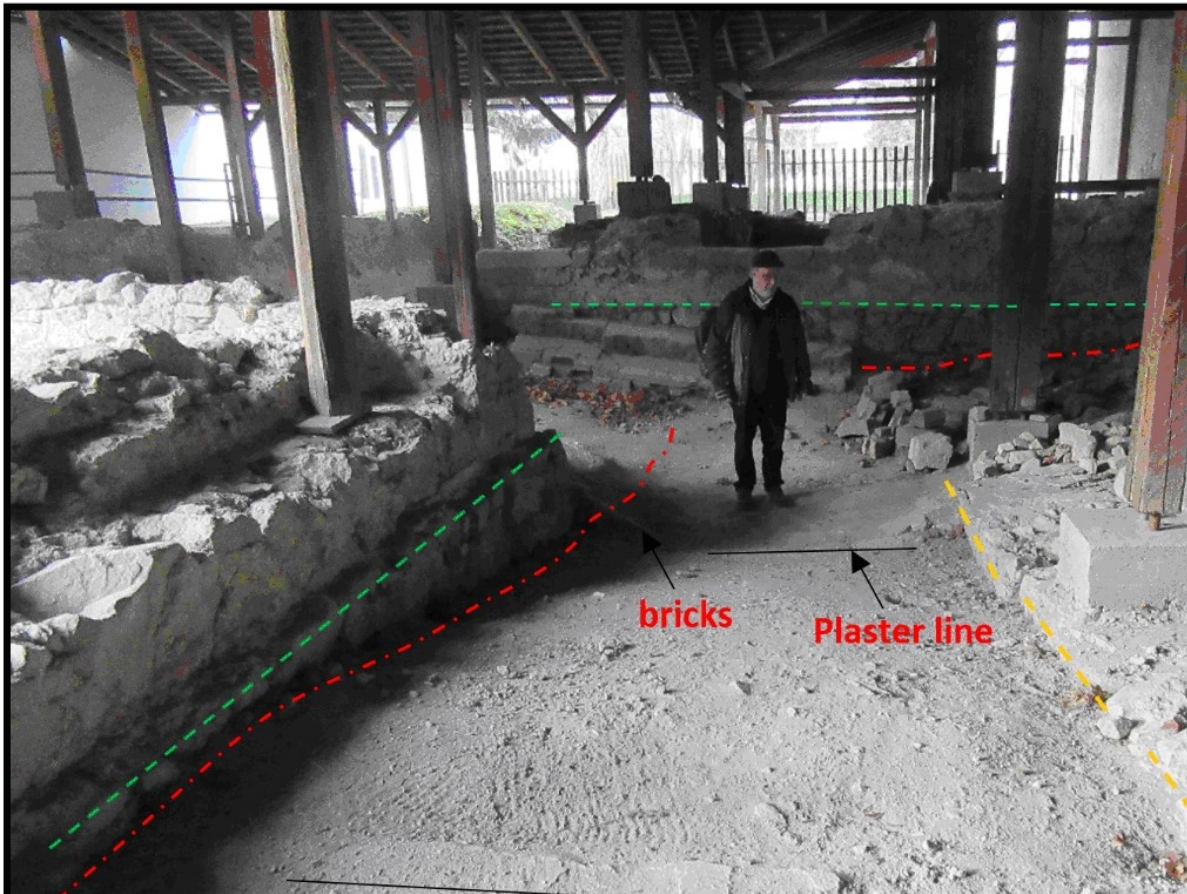
**Figure 7.** Subsided floor of the cloister walk in the northwestern corner. Original floor level marked on left with a green, horizontal, dashed line. Subsided floor marked with inclined, red dashed line. Maximum subsidence is 80 cm, where person stands. A few floor bricks, embedded in mortar, are still in place. Wooden columns, supporting protective roof of the excavated area, replace stone columns, which supported a double vault. The latter collapsed during shaking, due to subsidence of its foundation (raised, between aisles). Subsided, tilted stairs visible behind person (see Fig. 8). View to west. Sites 6-7 on Fig. 4. ADB photo #6705.

190 The foundation wall along the centre of the northern sector of the cloister – which supported the  
191 red marble colonnade – displays uneven settlement of about 50 cm (Fig. 7).

217 produced subsidence of buildings or their parts. Short-lived fountains and sand volcanoes could  
218 develop on the surface, removing 14 m<sup>3</sup> of sediment from below the floor (Fig. 7) (Bray and  
219 Dashti, 2014; Györi, 2005).

229  
230 A spectacular depression was formed in the northwestern corner of the cloister: 0.8 m subsidence  
231 of the floor was caused by escape of 14 m<sup>3</sup> subsoil from below the floor. Only liquefaction-  
232 induced escape of sediment-laden, overpressured water can remove such large amount of  
233 material. The escape could have been laterally directed into the adjacent cellar to the west;  
234 alternatively, it could have been filtered through tiny fissures in the brick floor, and subsequently  
235 removed during cleanup after the catastrophe.

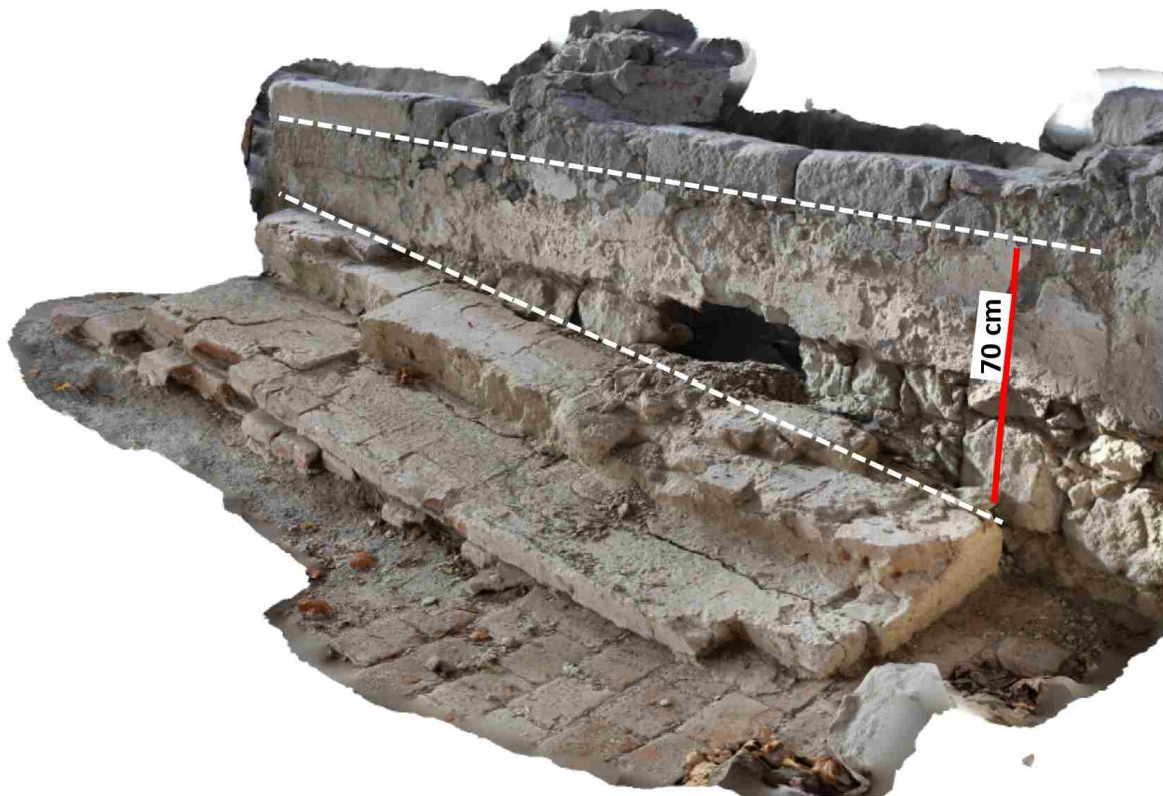
**Figure 9.** Tilted and subsided stairs 70 cm below thresholds of the doors in the western wall of cloister walk. Top of the stairs was at the upper dashed line before subsidence. 3D model by structure-from-motion photography. View to SW. Site 8 on Fig.4. ADB photo #6724.

184 There is a stair of two steps on the western side of the depression (Fig. 4, Site 8 and Fig 9). Both  
185 floor and stairs are tilted to the north. Original level is marked on Fig. 9. The northern  
186 termination of the stairs is 70 cm deeper than the original location. The northern wall of the  
187 cloister contains several holes (Fig 3, Site 9, and Fig. 10); these probably held beams of a  
188 temporary wooden floor above the depression.

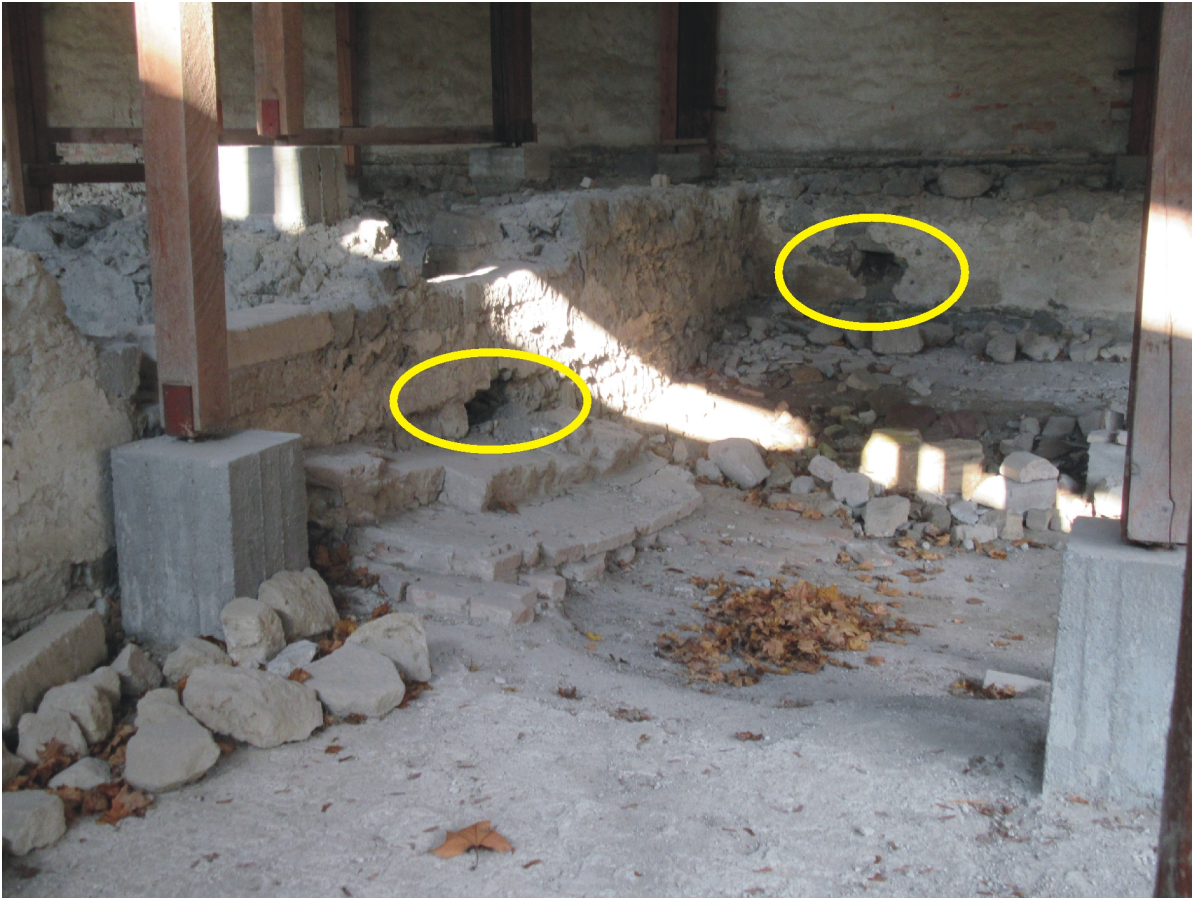
**Figure 10.** Holes for beams: one above the subsided stairs(!), indicating it was carved after subsidence. There is another in the wall in the back. Beams supported a wooden floor, put above the useless stairs. Site 9 on Fig. 4. ADB photo #6707.
