# INFLUENCE OF THE DEGREE OF COMPACTION ON THE BEARING CAPACITY OF A ROAD STRUCTURE REINFORCED WITH TRIAXIAL GEOGRIDS

The degree of compaction for a crushed stone roadbed is one of the most important technical characteristics of road construction works. Insufficient compaction can have significant effects on the resulting bearing capacity, even in road structures reinforced with geosynthetic materials. The present study concerns the utility of using geosynthetic reinforcement in the base layer of a road structure, while varying the degree of compaction on 1:1 scale models.

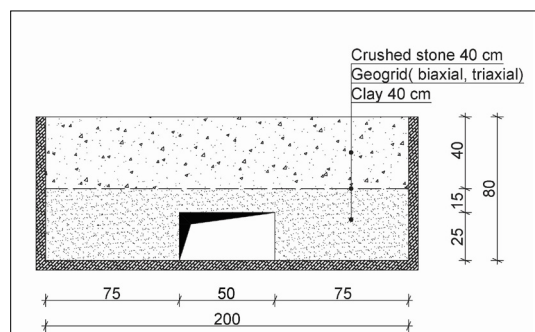
**Figure 1.** Schematic of the road structure used for testing (in the case of the unreinforced structure the geogrid has been removed).

The present research involves the building of three full scale models of the base layer of a road structure. The base layer of two of the models was armed with a triaxial geogrid, and the third model was unreinforced. The road structures were built in a box with dimensions: ( $b \times L \times h$ )  $1.50 \times 2.00 \times 1.00$  m, having an opening in the middle as a retractable drawer of dimensions:  $0.50 \times 1.70 \times 0.25$  m, as shown in the **Figure 1**. In this way a sinkhole was formed.

The load bearing test was carried out by static loading of the model in the direction of the sinkhole, with a Lucas plate, and was carried out until the structure failed. The deformations were monitored at the level of the loading plate, the deformations of the hole, and the displacements of two nodes of the geogrid reinforcement, located in the center of the hole and the edge.

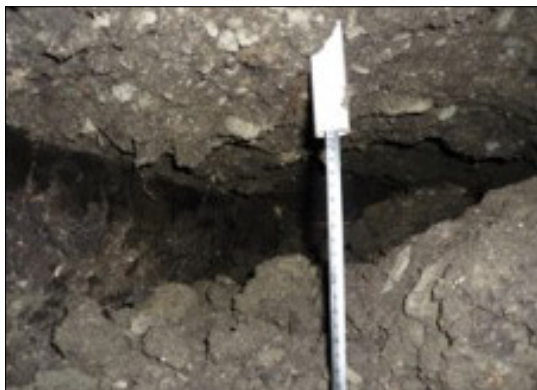
**Figure 2.** The progressive collapse of the hole under static loads.

The first bearing test was performed on a model reinforced with the triaxial geogrid, with properly compacted layers. The loading was performed with a Lucas static plate, 300 mm in diameter, centrally located, in the direction of the formed sinkhole. The loading stages were established according to STAS 2914/4-89 [3] for road systems, with a loading increment of 50 kPa, and a stabilization limit of 0.05 mm at an average of consecutive readings, made at intervals of 5 minutes. By its nature, the test was carried out until the model failure either by collapse of the hole, or by excessive deformations on the loading surface. During the first test, we recorded approximately 1 mm settlement at 100 kPa, 1.5 mm at 150 kPa, and 3 mm under a load of 200 kPa [4]. The first noticeable deformation of the hole was found at the reading of 10 minutes under the load of 200 kPa, the ceiling of the hole deforming 2 mm. The consolidation time of the structure was relatively fast, 15 minutes at the 50 kPa stage, 15 minutes at the 100 kPa stage, 20 minutes under the 150 kPa loading, and 15 minutes under the 200 kPa loading. The 250 kPa step caused a first drop of medium-sized earth lumps (Figure 2.).

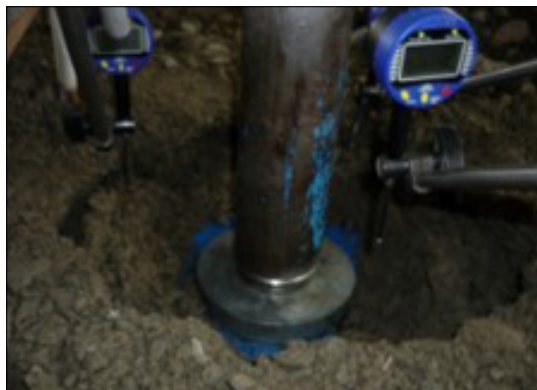
**Figure 4.** The load step of 350 kPa causes the ground layer to collapse.

evolution was similar and below the next loading step, that of 300 kPa, earthquakes continued to occur, but the stabilization limit was reached after about 20 minutes, with a setting value of 5.5 mm. Under the load of 350 kPa, a significant part of the upper area of the hole collapsed. At the same time it was possible to observe the formation of the arching effect in soils, which dissipated the pressure from the center of the hollow to the side walls. The behavior of the reinforced structure was noted under the load of 400 kPa, where the deformations stabilized after only 25 minutes. The structure was quickly consolidated and at 450 kPa, after 20 minutes a deformation increase of only 0.3 mm (from 7.0 to 7.3 mm) was measured. Even the change to 500 kPa did not cause a major jump in the deformations, the initial increments increasing by 1 mm, and in the end, when stabilizing the earth (after 35 minutes of loading), the total settlement increased by 0.5 mm (from 8 to 8.5 mm). On this structure deformations greater than 10 mm were recorded at the end of the loading step of 550 kPa. The constancy of the consolidation durations was also maintained on the next two loading stages, at 600 kPa and 650 kPa respectively, this being achieved in 45 minutes. The road structure has deformed relatively little, under the load of 600 kPa, an average of the vertical displacements of 12.2 mm, and 15 mm was recorded at a load of 650 kPa. The first rupture cracks on the surface of the crushed stone layer were found under 700 kPa load. The next load (750 kPa) resulted in a constant increase of 2 mm, per reading interval. At the 35-minute interval, the first movement of the studied inner node was recorded. Under this load the displacement increased slightly, reaching 6.5 mm in 15 minutes.

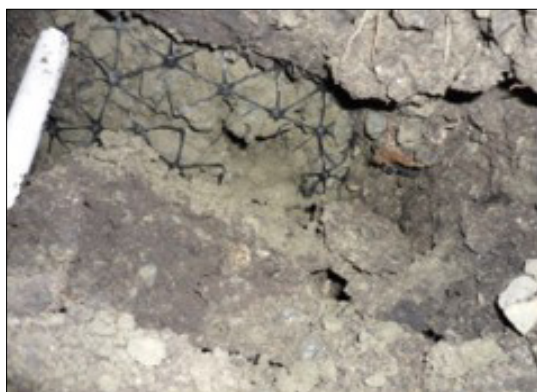
**Figure 3.** The collapse of the ground revealed the geogrid rupture.

Applying the following loading pressure of 800 kPa caused the model to fail after 5 minutes. After the collapse of the bare soil layer, it was possible to analyze how the crushed stone became stuck in the geogrid's eyes, and the way in which the triaxial geogrid broke (Figure 3).

After removing the crushed stone layer, and the triaxial geogrid, it was found that the rupture occurred on a portion of the pressure cone perimeter.

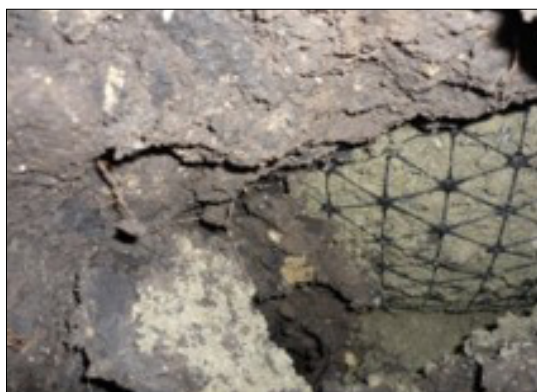
**Figure 5.** The collapse of the earth layer allows visualization of the confinement.

In Figure 5 it is possible to observe the cleavage of the crushed stone layer in the geographic

mesh, which indicates the confinement. From this moment the settlements increased rapidly, at a rate of 3 mm / minute, and the walls of the hole began to collapse.

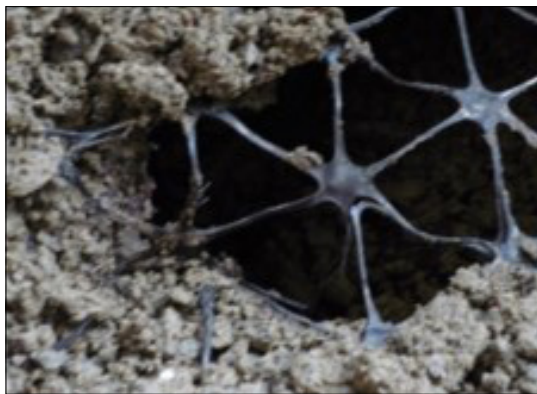
**Figure 6.** Fiber-failure of triaxial geogrids.

The inner node of the triaxial geogrid, followed by a fleximeter, moved by 1 mm per minute. After 12 minutes below 350 kPa the geogrid broke. At the moment of failure, a 51.6 mm settlement was measured under the plate. The breaking cone formed at the top an angle of approximately 45 degrees. After removing the crushed stone layer, the geogrid was removed and the size of the footprint of the breaking cone at the base was measured, which was 105 cm. The uncovering of the crushed stone layer revealed a break point of the geogrid, produced along the fiber (**Figure 6**), and after complete extraction, two similar failure points were reported (**Figure 7**), thus totaling three failure points located on a diagonal, occurring on the opposite side of the load.

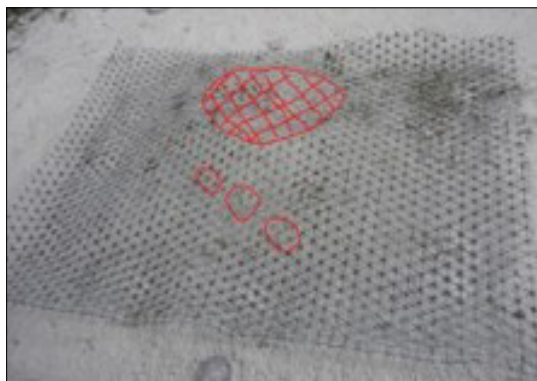
**Figure 7.** The pressure cone and the three failure points oriented after a diagonal.

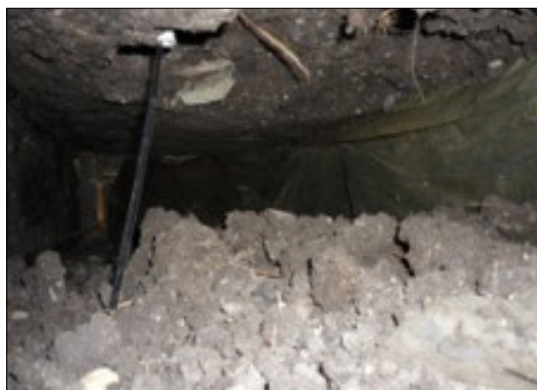
**Figure 8.** Large chunks in the hole ceiling collapse below the 350 kPa load step.

ans that the side walls of the hole had deformed continuously. The total settlement at the time of consolidation under this loading step resulted in 4.5 mm, after 40 minutes, corresponding to eight reading cycles. The next loading step, that of 350 kPa, caused the collapse of the hole ceiling in the direction of the measuring rod (**Figure 8**).

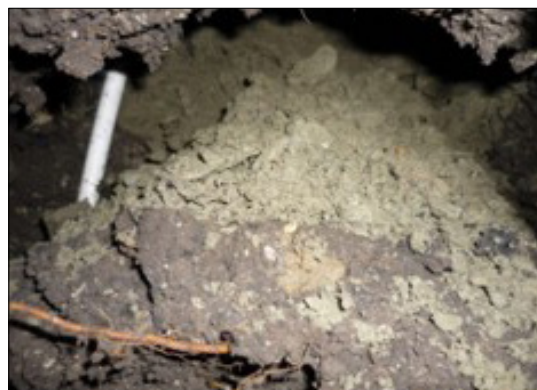
**Figure 9.** The hole is collapsed under the 550 kPa load step.

central rod 187 mm and 183 mm respectively. After 110 minutes, the settlement values were recorded indicating the consolidation of the earth layer, at a total deformation of 3 cm. At the next loading phase, that of 550 kPa, the earth collapsed (**Figure 9**), the deformations were increased, increasing from 3 cm reaching 5 cm, this all happened within 5 minutes, after which the plate sank under its own weight, and under the pressure of the hydraulic jack.

Considering the time elapsed from reaching the allowable values of the deformations to the collapse it can be stated that the failure was of a sudden character. A part of the upper layer of crushed stone flowed through the hole created in the ground. The failure cone formed at the top had a diameter of 45 cm. The removal of the crushed stone layer revealed the shape of the lower part of the cone, about 120 cm long, and 85 cm wide. The shape and size of the failure surface confirmed the initial hypothesis, of local failure, without the collapse of the entire surface of the hole.
