PARTIAL EXAMINATION OF THE DESIGN OF THE BOMBED OLT BRIDGE IN SÂNCRĂIENI

Throughout Transylvania, the ruins or remains of many engineering structures and buildings can be observed, and this allows us to draw a lot of interesting conclusions. This research seeks to shed some light on the design process of older bridges in Transylvania through a case study. Hydraulic calculations based on field measurements show the hydraulic requirements used in the original design of the bridge. The obtained data was compared to the current requirements of the Romanian design standards.

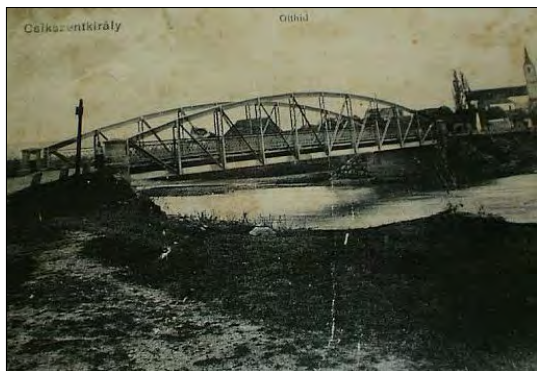
Figure 1. Postcard illustrating the former Olt bridge in Sâncraieni, before 1916 [1]

The subject of our topic is the old Olt Bridge in Sâncraieni, which was blown up in September 1916 by the retreating Austro-Hungarian army. The original plans of the bridge are not known, but the structure is not unique on the Olt River, similar bridges were built in Sântimbru, Sfântu Gheorghe and in other places. A postcard illustrating the original state of the bridge can be seen in [Figure 1](#). Although the superstructure of the bridge (truss, deck and barriers) was completely

The subject of this analysis is the cross section of the Olt River in Sanraieni, where the old bridge illustrated in [Figure 1.](#) was located.

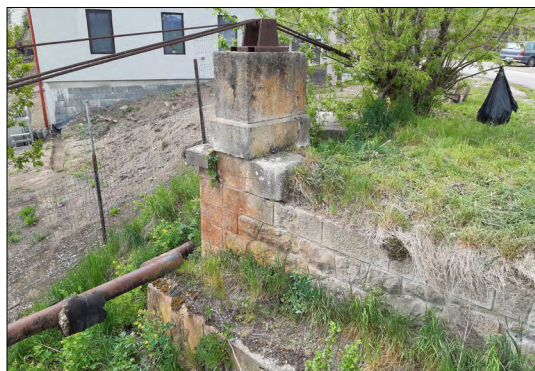
Figure 2. Ahe current state of the abutment

destroyed, no damage was caused to the two abutments ([Figure 2.](#)), thus an impromptu pedestrian bridge was made with their help ([Figure 3](#)).

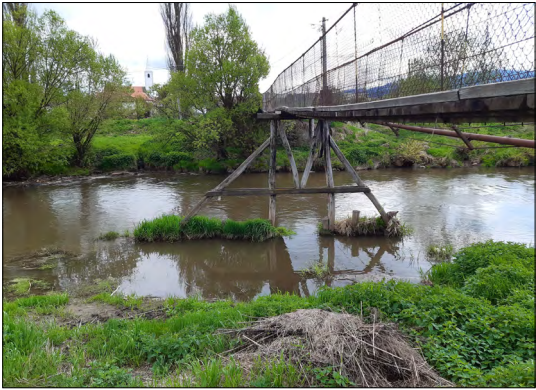
Figure 3. Pedestrian bridge on the original substructure

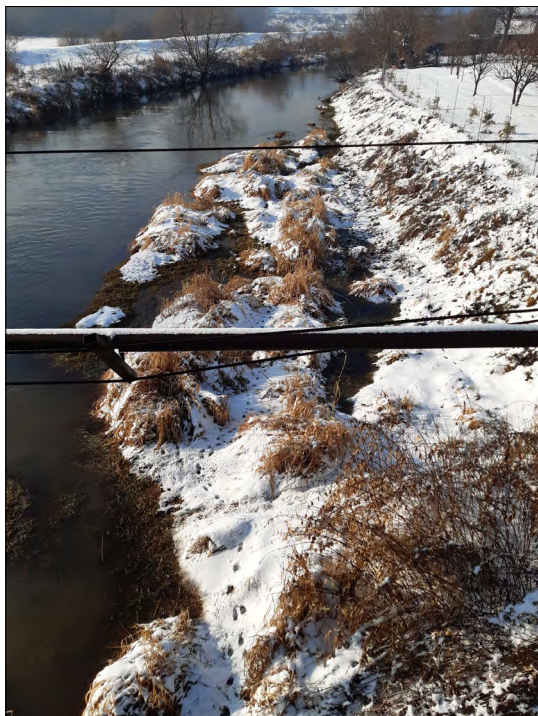
Figure 8. Islands created by riverbed deposits

Our second conclusion is that the current riverbed cross-section does not provide the free height required by the standards, and therefore it is necessary to remove the deposited bed sediment shown in Figure 8. and to stabilise the riverbed.
