Manuscript of the article: Sándor Szalai, Kitti Szokoli, Mohamed Metwaly, Delineation of landslide endangered areas and mapping their fracture systems by the pressure probe method. Appeared in: Landslides, 2014, Volume 11, Issue 5, pp. 923-932., doi: 10.1007/s10346-014-0509-6, ISSN: 1612-510X.

## Delineation of Landslide Endangered Areas and Mapping their Fracture Systems by the Pressure Probe method

### Abstract

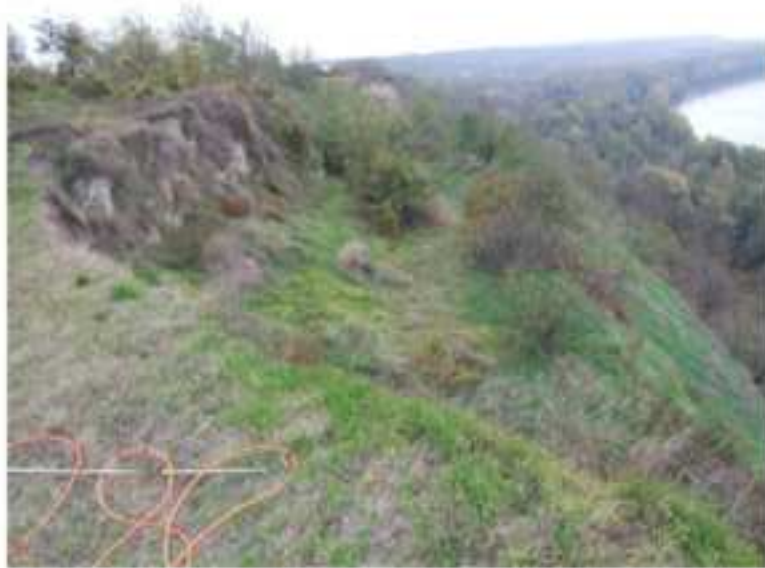
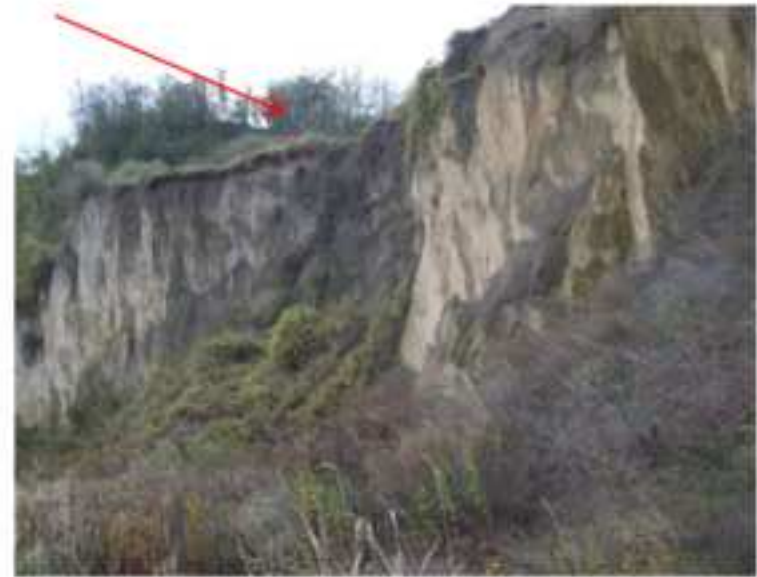
Figure 4  
[Click here to download high resolution image](#)

1  
2 **Fig. 4** a. The loess mass which has already slumped looking from the south, (the direction of the study area.) b.  
3 The quasi vertical scarp. The arrow indicates the research area. c. The study area from western direction with  
4 tapes along profiles S4-S10 and with Danube River in the background. The profiles are closely West-East  
5 orientated. The dotted red line shows the main fracture which is directly visible from the opposite direction. The  
6 scarp is about 6m from the east end of the tapes. d. The main fracture from the east with profiles S4-10. The  
7 main crack branches off here. The area which had been cultivated is in the background. The long profile (P2)  
8 elongated between two vineyards in line S10.

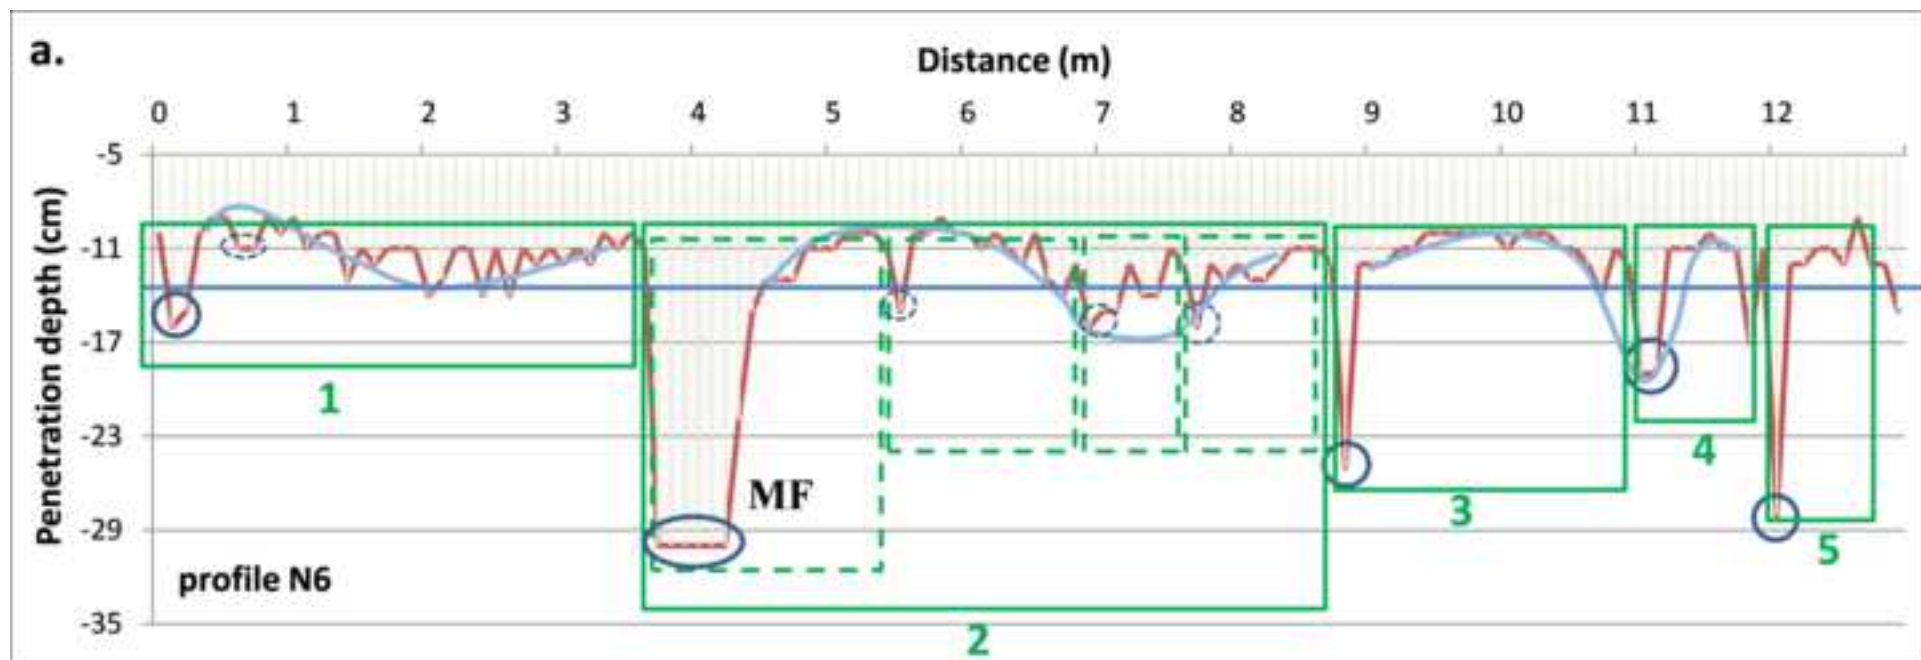
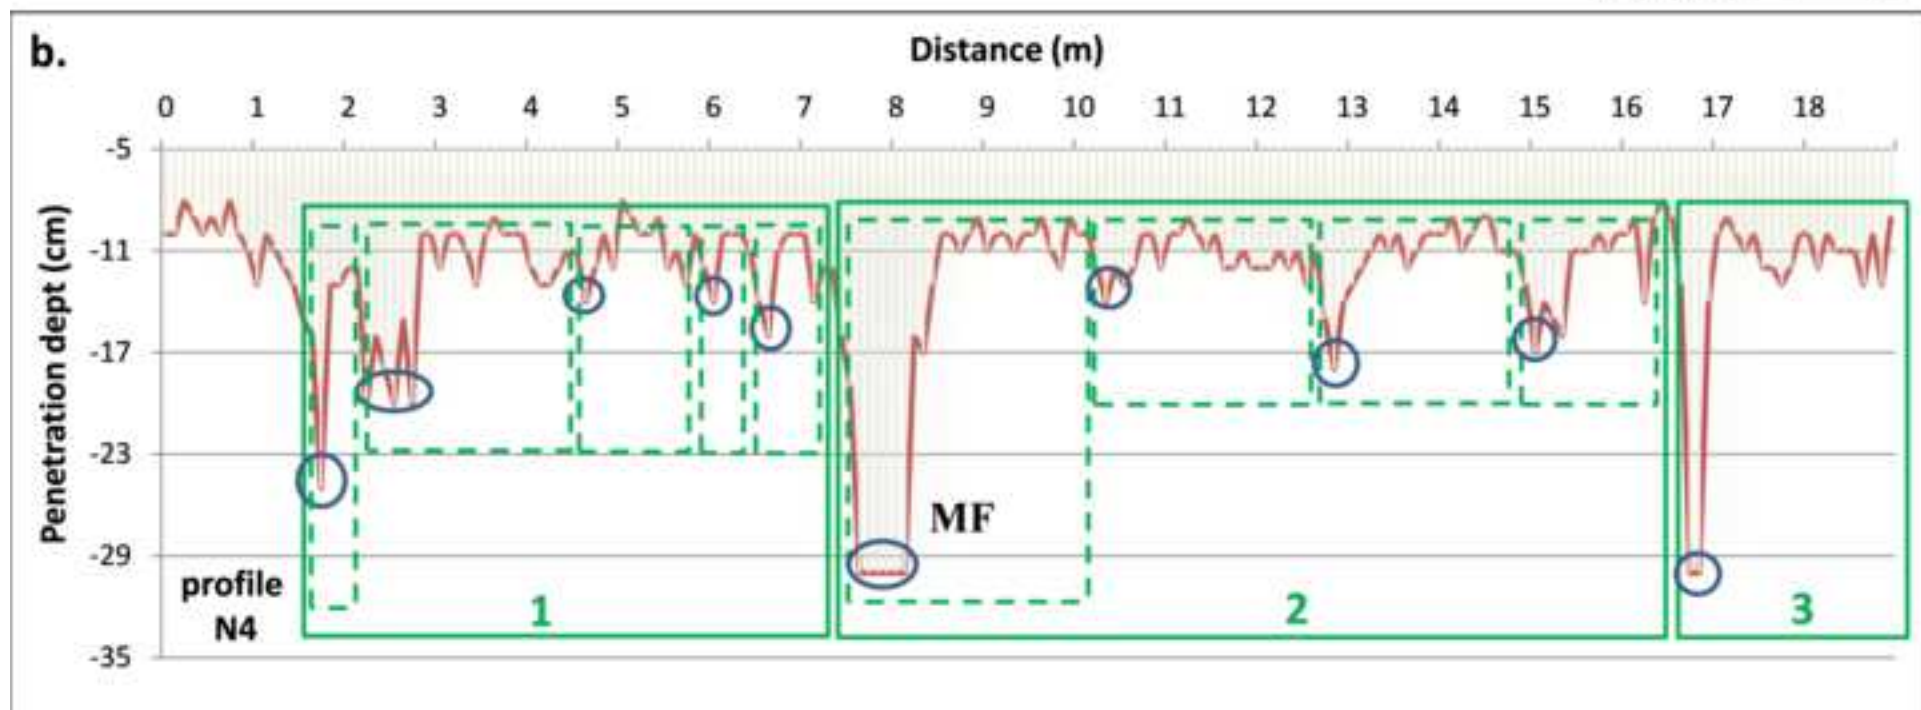
Figure 6  
[Click here to download high resolution image](#)

14  
15 **Fig. 6** Profiles N6 and N8. MF: main fracture

Significant, wide fractures were interpreted where the Pre-P values were much larger than in the neighbouring points. Outstanding values sometimes occurred only at one single measuring point but more often at several neighbouring points (Figs. 6 and 7). Zones were assigned to all dominant fractures. These are the zones which are on their eastern side and elongate from the given dominant fracture to the next dominant one. These zones were delineated by continuous line rectangles and numbered (see Fig. 6). These main fracture zones were further divided into smaller zones which belong to moderately significant, thinner fractures. These sub-zones were delineated by dotted line rectangles. The background values (where there are no fractures) were characteristically under 13 cm, mostly in the range of 11-13cm. Higher values most likely refer to the presence of fractures. The narrow range of the background values verifies both the homogeneity of the loess and the robustness of the Pre-P method.

At first a few typical profiles are presented and interpreted. They were measured in the area which has already started to slump, that is eastward from the MF and which is directly visible. It is 20-80 cm wide and the vertical displacement along it is in the range of 10-70cm. Five prominent anomalies are clearly recognisable on profile N6 (Fig. 6a.). They are most likely linked to major cracks. There is only one much smaller crack of 0.3 m west of the MF at 3.6-4.2 m. It is easily recognisable producing a strong local anomaly.

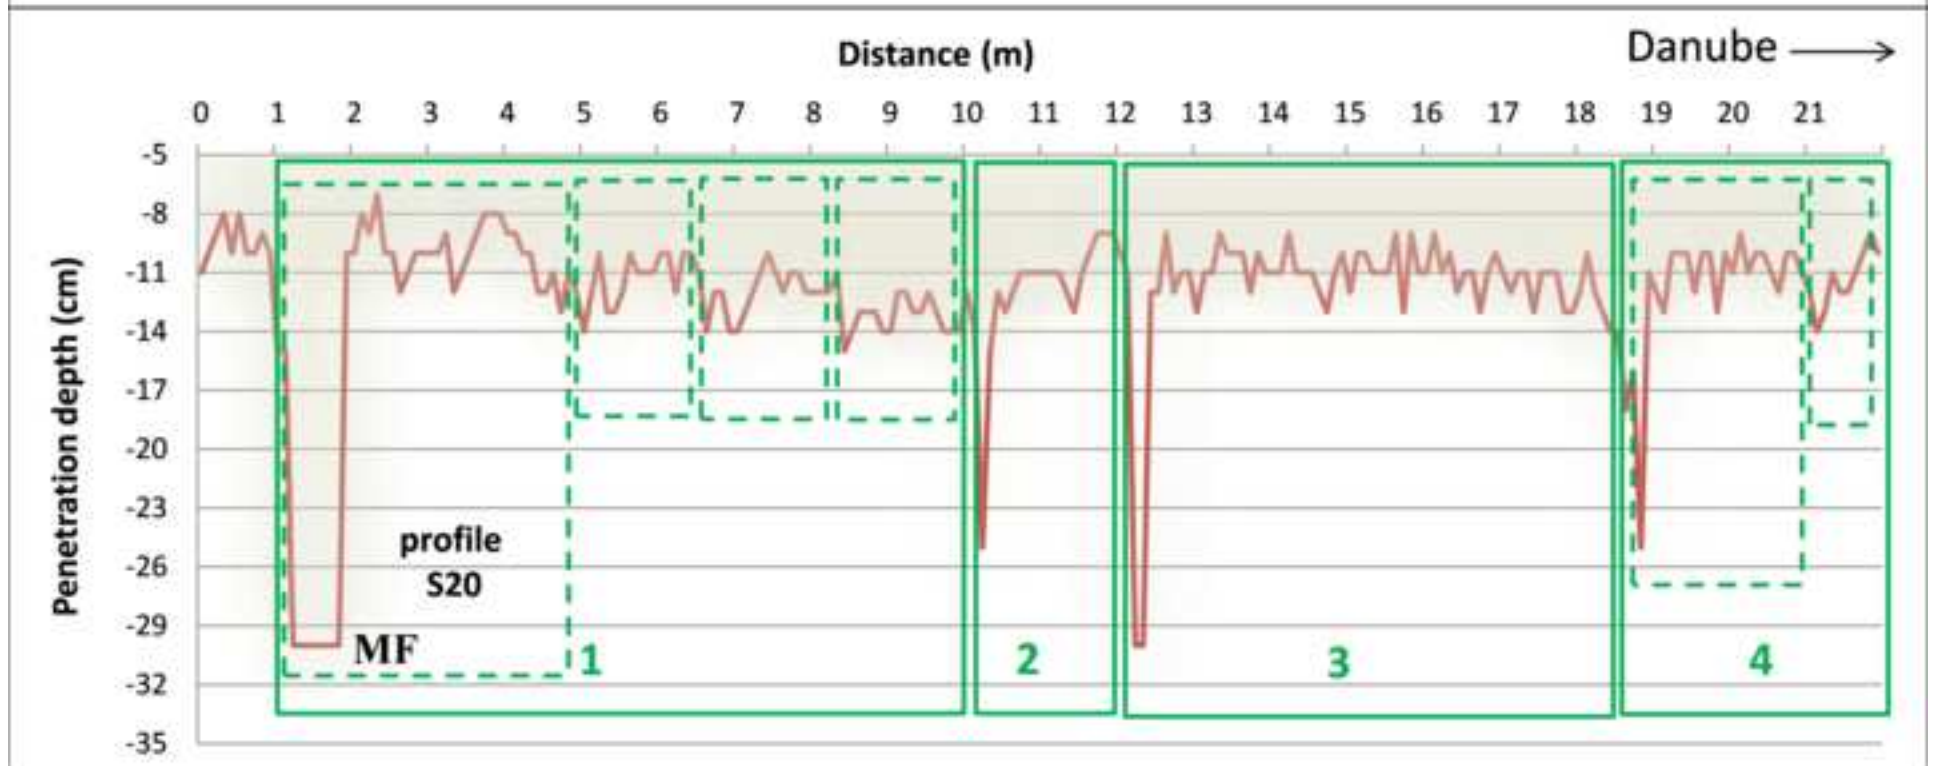
Figure 7  
[Click here to download high resolution image](#)

16  
17 **Fig. 7** Profiles S6 and S8. MF: main fracture

11 There are many small cracks on profile S6 (Fig. 7a), east of the MF at about 5 m. It can be clearly seen  
12 that fracture zones 2-5 east of MF are narrowing towards the Danube River. Thinner cracks (in the left sides of  
13 the dotted rectangles) are present every 1-2 meters. This distance is in very good correlation with those observed  
14 in the cave at Töröklyuk which is close to the measuring area (Újvári et al, 2009). This fracture density proved to  
15 be typical in the study area, especially below the S-labelled profiles. A rock fall can happen anytime on profile  
16 S6 at about 0.7 m.

17 On the southernmost profile of the area (S20, Fig. 7b), four fracture zones can be recognised. The  
18 stability of the first and especially that of the third zone where there are actually only minor cracks is interesting.  
19 There is a weekend house in this stable zone to the south, about 10 m from the profile. Its walls are not yet  
20 cracked, which supports our Pre-P results.

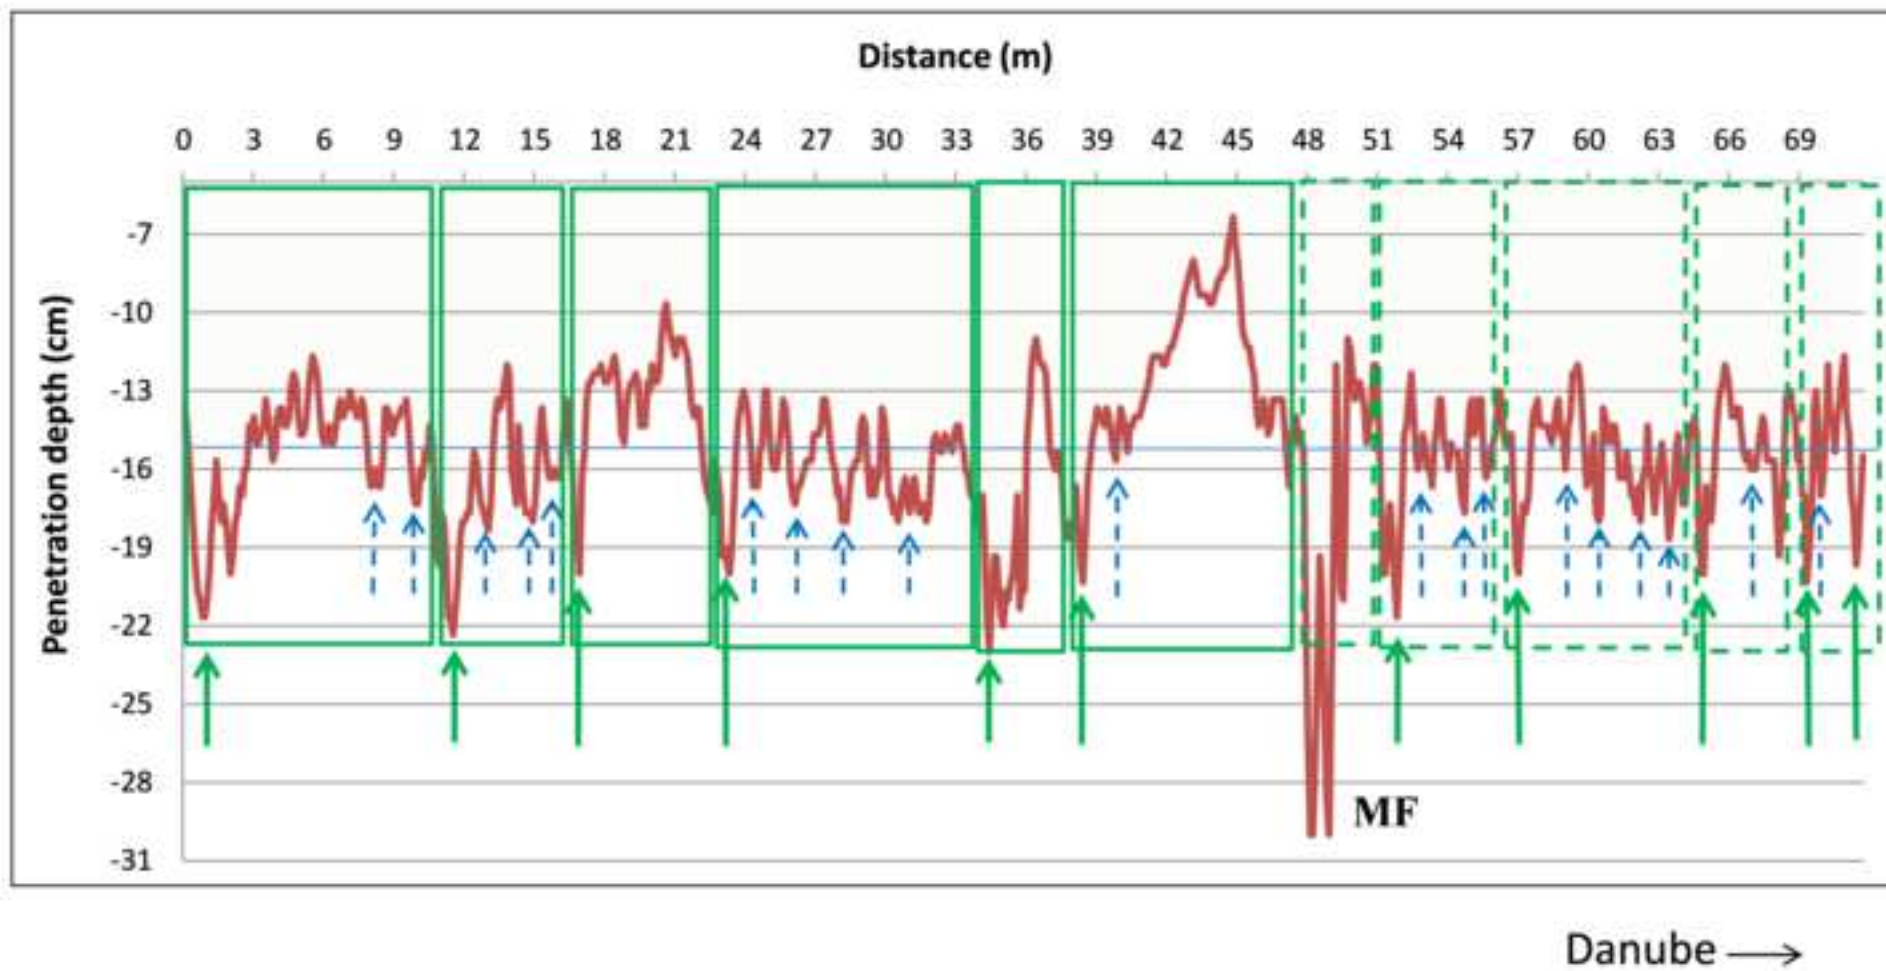
Figure 9  
[Click here to download high resolution image](#)

Figure 9 displays the running average each of 3 consecutive values measured on profile P1 (Fig. 2). (Such averaging enables simpler interpretation, but it can lead to information loss which has to be therefore controlled). It is clearly seen that the area, which is located on the stable, not-sliding, passive side (0-49 m) from the MF is also fractured. The cracks in this zone have greater amplitude than on the active side (49-72 m). The fragmentation of the loess appears to have been also started here. It is not surprising considering the dimensions of the Castle Hill: the height of the hill above the level of the Danube River is about 50 m while it is approximately 90 m long in the direction perpendicular to the riverbed (see Fig 3). It is worth mentioning that on the passive side of the MF there are 3 blocks, about 10 m wide (0-10 m, 23-34 m, 38-48 m). On the active side the blocks are only about 3-6 m wide. There are only two cases of penetration values below 13 cm: the anomaly at 43-45 m shows both wheel tracks which are definitely recognizable. The reason for the anomaly at about 21 m is unknown.

The active side of the profile is more fragmented as indicated by the higher density of thin cracks which is denoted by dashed arrows. Cracks are supposed to be where the Pre-P values exceed 15 cm. The selection of this threshold value is somewhat artificial but since the area is fairly homogeneous, the designation of such a specific value can be justified. If the area were more inhomogeneous, one would have to take the local anomalies into consideration. While in the active side of the MF there are 5+9 smaller and larger cracks within the 23 m length (MF is not taken into consideration), in the passive side there are 6+10 cracks 48 m in length. Thus while the average distance between the cracks is 1.5 m in the active side, it is 3 m on the passive side.

It is also important to note that it is although advisable to regard the running average representation for easier interpretation of the results (see e.g. Fig. 9) this form of presentation can lead to information loss. The original, not averaged values of the major anomalies are not smaller on the active side than on the passive one, so the width of the cracks must be about the same on both sides.
