Correction to: Fracture resistance and marginal gap formation of post-core restorations: influence of different fiber-reinforced composites

Correction to: Clinical Oral Investigations

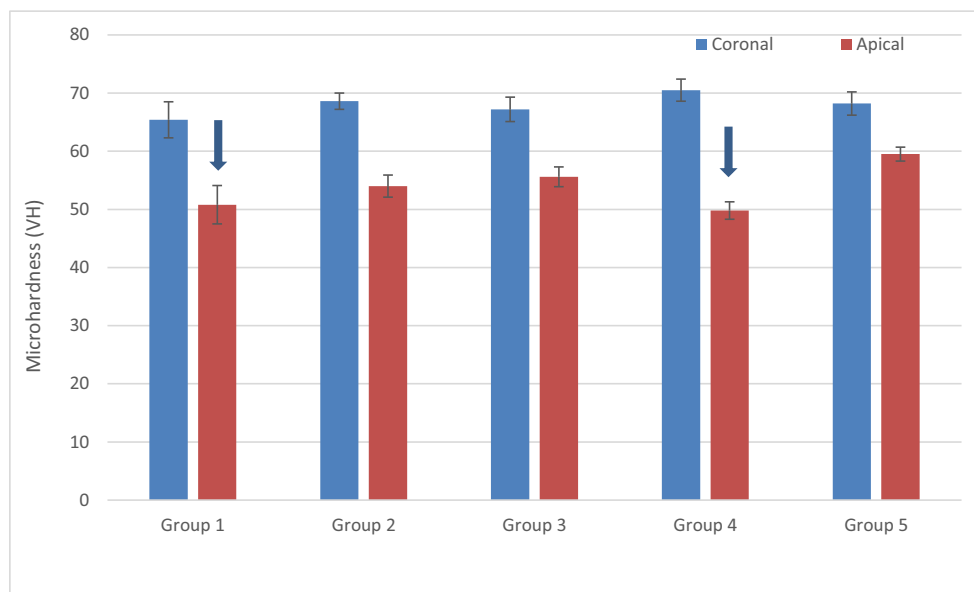
Fig. 4 Microhardness (VH) mean values for resin composites at the top (coronal) and bottom (apical) parts of the root canal. Arrows above the columns indicate VH of these groups dropped below 80% of the coronal part values. Vertical lines represent standard deviation

The authors regret that the tested groups in Fig. 4 were not in the right order and this mistake is only present in Fig. 4 (microhardness results). This does not influence the discussion or the conclusion of the study.

Please find below corrected Fig. 4 in order to aid the interpretation of microhardness results.

In results part, page 270, last paragraph: group 4 should be group 5. In discussion part, page 273, 2nd line on the right column: group 5 should be group 4.
