# Pannonia Underground

## Late Roman earthquake in Brigetio?

*Archaeological evidence at the Komárom/Szóny-Vásártér site in Hungary raised the question of a late Roman earthquake in the civil town of Brigetio, which was investigated by means of archaeoseismology. Modern research excavations at the site were carried out between 1992–2016 uncovering about 3000 m<sup>2</sup> in the centre of the former Roman settlement. Through the detailed study of the documentation made during the excavations, such as maps, drawings, photographs, and field notes evidence for suspected seismic damage was collected from the site. The deformed structures were then compared to similar structures distorted by known earthquakes from published archaeological sites. Using pottery and coins as the basis of dating, an earthquake some time after the middle of the 3<sup>rd</sup> century A.D. and before the early 4<sup>th</sup> century was identified. In the absence of standing wall structures, the intensity of the earthquake was estimated using the ESI-07 environmental seismic scale: an intensity IX event is suggested. Historical and archaeological data about earthquakes in the territory of Roman Pannonia ind

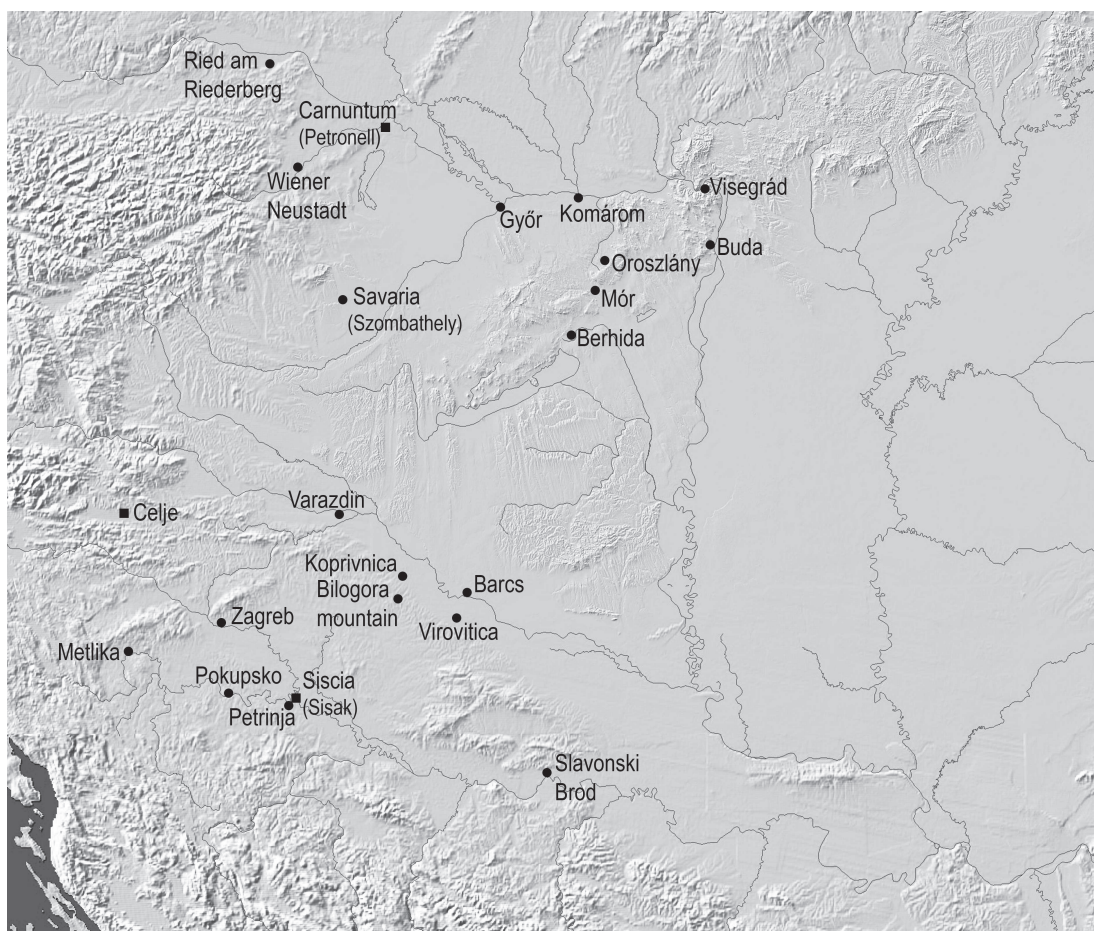
Fig. 4.

*Location of historical and archaeological earthquakes in the territory of Roman Pannonia (blank map: B. Holl)*

According to different written sources, more than 20 settlements in the territory of Roman Pannonia were affected by strong earthquakes around or above magnitude M 5.0 between the late Roman times and the present, roughly half of them in present-day Croatia (*Fig. 4*). Earthquakes listed here were collected from the historical earthquake catalogues of Hungary, Austria, Slovenia, and Croatia.<sup>7</sup> This data is supplemented by three unmentioned late Roman earthquakes that were discovered through archaeoseismology.

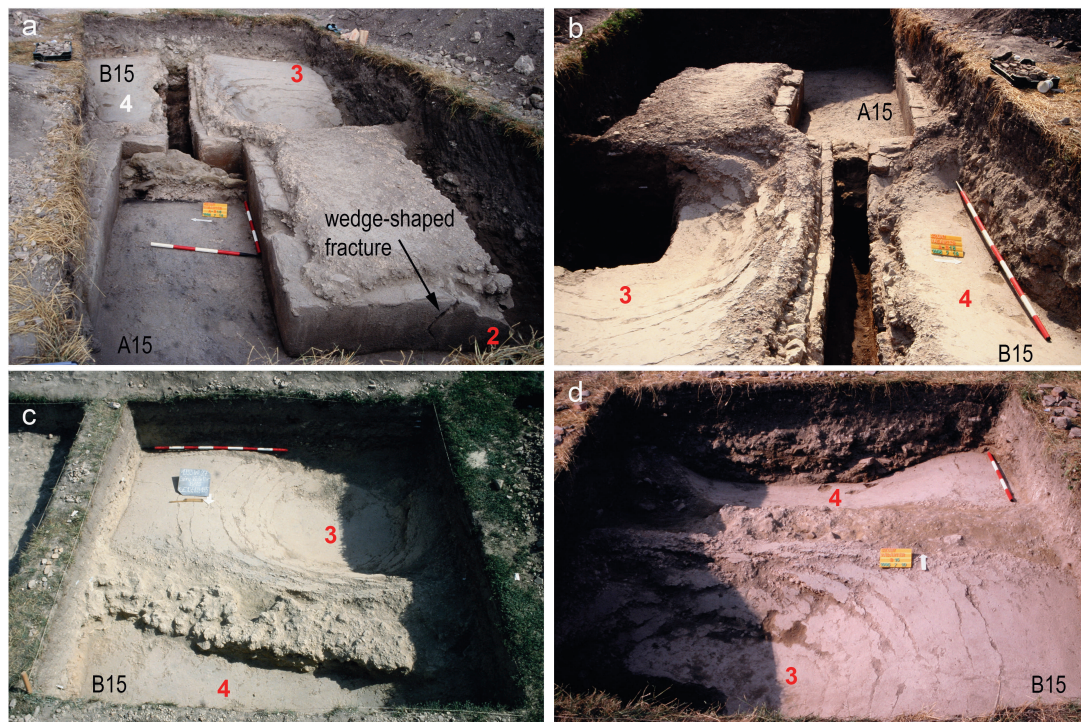
Fig. 12.

*Two liquefaction-caused depressions in the terrazzo floor of Room I/4 (nr. 3–4), on either side of the hypocaust heating channel. a, The wedge-shaped fracture in the forefront was caused by depression nr. 2 deforming the hypocaust floor. b–d, Depression nr. 3 measures 3.0 m in diameter and is 0.5 m deep. The concentric fractures formed during subsidence (photos: L. Borhy)*

A little to the north, three crater-like depressions were found in Room I/4 of House I/b (Fig. 9, 11–12). The most spectacular feature (nr. 3) is an oval depression with a diameter of roughly 3 m, and a depth of 0.5 m (Fig. 9, 12). Its volume measures appr. 1.2 m<sup>3</sup>. The western side of its wall is almost vertical, while the eastern side is gently sloping towards the centre. The uppermost layer of the terrazzo is 0.15 m thick, dissected by a set of concentric fractures. Under the terrazzo floor the remains of an earlier wooden structure, a rectangular well was found, which was probably filled just before Room I/4 was built in the first half of the 3<sup>rd</sup> century AD.<sup>57</sup> On the other side of the heating canal, in the northeastern corner of the room, another, less regular depression can be seen (nr. 4, Fig. 9, 12). Its depth measures about 0.3 m. The third depression in Room I/4 distorted the terrazzo floor of the hypocaust heating channel in the southwestern corner of the room (nr. 2, Fig. 9, 11). The floor visibly slopes to the east and south, and the in situ hypocaust pillars made of brick are tilted. The eastern wall of the heating channel is cut by a wedge-shaped fracture, indicating that portions of the wall settled in an uneven way.

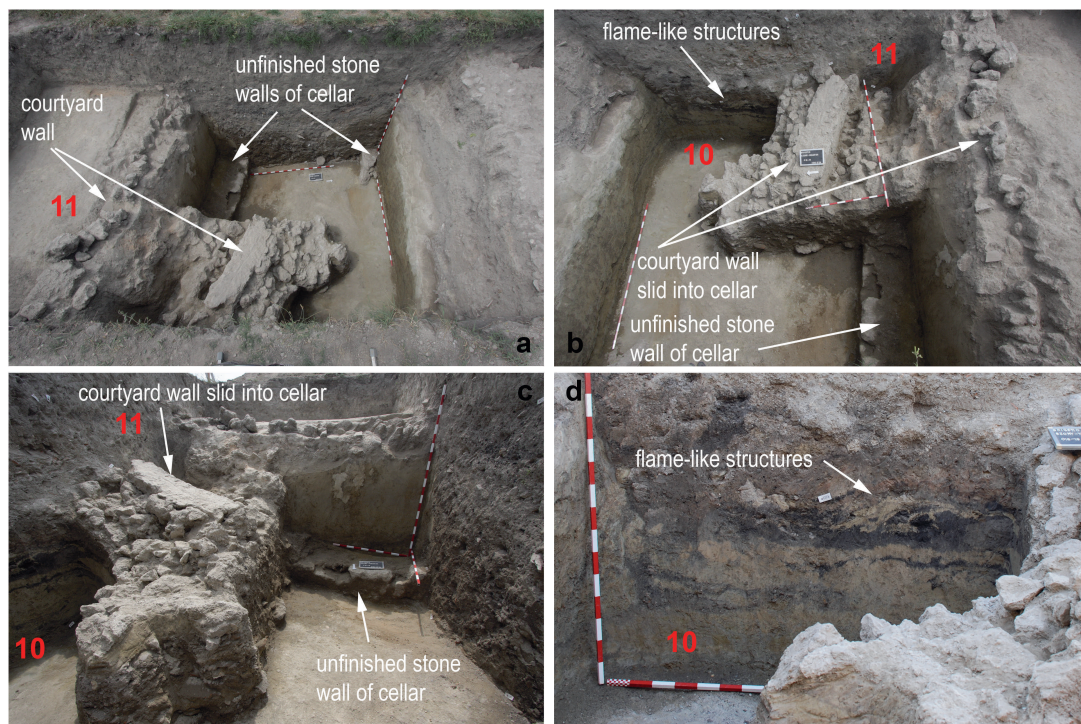
Fig. 19.

*Collapsed wall and flame-like features of liquefied sand. a-b-c, Courtyard wall collapsed into adjacent cellar (from east–west–north) b-d, Flame-like features of liquefied sandy clay (light colour) intruding into clay (dark colour). This feature indicates a shaking event preceding the construction of the cellar and the collapse of the courtyard wall into the cellar (photos: L. Borhy and N. Sey)*

the excavation wall, then seismic action can be considered proven. In Brigetio the disturbed layers in the subsoil might indicate seismic-induced liquefaction (nr. 10, Fig. 19).<sup>73</sup> Sand volcanoes can form a crater, when the extruded sediment is so much, that the remaining standing walls of the vent or dyke collapse. We attribute the oval-shaped depression in the terrazzo floor (nr. 3, Fig. 8–9, 12) to collapse after sand volcano action. Sand-laden groundwater escaped through the concentric fractures.
