Acta Archaeologica  
Academiae Scientiarum  
Hungaricae

# Reconstructing the riverside of the Danube in the medieval city of Pest

## ABSTRACT

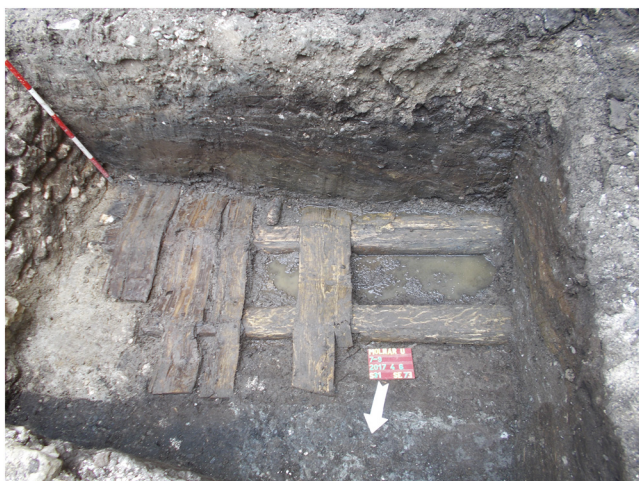
Fig. 6. Remains of a wooden platform sloping towards the Danube

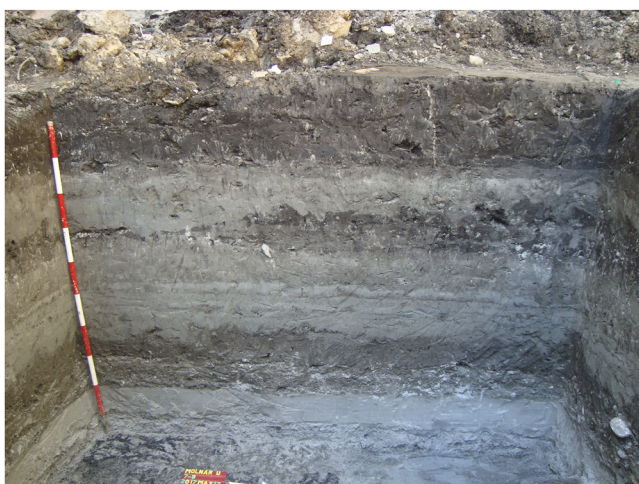
Fig. 7. Silty-sandy flood layers

Taking into consideration the aforementioned data, we can assume that the average water level of the Danube was significantly lower than today, as the operation of the medieval and Early Modern Age tannery had to be ensured. Muddy layers covering the area prove the frequent flooding of the river, which the artisans had to deal with somehow, as the floods threatened the town's inhabitants every year (Fig. 7).

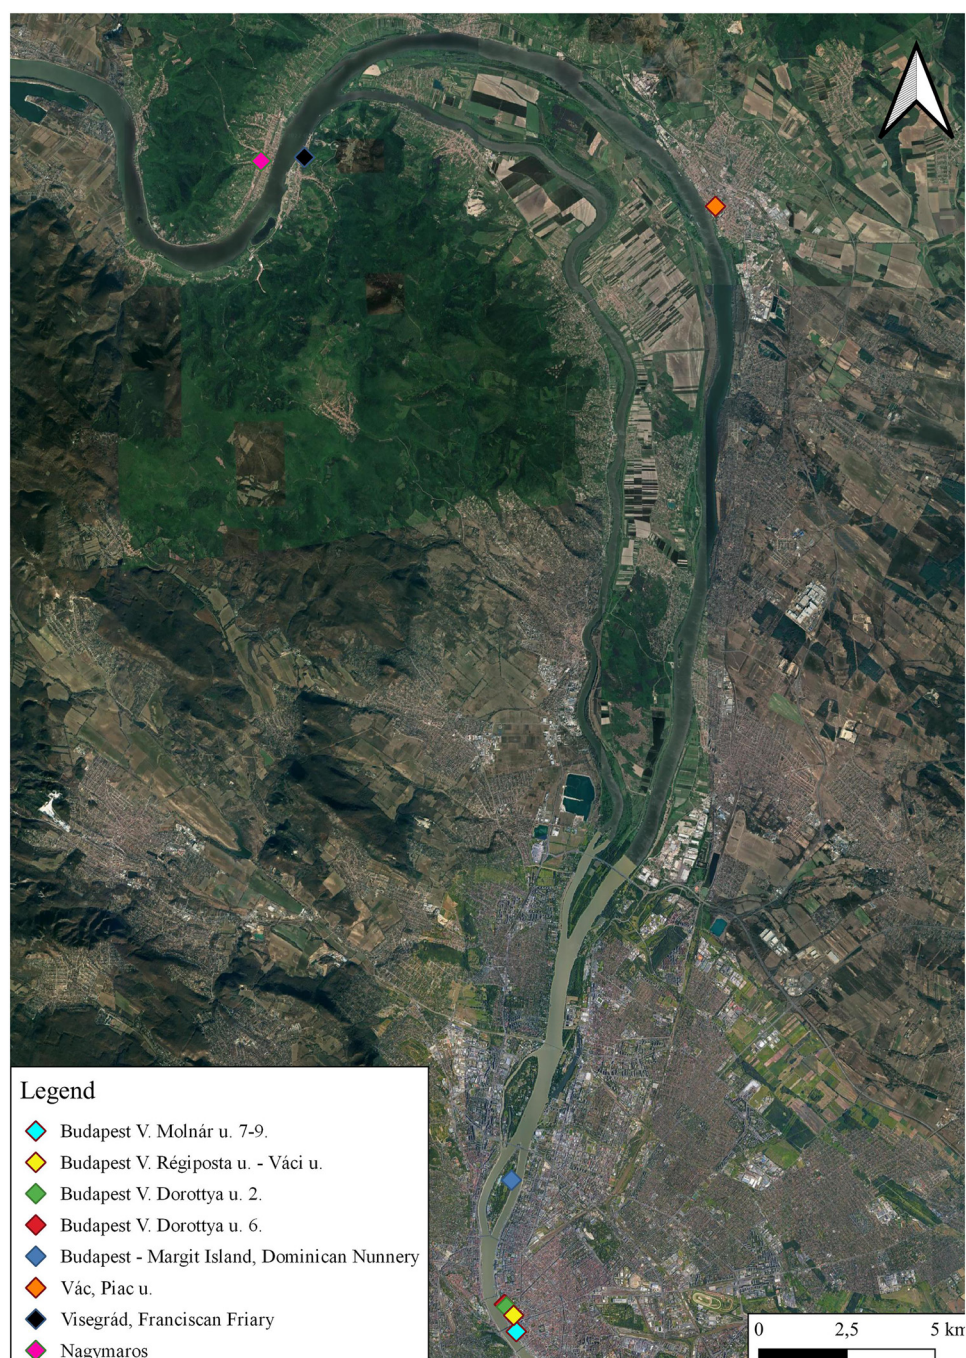
**Fig. 8.** Location of the sites presented in the paper

The geographical location of the site raises the need to compare the results of historical and scientific research conducted in a similar environment. Archaeological excavations near the riverbank have been carried out in only a few places in the medieval city of Pest (Fig. 8). During her research on the sites between Dorottya Street and Apáczai

North of Pest, in Vác and Visegrád, researchers focused on the changes in the geographical features of the settlement, the Medieval and Early Modern development of hydrographic conditions, as natural features can be defined as one of the most important elements of urban development (Fig. 8).<sup>30</sup> Excavations carried out in both settlements near the bank of the Danube unearthed 13<sup>th</sup>–18<sup>th</sup> century remains of the cities, with the same method seen in Molnár Street.

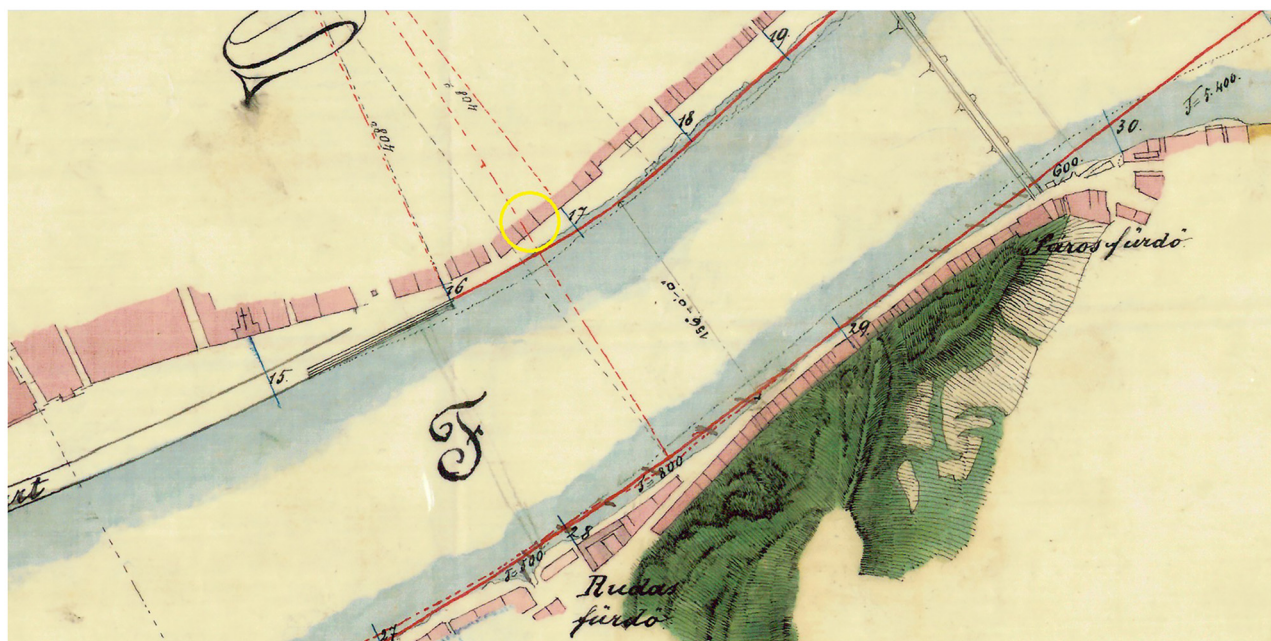
**Fig. 9.** Map of the part of the river Danube between Buda and Pest with the established regulation line. Yellow circle: site of the excavation in Molnár Street. Red line: planned new coastline. Catalogue of maps of Budapest 267. With the permission of the Budapest City Archives. Archival reference: BFL XV.16.d.241/13

It can be seen from the plans of the river regulation works of the 19th century that hardly any changes were made in this part of Pest,<sup>20</sup> so the width of the river probably changed so much in previous centuries (Fig. 9). This coincides with the fact that no medieval features are known from the area northwest of the downtown parish Church, bordered by the Danube-bank – Türr István Street – Március 15. Square. In our opinion, this can be explained by the fact that in the Middle Ages the river flowed a little bit elsewhere than today, and perhaps there had a bend north of the Church.<sup>21</sup>
