PRESERVATION OF ARCHITECTURAL AND URBAN HERITAGE
IN THE 21ST CENTURY: *CHALLENGES AND OPPORTUNITIES*

LEGO MONUMENTS: THE BAKÓCZ CHAPEL IN ESZTERGOM AND THE PROTECTION OF HISTORICAL MONUMENTS

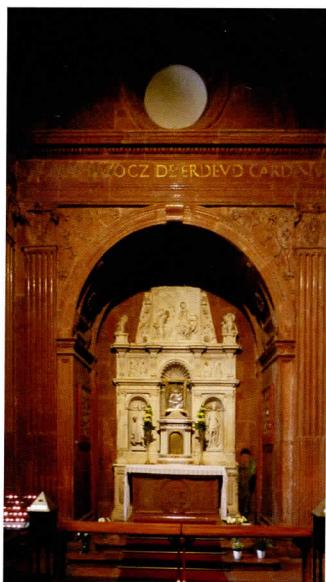
Fig. 1. Altar of the Bakócz Chapel carved by Andrea Ferrucci. Photo: Anna Tüskés, 2023

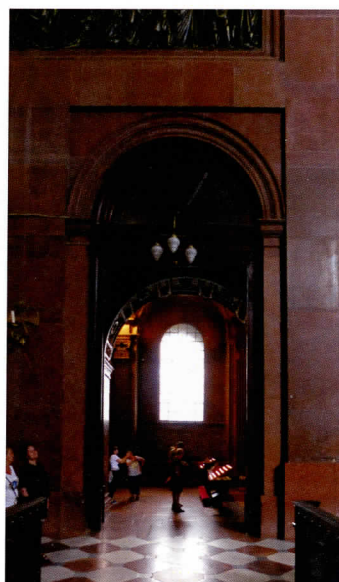
Fig. 2. Entrance of the Bakócz Chapel. View from the cathedral towards the chapel. Photo: Anna Tüskés, 2023

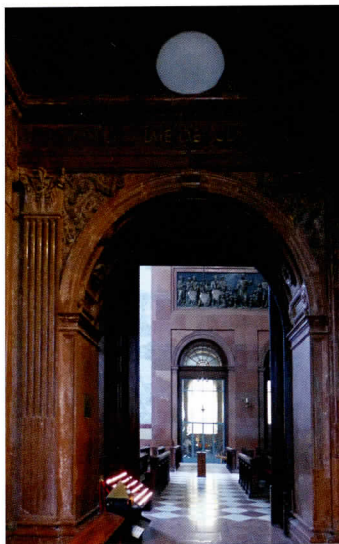
Fig. 3. Entrance of the Bakócz Chapel. View from the chapel towards the cathedral. Photo: Anna Tüskés, 2023

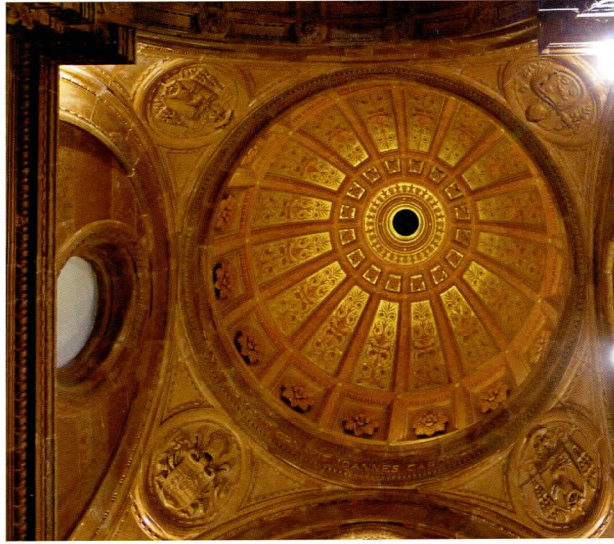
Fig. 4. Dome of the Bakócz Chapel with the coat of arms of Archbishop Tamás Bakócz (twice), King Vladislaus II of Hungary and Bishop György Szathmáry. Photo: Anna Tüskés, 2023

All of this shows that: 1. 1600 marble elements were salvaged from the old chapel. 2. Most of the architectural elements that have survived are believed to have been incorporated into the reconstruction.¹⁹ 3. The non-marble parts were not preserved; thus, nothing was saved from the old dome, which consisted of copper plates fixed to the frame structure. Likewise, nothing was saved from the original foundations or the crypt. 4. The chapel was given new foundations, a new crypt and a new roof. In other words, in the case of the Bakócz Chapel, we cannot talk about saving the building in its entirety.
