Investigations on the historical Széchenyi chain bridge

Balázs Kövesdi¹ | Dénes Kollár¹ | Bence Szabó¹ | László Dunai¹

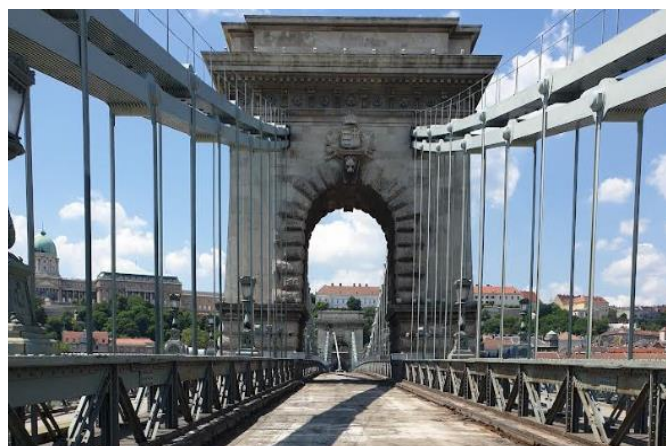
Figure 1 The Széchenyi chain bridge under reconstruction

The Széchenyi chain bridge (Figure 1) in Budapest was originally built between 1839–49. It was reconstructed several times in the history, but chain elements reached their 100-year-lifetime and the deck system was more than 70-year-old. The latest renewal process on the bridge executed within the last years has been designed by the Főmterv Co. and MSc Ltd. [1] The strategy of the current reconstruction was that the old bridge deck system (concrete slab and longitudinal steel stringers) has been replaced by a new orthotropic steel deck. The chain elements, the steel stiffening girder and the cross-girder system remain unchanged, only the corrosion protection is planned to be renewed. It is well known, stuck pins can change the structural behavior of the chain system, which could lead to damage of the bridge. One of the most serious chain bridge failures occurred in the USA in 1967 resulting in the death of 46 people [2]. The Silver Bridge collapsed due to a single chain element failure initiated from a fatigue crack resulting the total collapse of the chain system. Therefore, the evaluation of the structural condition of the remaining elements is an important task of the renewal process to determine their load carrying capacity and remaining lifetime. Therefore, connected to the current renewal process, the corrosion grade of the

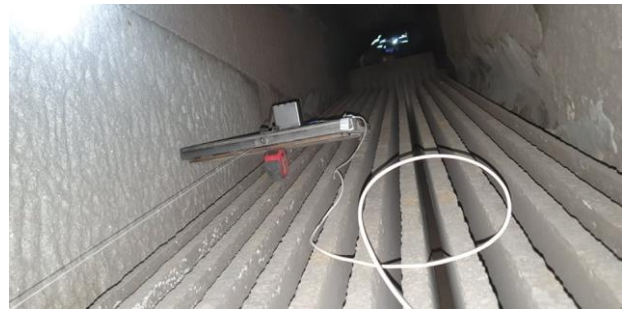
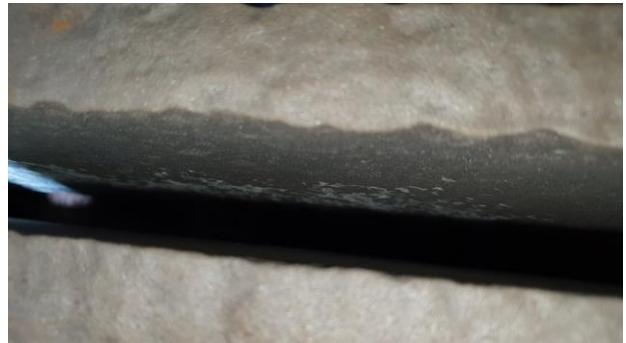
Before the measurements all the chain elements were cleaned by sand shooting to create a surface which could be scanned with high accuracy using a specific measuring device developed specially to the chain elements of the Széchenyi chain bridge. The typical corroded surface of the chain elements and the measuring device is presented in Figure 8. The measuring device could produce continuous measurements at 7 straight lines along the longitudinal axis of the chain elements. One example for one specific chain bar is shown in Figure 9, where the horizontal axis shows the longitudinal axis of the chain bar and the vertical axis shows the measured thickness. It can be seen the largest cross-section loss is located at the end of the chain bars. Its reason is that the rain flows alongside of the entire element, and it drops down at the end of the member.

Figure 8 Typical surface of the corroded and cleaned chain elements
