## MONUMENT CONSERVATION AND EXCAVATION OF THE ROSSZTEPLOM CHURCH IN TÖK, 2022

TIBOR ÁKOS RÁCZ<sup>1</sup>

Hungarian Archaeology Vol. 11. (2022) Issue 4, pp. 79–83. <https://doi.org/10.36338/ha.2022.4.6>

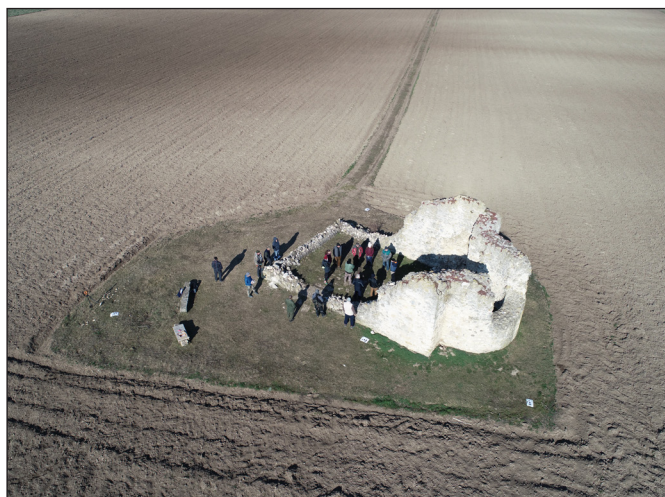
Fig. 1. Aerial photo of the Árpadian Age church before conservation (photo by László Rupnik)

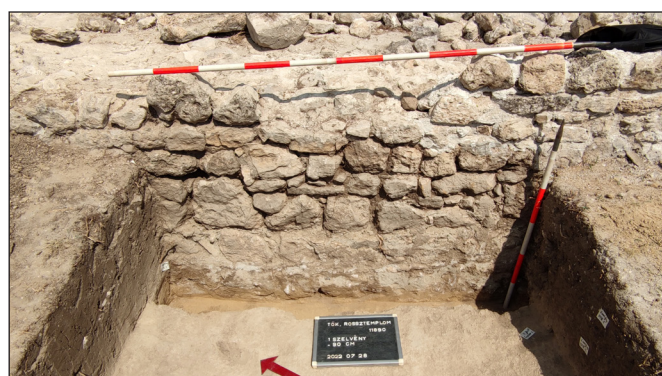
Fig. 3. The western wall in Trench 1, excavated to the bottom of its foundation (photo by Tibor Ákos Rácz)

The date was not legible on it anymore, but it was identified as a counterfeit coin imitating the type ÉH 766 (issued in 1564–1608). The yellowish, clayey subsoil was reached at a depth of 50–60 cm. We cleaned the ruined wall with a high pressure water gun and found that it was relatively easy to distinguish between the foundation and the wall itself, as the outer side of the foundation was also mortared. The overground parts of the nave's western end had been completely destroyed, but the underground part of the wall could be traced to a depth of 30–40 cm, under which we have found the 20 cm thick foundation set directly on the subsoil. This means, the floor level in the Árpadian Age on this side of the wall was 30–40 cm deeper than the present-day ground level. This observation corresponds to the stratigraphy of the trench, where the border of the two, clearly different observed layers was found in the same depth. The topmost layer (S-1) consisted of greyish brown humus admixed with rubble and mortar. Under that, we have distinguished a homogenous dense light greyish brown humus fill layer (S-2) with no rubble that yielded only a single human bone; it was identified as the Árpadian Age humus layer. The foundation trench (S-4) could also be traced along the foundation wall, deepening from the fill layer some 20 cm more; in summary, the foundation of the wall was 40 cm deep relative to the medieval ground level. Nothing suggested that an entrance had ever existed on the west side of the church.

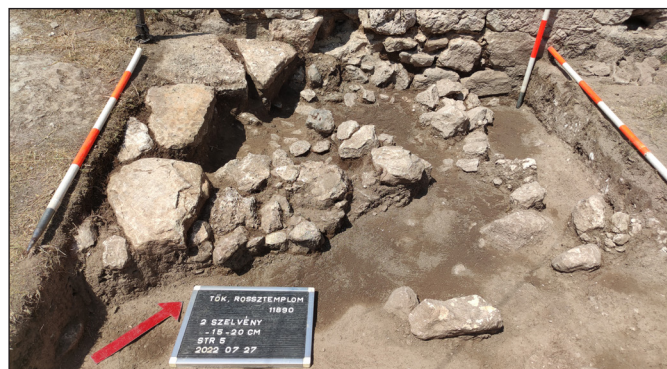
Fig. 4. Rubble of a collapsed wall section in Trench 2 (photo by Tibor Ákos Rácz)

The second trench was positioned next to the southern wall in order to clarify if there was an additional construction associated with the entrance there. The top 30–40 cm was identical with S-1 in Trench 1. Underneath, a layer containing the stones from a major collapsed wall section (S-5) was observed; it contained stones without any recognizable arrangement or connection. The layer also comprised a few pottery sherds, some animal bones, and perhaps human bones as well. A new layer started under the rubble, at a depth of 40 cm; it was a greyish brown fill with only a few stones (S-10) and somewhat more medieval ceramic fragments than the one above. Under the wall rubble at the southern entrance we discovered the remains of a foundation that protruded ca. 50 cm from the wall and served as a reinforcement of the entrance (S-14); this feature could be traced from the level of the rubble down to the yellowish subsoil. In the same section, under the foundation, we could also trace a narrow north to south foundation trench. In summary, we discovered the foundation of the south entrance in the second trench but nothing indicating a portico.

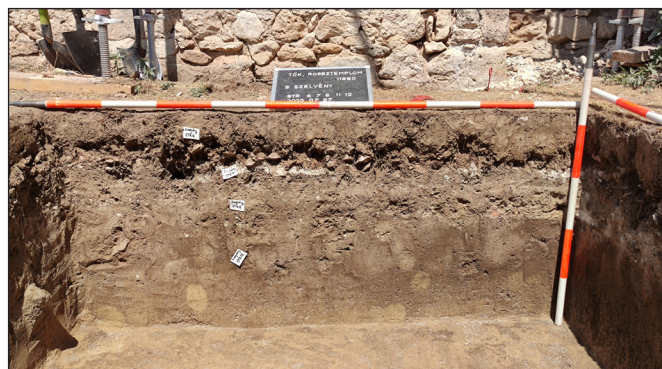
Fig. 5. Stratigraphic sequence in Trench 3 (photo by Tibor Ákos Rácz)

Trench 3 was positioned inside the nave, close to the sanctuary. The aim here was to clarify the stratigraphy of the church's interior. The position of the trench was partly defined by the scaffolding around the walls that prevented us from excavating at their feet and the building material piled up beside them, which made other parts of the church interior inaccessible. The trench was positioned in a more-or less clear area in the centre of the nave in a way to make sure that it intersects all potential important burials in the axis of the nave near the sanctuary. We found several distinct layers and a large pit. The topmost 5–10 cm was modern humus (S-6) that deposited after the first monument conservation works in 2000, when slabs had been laid in the topmost layer to create a paved pathway. The soil layer rich in gravel under S-6, observed throughout the whole trench, was a result of ground levelling during the same conservation works. It must have been created to protect the historical layers underneath, and consisted of stones that do not occur in the area naturally. The

first historical stratum was a 20–30 cm thick sandy, grey humus layer with rubble (S-8). A coin from the time of Béla IV (counterfeit of type ÉH 218, issued around 1242–1270) was found at the border between layers S-7 and S-8, while the bottom of layer S-8 featured patches of brick rubble and lime (S-11): this was the construction layer of the church. S-12 under that was a homogenous light brown humus layer that yielded no finds except for a few bone fragments in secondary position, brought there by burrowing animals. In Trench 3, the profiles proved to be the most useful in clarifying the stratigraphy of the church interior: S-8 corresponded to the medieval period of the church, while S-11 was connected with its construction.

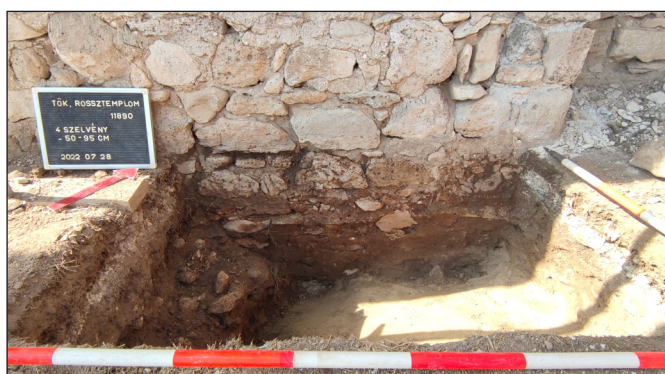
Fig. 6. The north wall of the church in Trench 4 (photo by Tibor Ákos Rácz)

To document the perpatranted layers and clarify their position relative to the wall, we dug another small trench, 150×90 cm in size, as the continuation of Trench 3 but separated from it by a profile wall (Fig. 6). To make that, some parts of the scaffolding had to be dismantled first, but the standards that had to be left in place still prevented us from extending it to be two-metre wide. However, the trench ran up to the inner side of the northern church wall. All layers described in Trench 3 could also be observed and documented in the extension, and we even found a few pottery fragments in S-8. Furthermore, we have revealed a direct connection between layer S-11 and the foundation wall, proving that the former was indeed the construction layer.

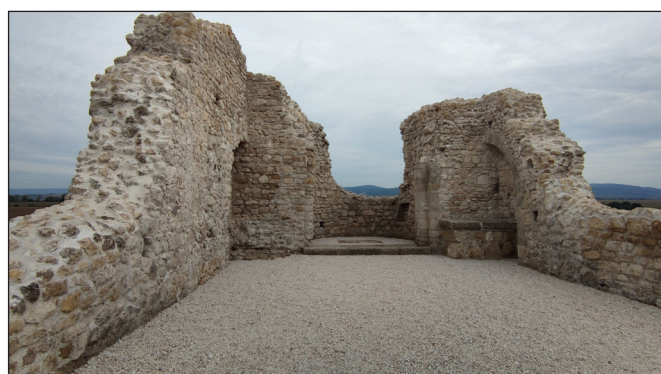
Fig. 7. The apse of the restored ruin, viewed from the west (photo by Tibor Ákos Rácz)

Our findings suggest that the church had only one construction phase in the Árpáadian Age. It had no western entrance, and the cultural layers were thin and only yielded very few artefacts. The Árpáadian Age village was located at a distance, but a few houses were built in the vicinity of the church building in the late Middle Ages. The church was in use during the Middle Ages, but the youngest finds from the scattered settlement surrounding it can be dated to the reign of Matthias I. The inhabitants moved to another location at an unknown date in the medieval period. A scattered settlement may have remained around the church, but no proper village stood there in later centuries (Fig. 7).
