Secondary effects generated by earthquakes: Liquefaction occurrences in and around Hungary --Manuscript Draft--

Secondary effects generated by earthquakes: Liquefaction occurrences in and around Hungary

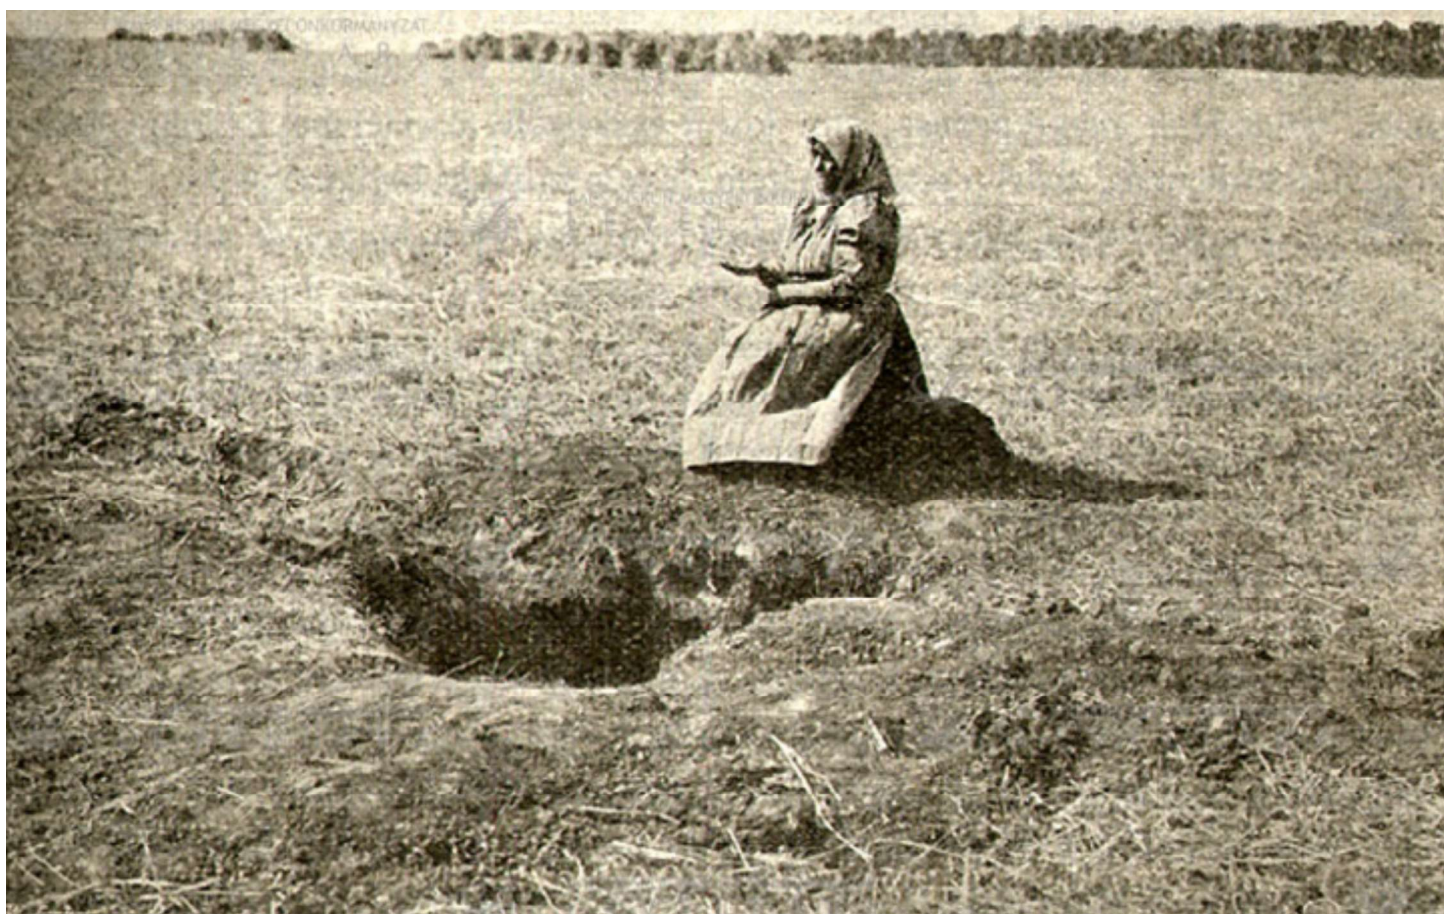
Figure 6.
[Click here to download high resolution image](#)

The mud-volcano caused by liquefaction had been considered as the epicentre by Réthly (1912) and its co-ordinates had been also specified by him ($\lambda=19^\circ 38' 29''$, $\varphi=46^\circ 55' 40''$, $h=130$ m). The site of the mud-volcano with a diameter of 1.5 m had been excavated as shown in the photo in Fig. 6. Top- and side-views can be found in Fig. 7.

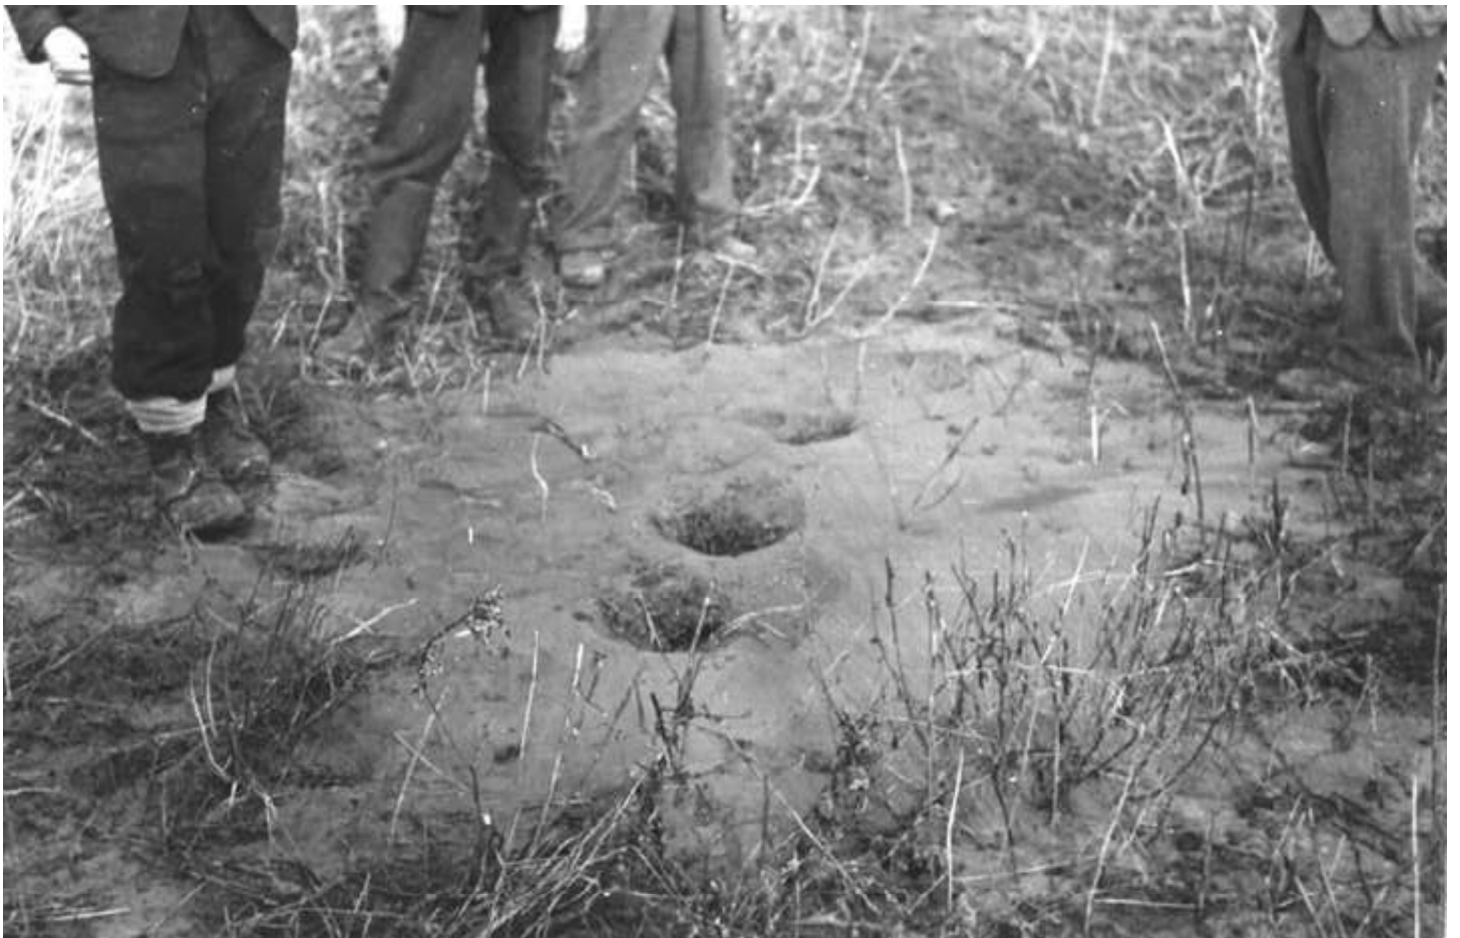
Figure 9.
[Click here to download high resolution image](#)

4 Formation of cracks indicating soil liquefaction, as well as sand and mud volcanos
5 have been observed at some settlements particularly in areas close to the Danube. Several
6 cracks of SSW-NNE direction have been observed in the soil in the inn yard of “*Liget*
7 *Csárda*“, at Taksony side of small island in the Soroksári Danube branch (Somogyi 1956).
8 Eyewitnesses claimed that water was ejected into high from the fountain of the Inn. Bluish
9 gray silty sand came to the surface through the 5-8 cm holes found behind the inn and N from
10 the inn (Fig. 9).

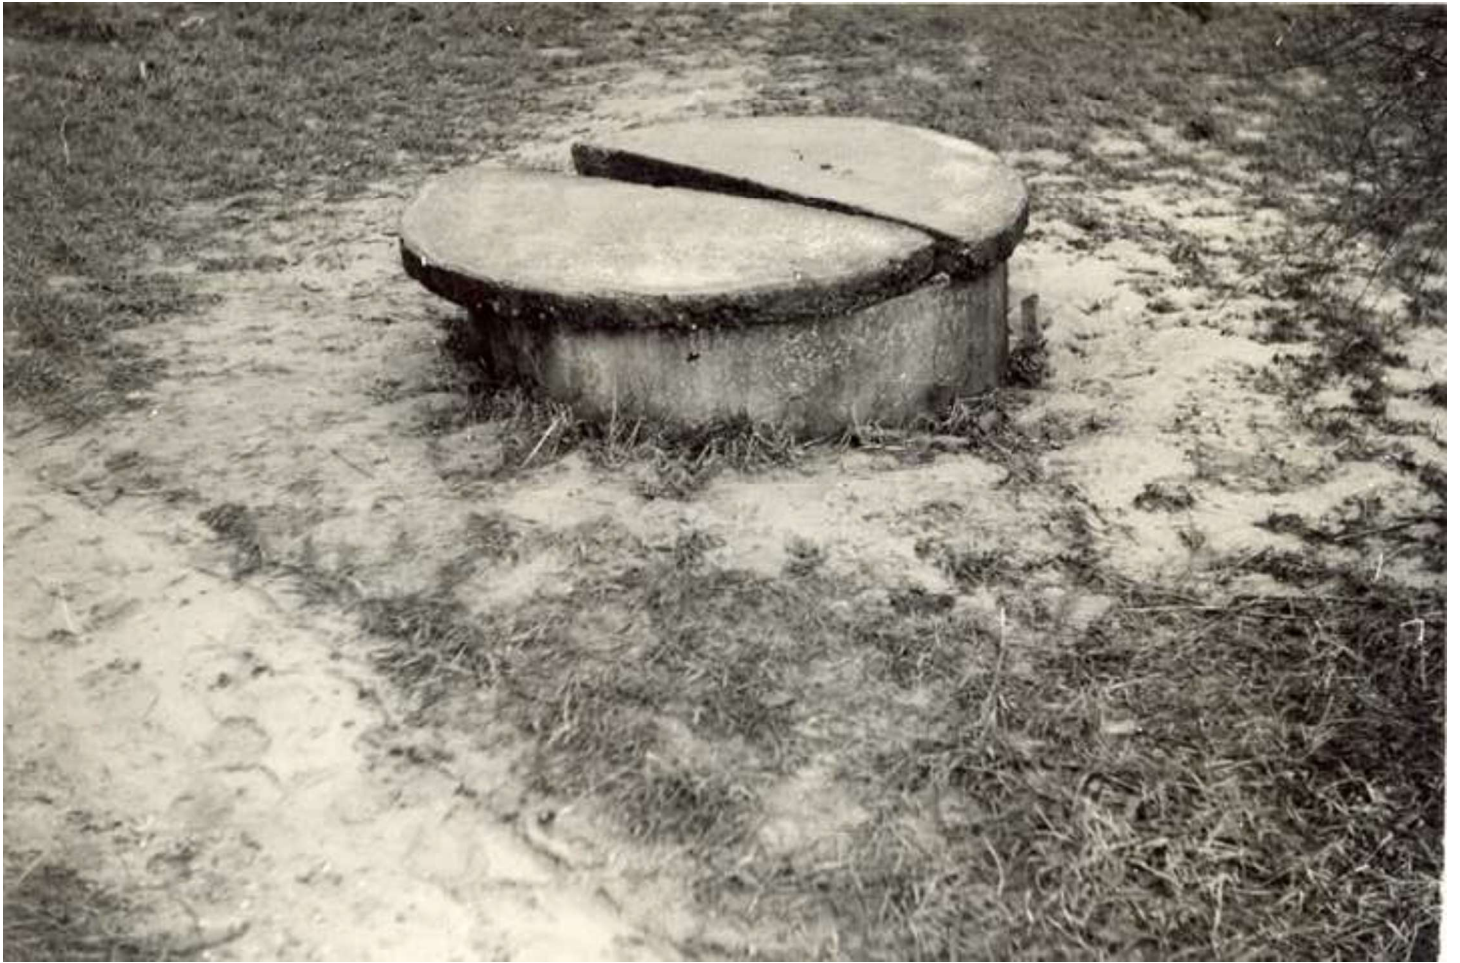
Figure 10.
[Click here to download high resolution image](#)

11 At Szigetszentmiklós, sand and mud spurt and siltation of dug wells were observed
12 around Szilágyi, Árpád and Rákóczi streets, near to the Suburban Railway.
13 The same phenomena were observed in Damjanich and Duna streets (Fig. 10), in areas along
14 the Danube, at Dunaraszti.

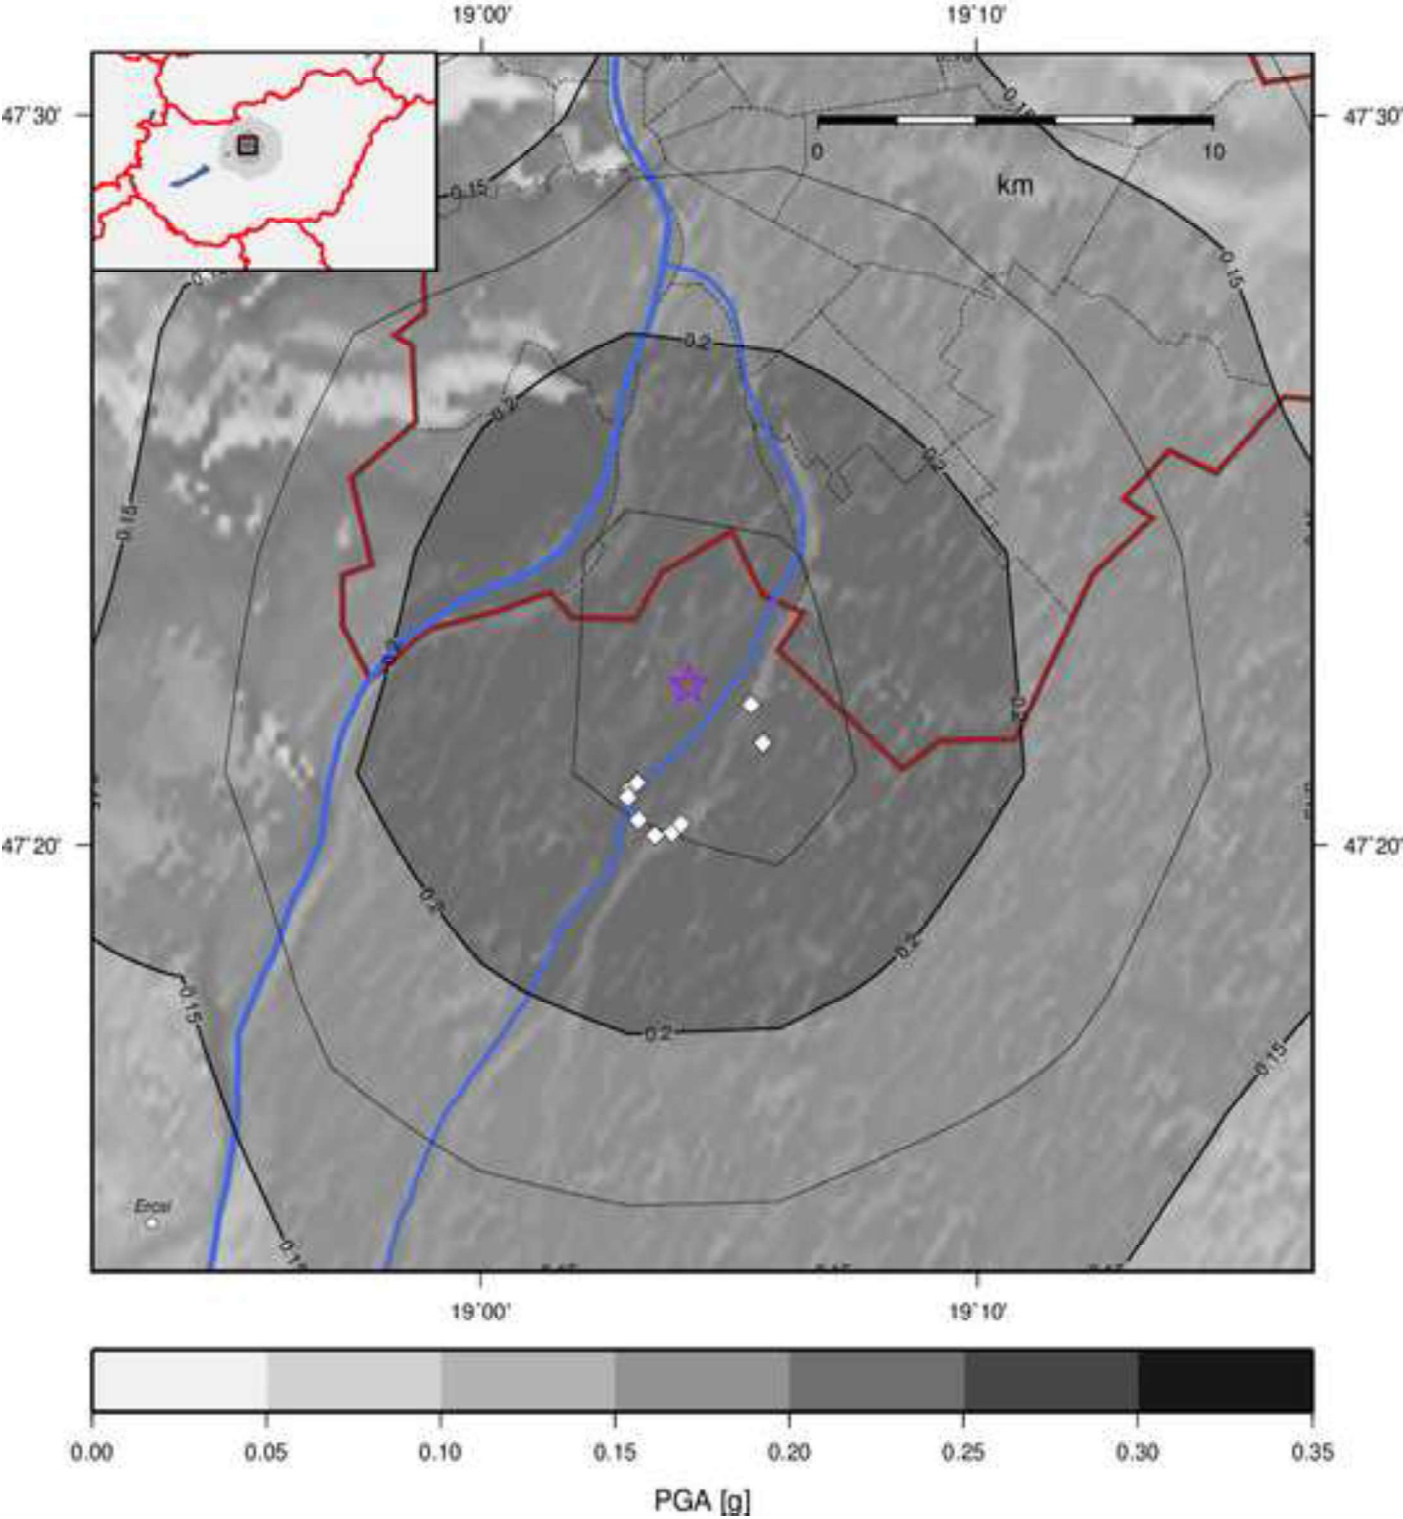
Figure 11.
[Click here to download high resolution image](#)

31 ShakeMap simulation of horizontal peak ground acceleration distribution of the
32 Dunaharaszti earthquake resulted PGA > 0.2 g in the 220 km² area of the epicenter. The
33 horizontal PGA was greater than 0.1 g in an area of 2,600 km² and reached 0.05 g at about
34 8,000 km². (Fig. 11)

Fig. 11 ShakeMap simulation of horizontal peak ground acceleration (PGA) distribution of the 1956 Dunaharaszti earthquake. White diamonds on the map indicate liquefaction sites.
