Operational experience with the CMS pixel detector

PIXEL 2014 INTERNATIONAL WORKSHOP SEPTEMBER 1–5, 2014 NIAGARA FALLS, CANADA

J. Karancsi on behalf of the CMS collaboration

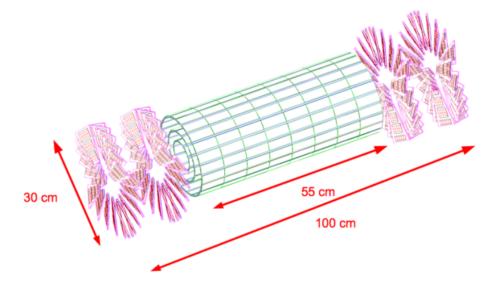
Figure 1. Schematic view of the CMS Silicon Pixel detector. The interaction point is surrounded by three cylindrical barrel layers at radii of 4.4, 7.3 and 10.2 cm and two endcap disks on each side with modules between 6 and 15 cm from the beam axis.

The sensors consist of high dose n-implants inserted into a high resistance n-substrate with rectifying pn-junctions on their backside, and are connected with readout chips (ROCs) by indium bump-bonds. The total number of pixels is approximately 66 million, each with a cell size of $100 \times 150 \,\mu\text{m}^2$. There are all together 15840 ROCs located on three barrel layers and two endcap disks (figure 1).

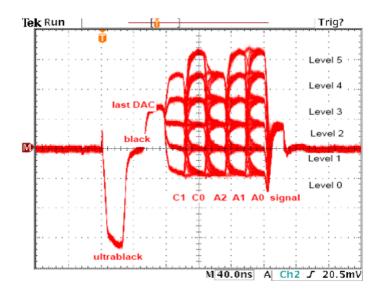
Figure 2. Oscilloscope view of the analogue signal for a pixel hit.

In the commissioning period and throughout running the different components of the detector need to be calibrated in order to ensure fully efficient and reliable data collection. The analogue signal (figure 2) consists of data packets that contain the information about each pixel hit. The pixel coordinates are encoded by using a six-level address scheme, while the charge information is contained in the analogue pulse height of the last clock cycle [4].

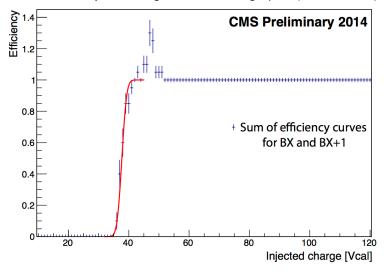
Scan over injected charge values for a single pixel (standard scan)

Figure 3. Sum of in- and out-of-time charge collection efficiencies as a function of injected charge.

Another set of calibrations needs to be done every few months due to the aging of the detector. One of them is the threshold calibration for which electric charges are injected through a circuit on the readout chip and the efficiency is measured. A scan is done for each pixel in units of V_{cal} which corresponds to 65.5 electrons. The efficiency is measured and the threshold is derived from a fitted turn-on curve (figure 3). The measurement [5] is then repeated in an iterative way for various ROC threshold settings in order to minimise the thresholds.

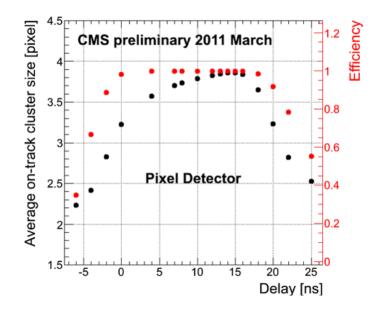
Figure 4. Average cluster size and hit efficiency vs. time delay with respect to the LHC clock.

Usually once per year, at the beginning of data taking the timing calibration of the detector is done in which the pixel detector clock is synchronized with the LHC collisions. A scan is done for various settings of the relative phase delay with respect to the LHC clock. A delay is chosen that ensures the collection of the high pixel charges and also gives enough time for most of the smaller charge pulses to cross the readout threshold in the same 25 ns readout window. The goal is

to maximise both the hit- and the charge collection efficiency (figure 4) and to allow the usage of smaller thresholds which then improves the hit resolution. Therefore a point is chosen near the end of the efficiency plateau.

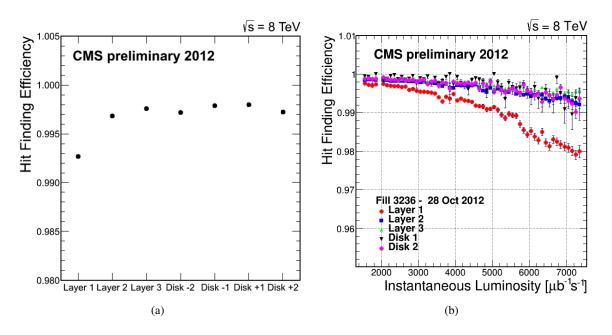
Figure 5. The hit finding efficiency for all barrel layers and endcap disks (a) on average in 2012 and (b) as a function of instantaneous luminosity in a longer LHC fill.

The hit efficiency is an important parameter to monitor throughout data taking. It is defined as the probability to find a cluster along a charged particle trajectory. Nonfunctioning modules or those that were affected by a single event upset are excluded from the measurement. The method is explained in more detail in [6]. In 2012 the average efficiency of the detector was above 99% for all layers and disks (figure 5). Compared to the outer part of the detector, the innermost layer experienced a lower efficiency, on average 99.27%, due to the higher particle flux. This is an expected behavior, due to the limited buffer size in the current readout chip [7]. The inefficiency depends on the instantaneous luminosity as shown in figure 5(b).
