Distinguishing damages from two earthquakes—Archaeoseismology of a Crusader castle (Al-Marqab citadel, Syria)

Damages from two major earthquakes are identified in medieval Al-Marqab citadel (Latin: Margat) in coastal Syria. Built by the Order of St. John (Hospitallers) in the twelfth–thirteenth centuries, the hilltop fortification has masonry walls made with and without mortar, using the *opus caementum* technology (Roman concrete). V-shaped and U-shaped failures, single-corner and symmetrical corner collapses, and in-plane shifts of ashlar masonry walls are identified and dated by historical and archaeological methods. The azimuth of displacement is NE-SW for the older damages of the Crusader period (A.D. 1170–1285), possibly related to the A.D. 1202 earthquake. A later, NW-SE displacement occurred during the Muslim period (post-1285). The 1202 earthquake produced at least VIII intensity on the MSK scale at Al-Marqab, which is higher than previously considered.

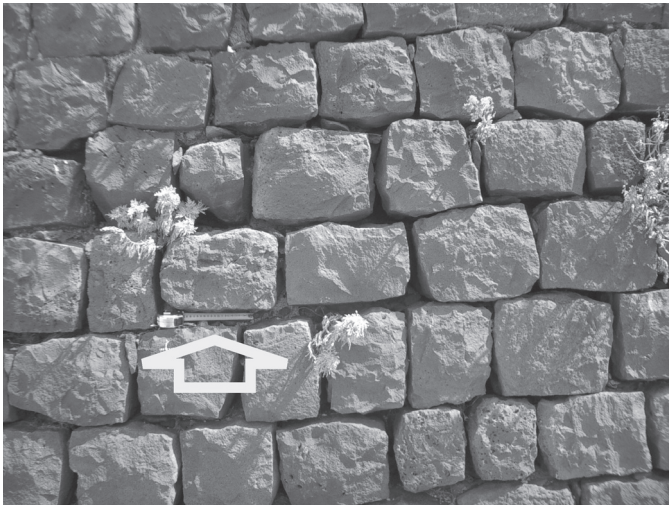
Figure 4. Ashlars in the western, windward wall of the donjon are seemingly unsupported. However, their rear side is firmly embedded in Roman concrete, the cementing material of the several-meter-thick wall. Laid initially with mortar, westerly winds and rain have removed much of it throughout eight centuries. Arrow: measuring tape for scale, 20 cm long.

This multilayer construction technology made walls of Al-Marqab castle extremely durable, even without reinforcement. For assessment of earthquake damages, the external masonry is treated as consisting of discrete blocks, while the concrete wall behaves as a cohesive block. For modeling purposes, this kind of wall is treated as poor Portland cement concrete (Ferretti and Bažant, 2006). While this type of wall may deteriorate through the centuries due to creep and fatigue (Anzani et al., 1995, 2009), we can be sure that this was not the case just a few decades after construction.

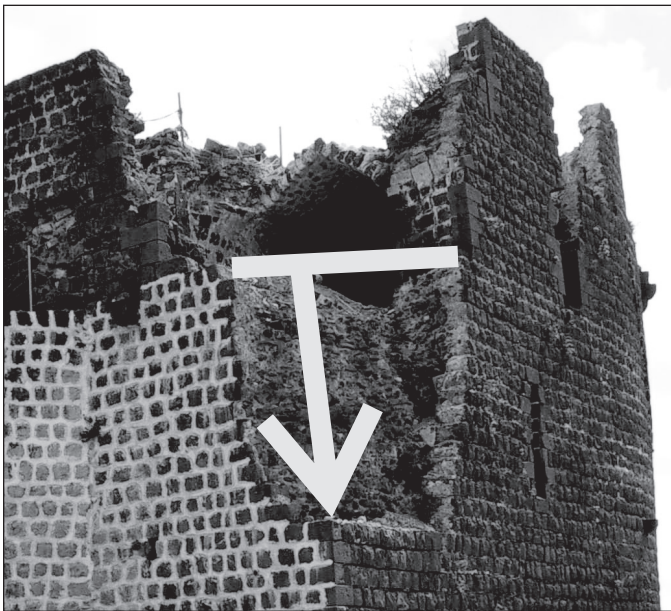
Figure 6. Failed corner of perpendicular walls at NW corner of the donjon. Approximated by a normal fault dipping ~50° to 284°NW direction. Failure is ~3 m wide at horizontal line.

Adjoining, possible perpendicular walls have collapsed at their joining. Collapse occurs where both walls are free-standing, i.e., unconfined at least to one side. This partial collapse produces an uneven oblique surface, cutting both walls at an angle (Fig. 6). Although of irregular shape, the pattern of collapse is comparable to a failure plane that can be interpreted as a normal fault. The smoothed surface of the failure is considered the fault plane, where the two directions necessary for geological characterization, strike and dip, can be measured and/or calculated. Because we do not have any evidence for the displacement direction of the hanging wall (fallen fragments have been cleared centuries ago), we assume dip slip.

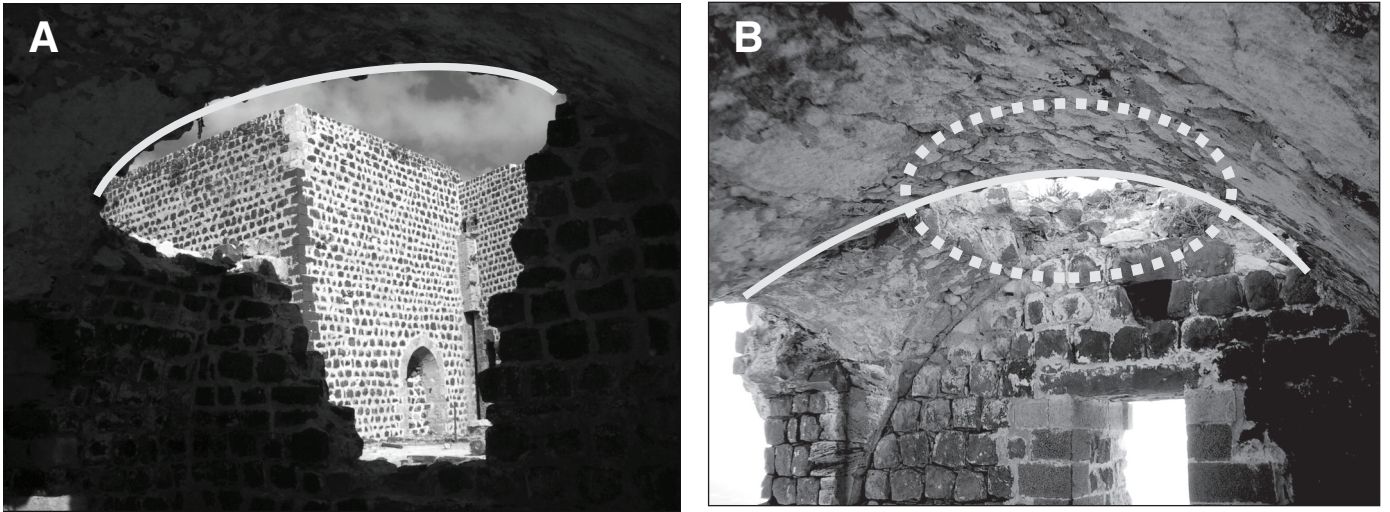
Figure 7. Room M3, as seen from inside, bearing symmetrically arranged damages to opposite corners due to a NE-SW-oriented vibration. (A) Collapsed NE corner of room M3, concave fracture (light curve) facing 50°NE. Failure is 4 m wide. (B) Partially damaged SW corner of room M3, concave fracture (light curve of 4.5 m span) facing 240°SW. Fallen portion of damaged vault is encircled by dashed line.

Room M3 sits on top of the vault of the kitchen. It is the sole remnant of a previous, larger cluster of rooms, which might have served as an independent kitchen. Walls that are 66 to 104 cm wide bear a barrel vault. Diagonally opposite corners have suffered symmetrical damages (Figs. 7–8). Fractures that are concave outward have developed. The NE corner collapsed in full, destroying a segment of the vault and portions of the adjacent wall (Fig. 7A). The concave fault developed in the SW corner as well, but only part of the vault collapsed: there is a 2×1 m hole in the top of the vault, connected by an arcuate fracture—a would-be failure scar—to the still-intact adjacent walls (Fig. 7B).

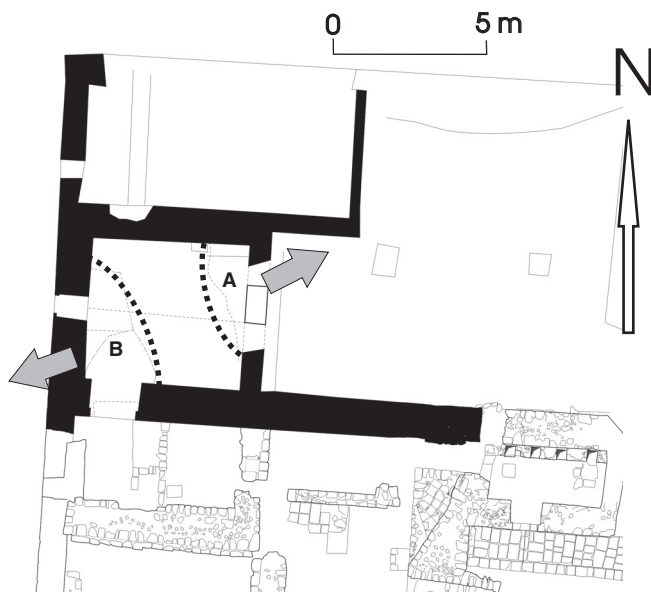
Figure 8. Plan of room M3. Outline of symmetrical failures is indicated by dotted lines. Letters A and B correspond to failures shown in Figure 7. Arrows indicate 50°–240° extension direction, similar to the azimuth of the V-shaped failure of the donjon.

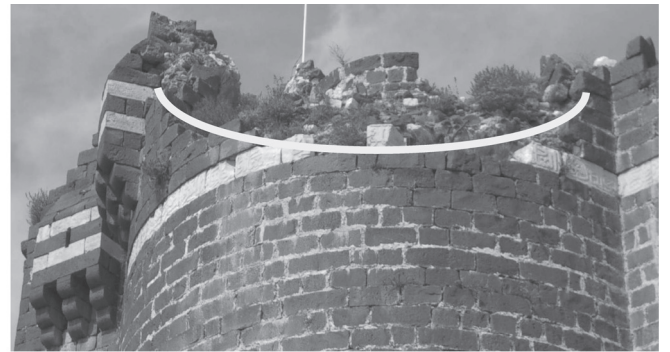
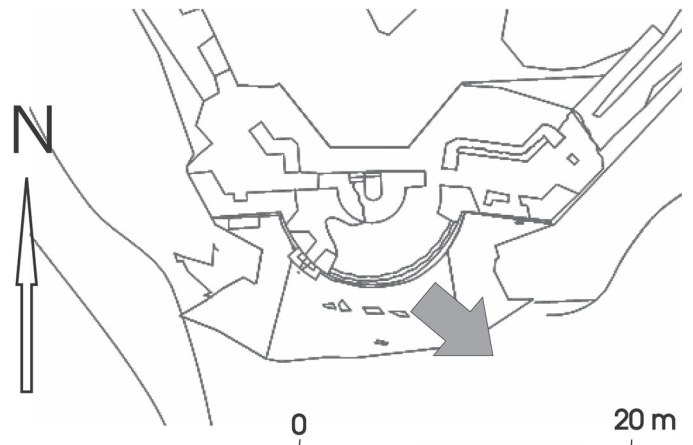
Figure 9. Symmetrical, scoop-like damage affecting top of Mamluk tower facing toward 130°SE. Both upper, thin (140 cm) and lower, thick (>3 m) portions of wall collapsed toward SE (arrow). Two box machicolations are visible on top left.

The top of the southern corner tower of the outer enceinte, the outer ring of walls of the Mamluk-built structure, bears a downward-concave failure. Both thin and thick portions of the tower have failed (Fig. 9).

Earthquake 2 produced the U-shaped damage to the southern corner tower. Additionally an extension of the top of the tower and of the box machicolation occurred in 120° – 300° direction. We can give only a *terminus post quem* date: it happened after 1285, i.e., during the Muslim period of Al-Marqab. In addition, a relative intensity of this quake would be lesser than that of the 20 May 1202, since it did not cause any visible damage to the donjon.

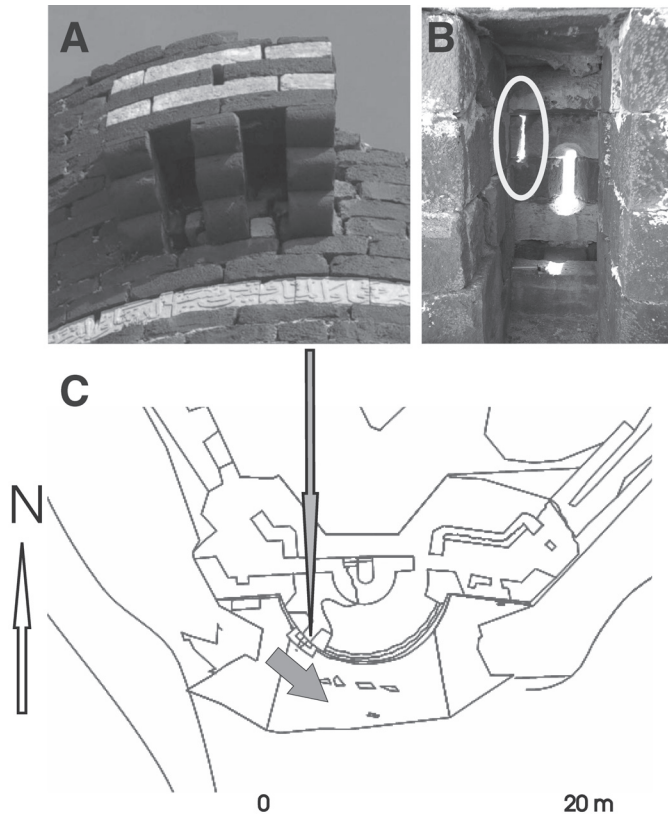
Figure 10. (A) Battlement with box machicolation suffered in-plane extension in 120°SE direction due to extension of the supporting wall. The upper 12 rows of ashlar have been displaced. Gaps between ashlar of the white stone are particularly wide, while blocks of the lowermost white row are still adjacent to each other. This is considered to be hard evidence for vibrations affecting the top of the Mamluk tower. Box is ~ 2 m wide. (B) Same box machicolation viewed from inside. Besides the observation slot in the center, there is a 10-cm-wide gap between adjoining ashlar on the left (encircled), testifying to in-plane shaking. Extension is parallel with box machicolation face, in $120\text{--}300^{\circ}\text{SE-NW}$ azimuth. Walk is 70 m wide. (C) Location of the semicircular Mamluk tower within the southern part of the citadel. Thin arrow points to the box machicolation that underwent extension. Wide gray arrow indicates direction of extension.

A large variety of shifted and rotated building blocks (ashlars) are seen at Al-Marqab. A shift within the plane of the wall is spectacularly shown in Figure 10. Heavily protected stone boxes extrude from the top of walls. Open bottoms allowed defenders to pour hot water, oil, or burning tar on attackers climbing the walls.

Box machicolations and adjacent walls on top of the southern Mamluk tower suffered in-plane extension of several tenths of a meter, and open spaces up to 10 cm wide formed between adjoining blocks during ground shaking. Although an indirect observation, this type of damage is confidently assigned to earthquakes, even by the otherwise cautious Ambraseys (2006, p. 1010). Similar open joints are described by Sintubin et al. (2003, their Fig. 5a) and Marco (2008, his Fig. 2F), and have been reproduced by vibration experiments (Vasconcelos et al., 2006, their Fig. 7).

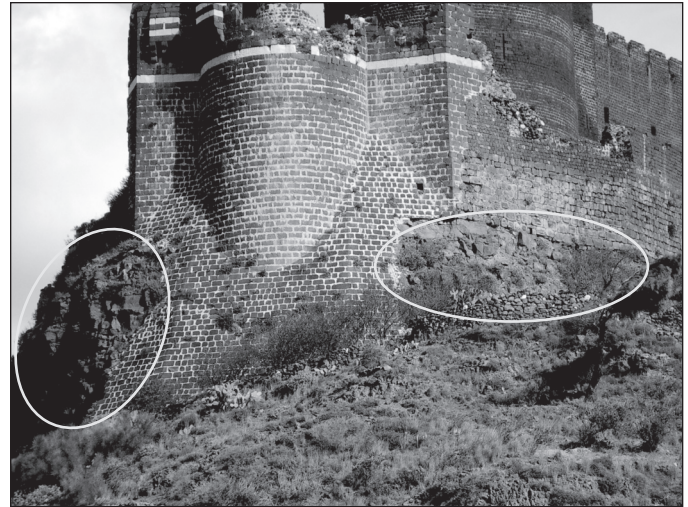
Figure 11. Crusader donjon (round tower partly hidden in background) and a later addition, Muslim southern tower built by Sultan Qalawun after his successful siege in 1285, bearing a row of white ashlar in the foreground. Both were firmly erected on several-meter-thick, unweathered vesicular basalt lava flow of Pliocene age (encircled), as seen on both sides of the glacis (inclined wall). Muslim tower is 20 m wide from corner to corner.

The buildings and walls of Al-Marqab have been erected on the solid subsoil of a several-meter-thick layer of compact Pliocene basalt (Fig. 11). This rock is not prone to liquefaction, even under major earthquakes, and neither is it affected by compaction under changing groundwater level (Ambraseys, 2006). The latter is ~50 m below the citadel, as shown by the location of the public bath on the western hillside.

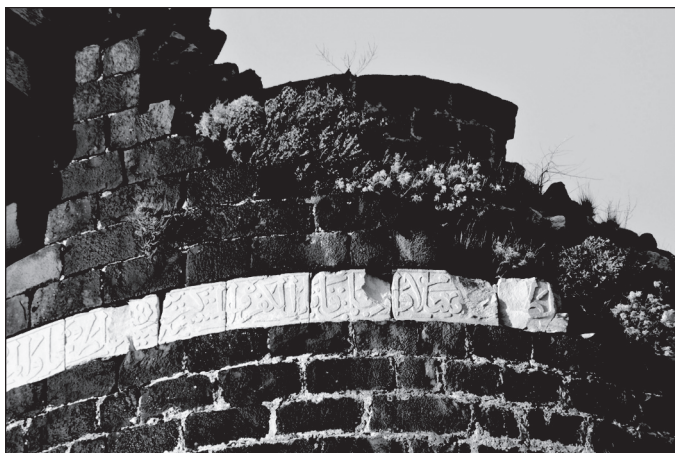
Figure 12. Portion of an Arabic inscription on the southern tower bearing the name of Sultan Qalawun, who conquered Al-Marqab in A.D. 1285. The full text says “This well-guarded fortress has been conquered and this tower rebuilt by Sultan Qalawun in months of the year [H.] 684. This work was executed under the direction of Balaban al-Mansuri,” as read and published by Max van Berchem in his *Voyage en Syrie*, on p. 303 in the early twentieth century (*vide* Deschamps, 1973, p. 273).

The first archaeological excavation in Al-Marqab started in 2007; therefore, a large proportion of the castle fabric is still undated. However, a relative chronology (architectural stratigraphy as understood by Galadini et al., 2006) can be readily established for the buildings studied in this project. Muslim-built portions of the circumferential wall, especially the southernmost tower in the outer enceinte, are decorated with a frieze-like white row of ashlar within the black basalt wall. These blocks bear an Arabic inscription, testifying to its construction by the sultan Al-Mansur Qalawun (Mamluk sultan from 1279 to 1290), who took the castle in 1285 (Fig. 12).

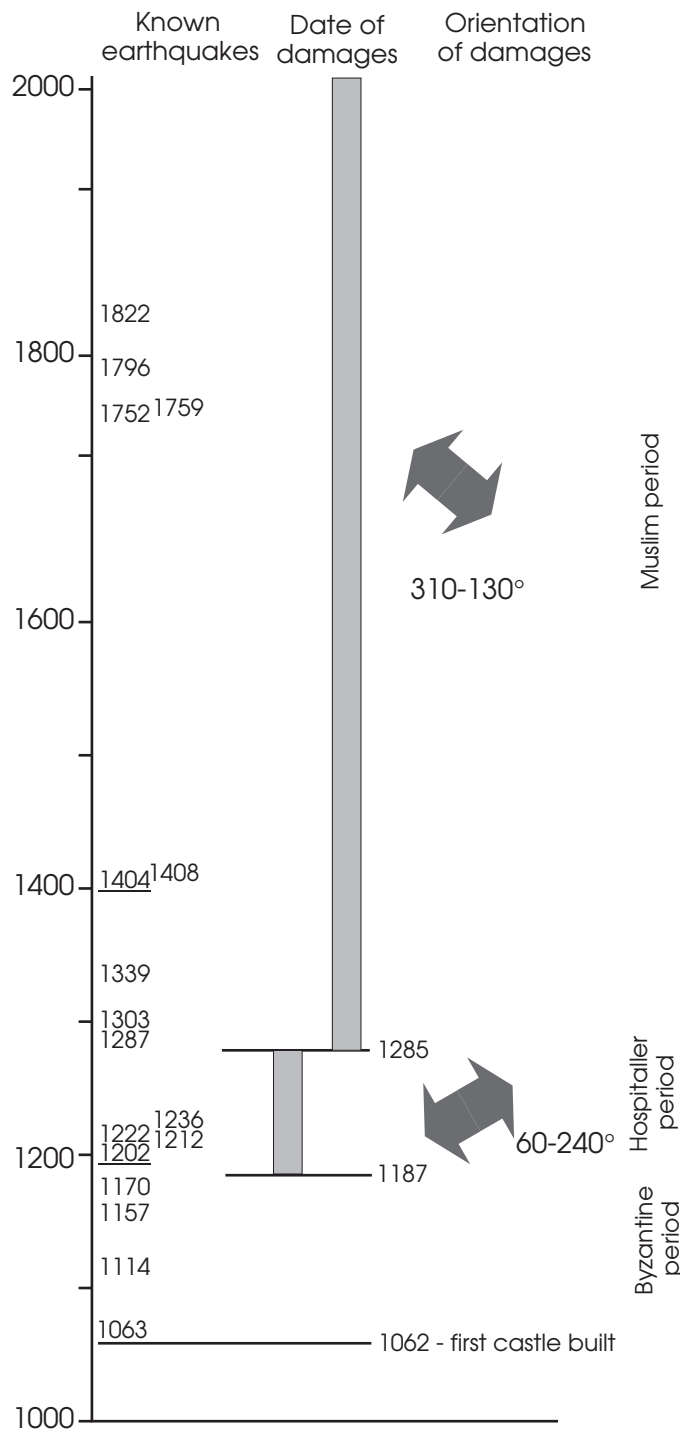
Figure 13. Dating of major earthquake damages in the history of Al-Marqab citadel. Known earthquakes are listed after Sbeinati et al. (2005); most damaging seismic events are underlined. Double arrows refer to vibration directions as calculated from orientation of failures. These display an earlier, 60°–240° direction as shown by V-shaped extrusion of the donjon and symmetrical extensional failure of room M3 (Figs. 7–8). This is probably due to the 20 May 1202 earthquake. The later, 310°–130°-directed vibration is seen on the southern tower, built during the Muslim period (Fig. 9). It occurred any time after 1285 and may be correlated to the 1404 (and/or 1408?) earthquake.

The supposed construction date of the donjon soon after 1187 and the precise dating of the southern corner tower after the successful Muslim siege of 1285 put constraints on dating the earthquake damages (Fig. 13).
