POLLACK PERIODICA An International Journal for Engineering and Information Sciences DOI: 10.1556/606.2016.11.1.3 Vol. 11, No. 1, pp. 25–34 (2016) www.akademiai.com

SIMULATION OF FLOOD PROGRESS ON THE RIVER GIDRA

Abstract: In Slovakia, the year 2011 can be characterized as dry with an irregular distribution of rainfall during the whole year. However, there were also some important hydrological events in form of flash floods. One of them a flash flood on the River Gidra, which passes the village of Píla situated below the Small Carpathians. A numerical simulation of this type of flood event was the main goal of the research in order to avoid the future devastating consequences of these kinds of floods. It was necessary to setup a mathematical model of the river using the HEC-RAS modeling tool to develop a correct evaluation of the flood course and to design appropriate flood protection measures, which will enable the interception of flood waves and to protect people and their property.

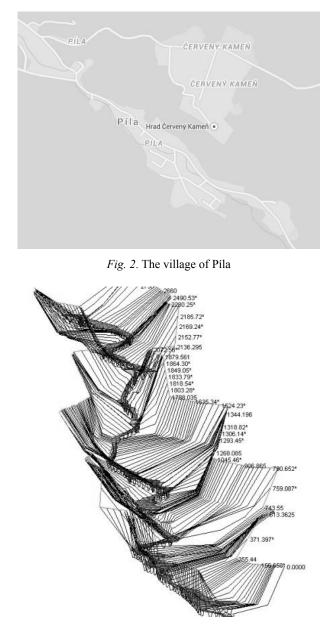
HEC-RAS software package, for most properly fitted to the actual situation. In *Fig.* 3 the output from the HEC-RAS program is shown.

Fig. 3. Longitudinal cross-sections along the River Gidra at the village of Píla

The first phase of the field-research was focused on collecting the morphological data of the River Gidra. This data is essential for setting up a 1D model by means of the

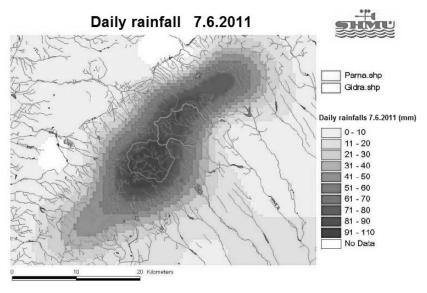
The spatial distribution of the daily rain on June 7, 2011 in the area of the Small Carpathians was performed by the Slovak Hydro-Meteorological Institute (*Fig. 4*) [4], [5].

Fig. 4. Daily rainfall on June 7, 2011 [4]

An insignificant pressure field existed above Europe from June 5-6, 2011. Thunderstorms came from the west, and the highest rainfalls occurred during the afternoon in the Small Carpathians region. On Monday (June 6, 2011) rainfalls was concentrated in the area of the Small Carpathians, north of the town of Modra. On the eastern slopes of the mountain and at its foothills, from 50 to 100 mm of precipitation fell and in the most exposed locations, more over than 120 mm was observed. During the night from Wednesday to Thursday (June 8-9, 2011) and during Thursday it rained on the southern mountains of the Small Carpathians (more than 50 mm). A precipitation value 60 mm is defined here as a value with the probability of occurring once every 40-50 years, and a precipitation amount of 100 mm or more can be classified as a value with the probability of occurring once in 50 years [1].

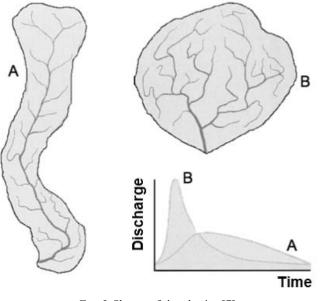
For river basins with a circular shape (*Fig. 5*), it is typical that water accumulates faster and in a short time period. That means the occurrence of a greater runoff than in the case of the longitudinal shape of a basin where the water flows to the main stream gradually, little by little [3]. As it is shown in *Fig. 5*, the River Gidra basin has a circular shape, so this factor was identified as one of the main factors for the formation of the flash flood in the village of Píla (2011). The combination of the extreme weather situation (rain, snow, snow melting, etc.) with the circular shape of a basin leads to the high probability of the occurrence of flash floods.

Fig. 5. Shapes of river basins [7]

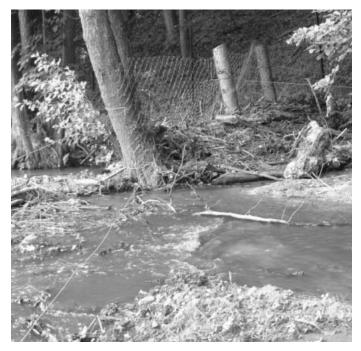
Fig. 6. Damaged fences

Acknowledging the diversity and variety of local conditions in a river basin and its physical and geographical characteristics is necessary for understanding flash floods as a hydrological response of especially small basins in an extreme meteorological situation [3]. It is also assumed that breaking of barriers affected the extent of the flash flood in the village of Pila. They have been naturally created through accumulation of river sediments on the fences (*Fig. 6*), which border the forest and swamp communities in the basin of the River Gidra (*Fig. 7*) during the extreme precipitation period.

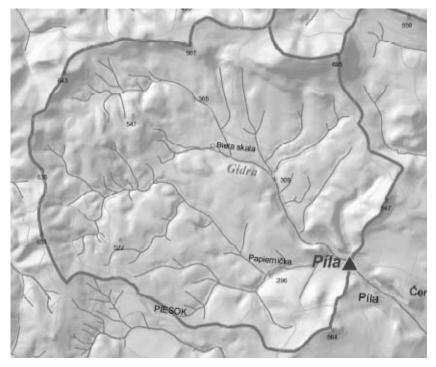
Fig. 7. Basin of the River Gidra [4]

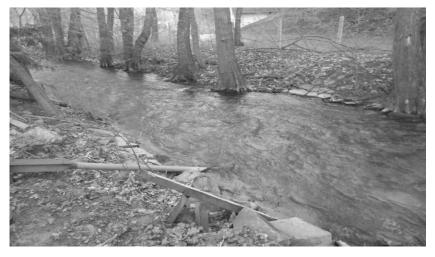
After the evaluation of all the available morphology data about the River Gidra and surrounding terrain the second part of the field-research evaluation, which was focused on the hydrological data was proceeded. One gauging station is situated directly above the village of Píla (*Fig. 8*). So, after measuring the cross sections along the River Gidra, the field-research was focused on water level measurements in several cross-sections, as well.

Fig. 8. The River Gidra at the gauging station site

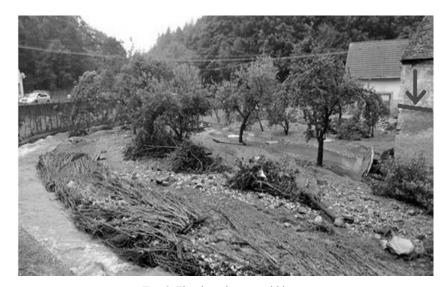
Flood marks can be seen on the houses and on the other private properties after the flood event. All of those flood marks were measured by the GNSS device. These data served in the simulation process for the calibration and verification purposes of the numerical model established during the flood. An example of a flood mark is shown in *Fig. 9*.

Fig. 9. Flood mark on an old house

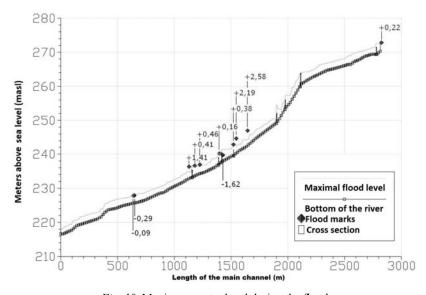
The HEC-RAS simulation package was used for the flood reconstruction [9]. The result of the unsteady river flow simulation was achieved after filling the model with all the necessary data (cross section profiles, roughness, possible barriers in the river, like fences and bridges, discharge, etc.). The results are shown in *Fig. 10*. The maximum flood level was verified by the flood marks (see legend).

The differences between the measured and calculated values could have been caused by various factors. Firstly, it is important to remember that for the unsteady open channel flow during the flood event, a 1D model was chosen. For this type of model it was quite complicated to specify the Manning roughness coefficient properly. The next problem was not taking into consideration the lateral inflow from the surrounding valley hill slopes. Finally, some mistakes could have appeared during the field-research, as well. In spite of those mistakes, the differences between the measured and the calculated values (*Fig. 10*) are sufficient and the model worked properly.

Only on two flood marks were differences between the measured and the calculated values greater than 2 meters. This could be due to the fact that these flood marks were actually located in the river bend and that the program did not calculate this situation properly.

Fig. 10. Maximum water level during the flood
