The influence of geologic structure on design and construction in a moderately deformed paleozoic sequence in Eastern Australia

This paper presents a case study to illustrate the role played by geologic structures in the design and construction of major transportation infrastructure, in a setting of moderately deformed Paleozoic sedimentary rocks in eastern Australia. It describes a complex development of folding, faulting and jointing that has resulted in significant inclination of beds, juxtaposition of strata and affected the weathering characteristics of a wide range of rock types. The sequence, which displays an upward transition from marine to terrestrial sediments, comprises an interbedded succession of conglomerate, sandstone, shale and erratic volcanics and crystal tuff. Unfavorable relationships between major excavation faces, inclined beds and jointing have resulted in problems with the stability of road cuttings. Also, the presence of faults and dykes at various scales has had a significant effect on weathering and rock strength. The paper demonstrates the importance of the choice of alignment at design stage, and how a basis of good structural interpretation and geolo

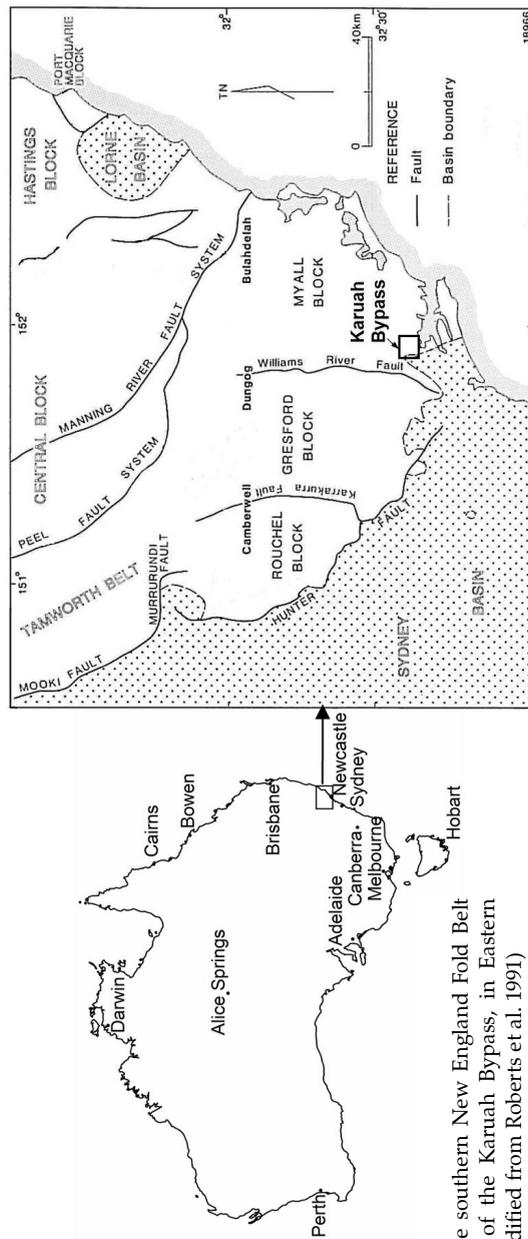
Fig. 1
 Locality of the southern New England Fold Belt
 and the site of the Karuah Bypass, in Eastern
 Australia (Modified from Roberts et al. 1991)

The area considered in this study lies within the broad geologic region of central-eastern Australia, which is generally referred to as the New England Fold Belt (NEFB) (Fig. 1). It is a sequence of sedimentary and volcanic units ranging in age from Late Devonian to Late Carboniferous (Carey and Browne 1938). It is more correctly described as the New England Orogen (Voisey 1959), although the more traditional term of Fold Belt will be retained here, because of its wider familiarity. Murray (1997) contends that the New England Orogen is the "easternmost element in the Tasman Orogenic Zone of eastern Australia, extending 1,500 km from Newcastle in the south to Bowen in the North".

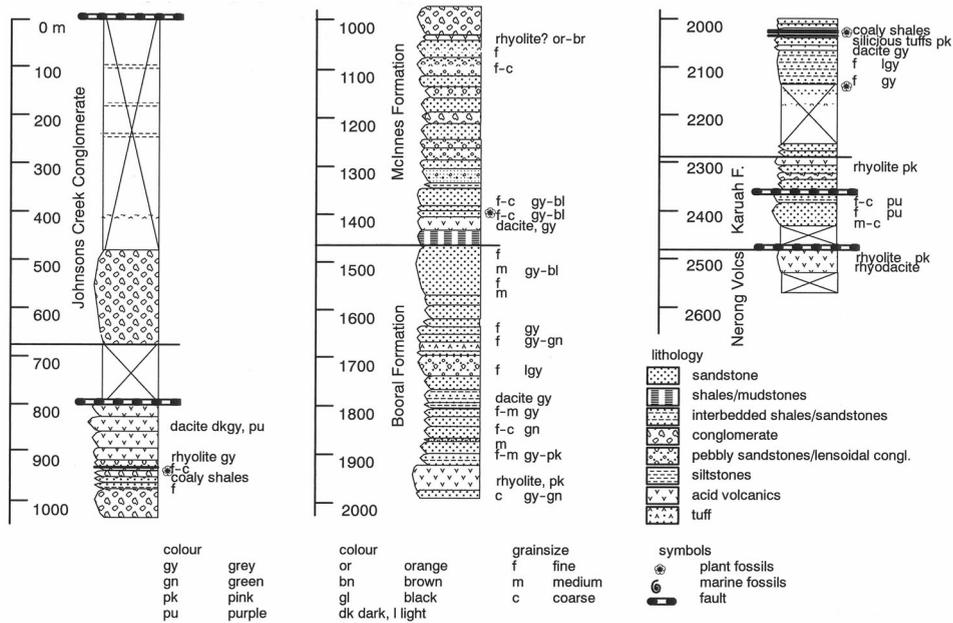
Fig. 2
Interpreted stratigraphic section and unit names for the Karuah Bypass Section (modified from Fityus et al. 2005)

In a structural interpretation compiled by Scheiber (1998) and in a later compilation by the Geological Survey of New South Wales (GSNSW 2003), the area considered in this study is consigned to the western Myall Block, without further differentiation. This consignment was confirmed by Fityus et al. (2005), who mapped and interpreted the succession of the Karuah Bypass. The interpreted stratigraphic section of the Bypass is shown in Fig. 2.

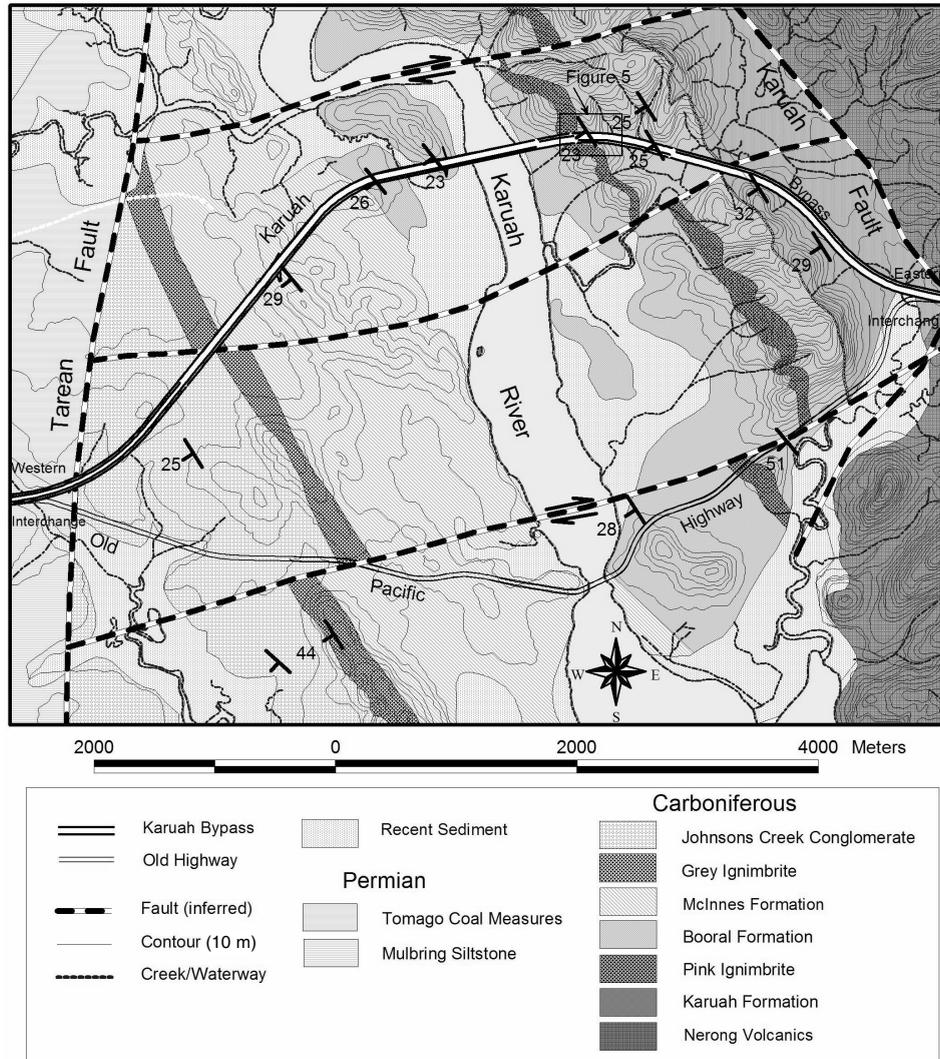
Fig. 3 Arrangement of geologic units and major structural features of the Karuah Bypass

The general arrangement of the Karuah Bypass geology is shown in Fig. 3. Important aspects of the geologic structure of the area are the orientation of bedding and the widespread presence of jointing and faulting. A detailed structural analysis has not been undertaken, although sufficient observations are available to support a brief discussion. Figure 4 presents some limited bedding, jointing and faulting data from the area.

The faults described above bound a block (see Fig. 3) in which the Bypass is mostly situated. This block is dissected by a number of significant, sub-parallel,

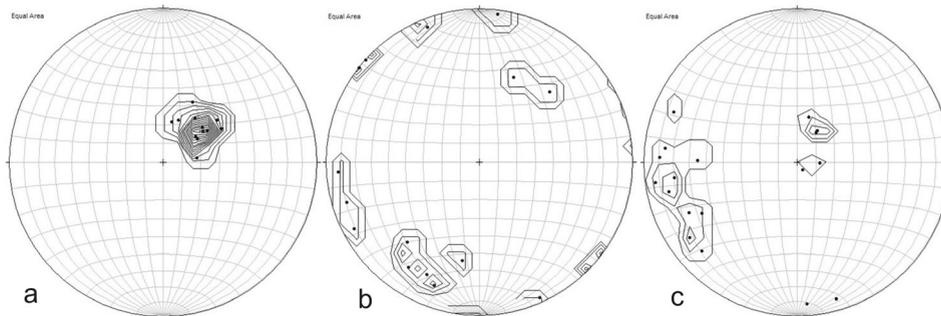
Fig. 4
Plots of structural data from the Karuah Bypass; a: poles to bedding planes; b: poles to joints; c: poles to fault planes

The contoured equal area stereographic plot of poles in Fig. 4 gives a regional dip of the strata, striking 136° , dipping 25° southwest. The plot is slightly scattered, suggesting that small variations occur between regions within the study area.

Small displacement (<1 m), low-angle, thrust faulting was noted in several areas, and extensively developed within Cut 6. These fault planes (Fig. 4) usually follow bedding planes, and are difficult to detect. Within the softer rocks of the McInnes Formation it is seen as fault-propagated micro-folding as the fault steps from one bed to the next, and it is highlighted by coal seams contained within the formation. Within the more indurated rocks of the Booral Formation, shearing along bedding planes is apparent through iron-stained, crushed zones up to 50 mm thick that frequently serve as sources of seepage. The most notable indication is displacement of the basalt dykes eastward by up to a meter (Fig. 5).

Smaller, sub-vertical faults occur in several cuts (Fig. 4). One set, examined in detail in Cut 6, formed a small graben several meters wide, with a vertical displacement of approximately 1 m. It is evident from Fig. 4 that most of these smaller faults strike between north-south and northwest-southeast, similarly to joints shown in Fig. 4. The plunge of striations, observed on the surfaces of these faults, varies between 10 and 20 degrees, indicating a major strike-slip component in their movement.

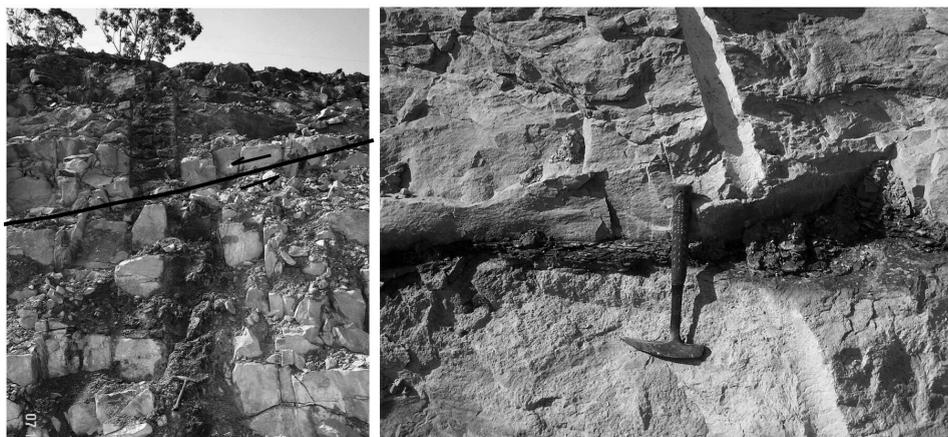
Fig. 5
Low-angle faulting, producing an offset in a basalt dyke (left picture), showing porous, iron-stained discontinuity in otherwise fresh rock (right picture)

The low-angle faulting, which is mostly parallel, or sub-parallel to bedding, is an important factor that exacerbates the loosening and sliding of potentially unstable blocks (see Fig. 5). This conclusion differs from that of Fityus et al. (2005), being modified to accommodate new experiences with such faulting gained in similarly deformed rocks in other areas. It is difficult to evaluate how extensive this low-angle faulting is, as its displacement is small and usually confined to the bedding planes. However, from the widespread bedding-plane seepage in some exposures of apparently fresh rock (Fig. 11), it would seem that rockmass disruption at bedding plane surfaces is a pervasive feature of this geologic environment.

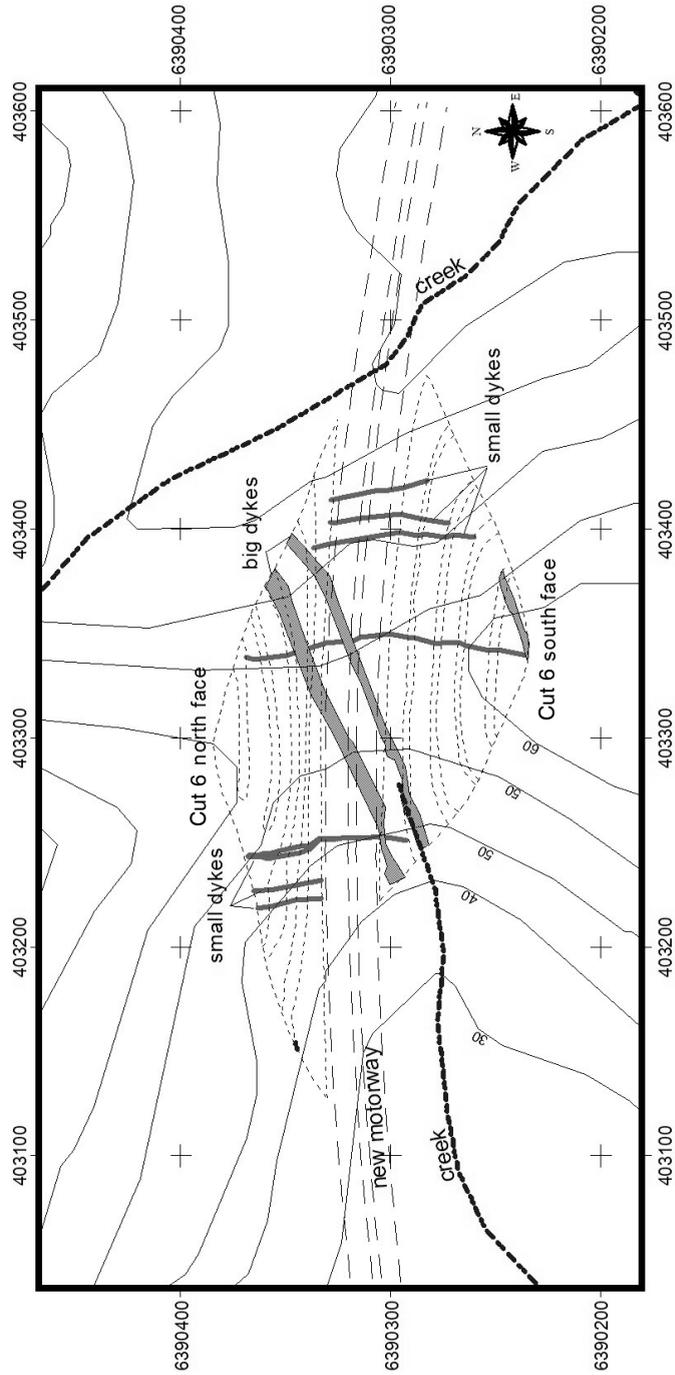
Fig. 6
The arrangement of dykes in Cut 6

Thirteen sub-vertical, mafic dykes were encountered within road cuts to the east of the Karuah River. Ten dykes are in the large Cut 6 (immediately east of the river) whilst the remaining three are exposed in cuts further to the east. The dykes have two primary orientations: eight trend north/south (175° – 355°), dipping slightly to the east (87° – 90°), the remaining five trend northeast (065° – 245°) and are close to vertical. The orientation is similar to that of joints, shown in Fig 4. Within Cut 6, the northeast-trending "large" dykes are much thicker (3–6 m) than the north-south trending "small" dykes (0.3–1 m), and are more altered. The arrangement of dykes in Cut 6 is shown in Fig. 6. The north-south dykes are composed of basalt of a common appearance. One of the thicker, northeasterly dykes is composed of fractured basalt, veined with secondary minerals. Another of the thick northeasterly dykes is composed of dolerite, and contains plagioclase and pyrite, with "clotted" plagioclase making up about 40% of the rock.

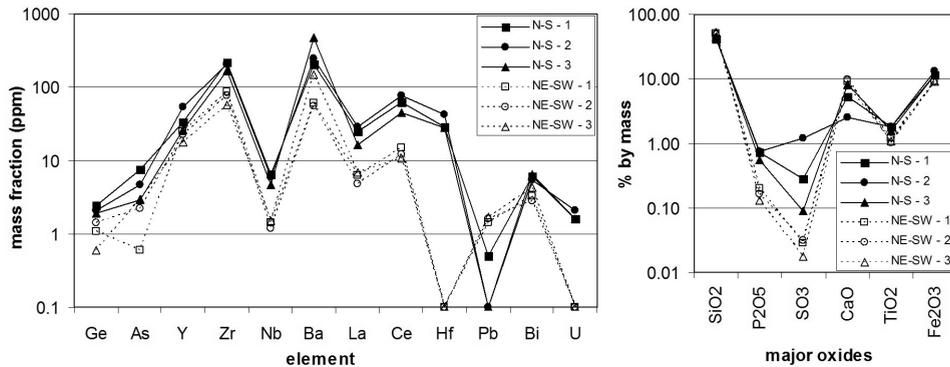
Fig. 7 Selected chemical analysis data for three basalt samples from the north-south dykes (N-S) and three samples from the north-east dykes (NE-SW)

Selected chemical analysis results of six of the dykes within Cut 6 are shown in Fig. 7 and they suggest that the north-south and northeast groups have slightly different chemical compositions. Offler (2004, pers. com.) suggests that the north-south dykes display calc-alkaline signatures, while the northeastern dykes show island-arc, tholeiitic signatures.

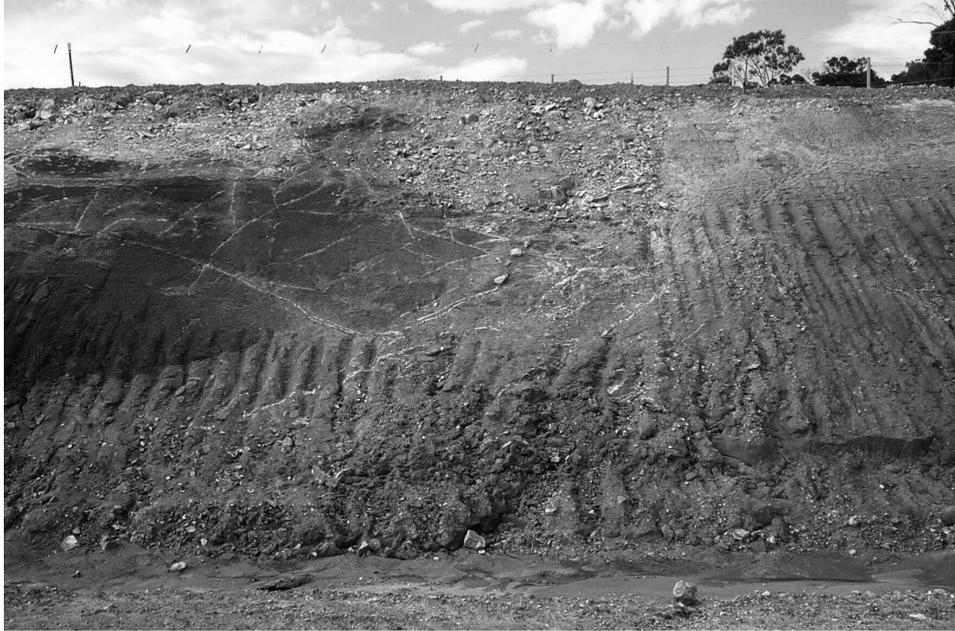
Fig. 8
Photographic compilation of fault-affected rocks and soils at the eastern end of the Karuah Bypass, showing the Karuah Fault

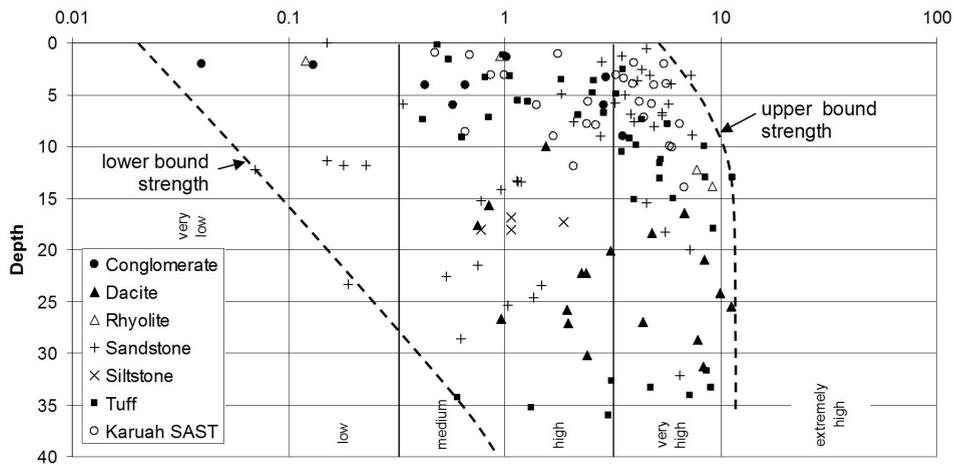
Fig. 9
Rock strength as a function of type and depth for the Karuah Bypass

Figure 9 presents data on rock strength as a function of rock type and depth. Although there is a weak trend for average rock strengths to increase with increasing depth, rock strengths are still widely scattered at more than 25 m, and this includes results for naturally stronger materials such as dacite and crystal tuff. This variability is a consequence of the variable effects of weathering that result from faulting and other factors. Nevertheless it is important to note that the range of strength is probably greater than shown in Fig. 9, since more competent

Figure 9 indicates that several of the different rock types exhibit great strength at relatively shallow depth. In general the clastic sedimentary rocks exhibit varying strength, and these include the weakest rocks encountered, with sandstone in some cases possessing only low to medium strength at depths as great as 20–25 m. Tuffaceous rocks generally possess medium to very high strength, being mostly of high to very high strength at depths greater than about 10 m. Felsic volcanics mostly possess high to very high strengths; however, despite extensive, well-developed surface expression in adjacent areas, almost no volcanics were encountered within 5 m of the surface during the initial site investigation. The relatively tuffaceous, characteristically purple, Karuah sandstone possesses high to very high strength at shallow levels (as shallow as 2–3 m), consistent with its strong outcropping tendencies at the eastern end of the section.

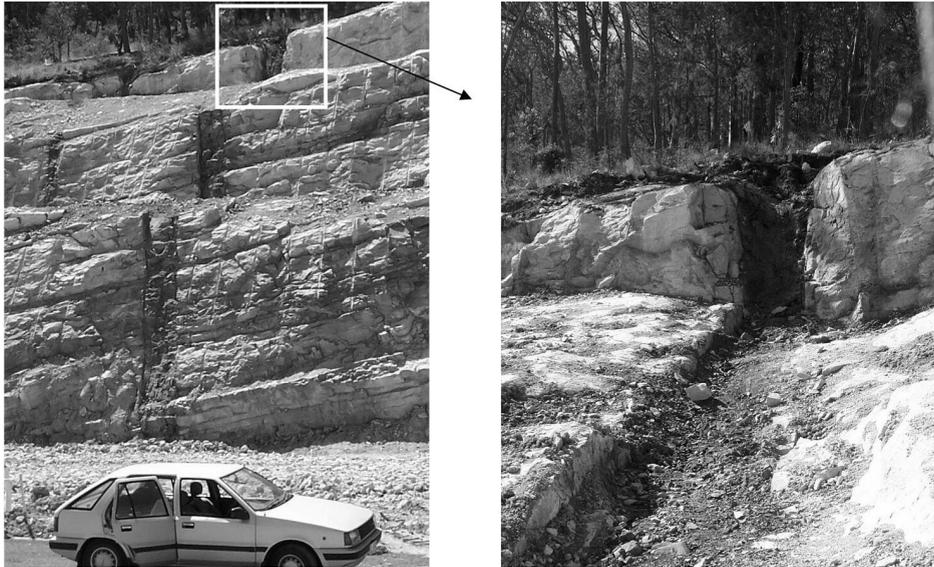
Fig. 10 Expressions of weathered mafic dykes in excavation (on the left a north-south dyke in road cut 6, on the right a close up view shows the preferential weathering in the upper part of the dyke zone)

One factor affecting weathering, not yet discussed, is the occurrence of the mafic dykes. These exhibit a tendency to weather preferentially and deeply under the prevailing conditions, so that they produce pockets of deep soil in otherwise competent rocks. Figure 10 shows three narrow dykes in Cut 6. Note how, adjacent to the one to the right, the rock mass has become preferentially fractured and weathered for a considerable depth below the surface. Figure 10 also displays how the dyke material weathers preferentially, relative to the sandstone into which it was emplaced.

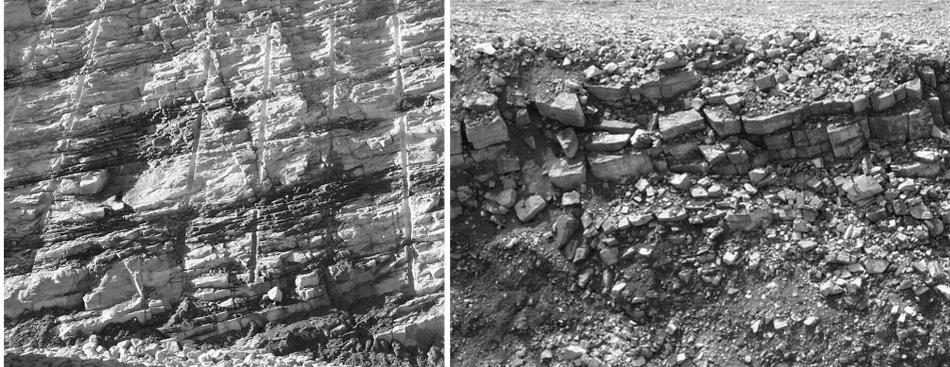
Fig. 11
Bedding plane features. Left picture shows seepage (darker areas) from bedding plane surfaces in fresh rock. Right picture shows the unfavorable relationship between bedding planes and excavation surfaces, leading to looseness and instability

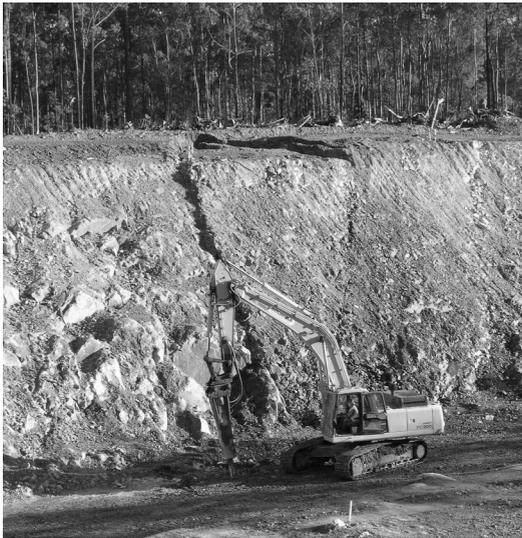
Fig. 12
A V-slide wedge failure in thinly-bedded siltstone and fine sandstone

In one location, in a sequence of thinly-bedded siltstone and fine sandstone, the intersection of a dipping bed 202°/25° and another planar feature 097°/62°

produced a triangular wedge, extending over the full height of an 8 m-high cutting. This wedge failed spectacularly in a V-slide as is shown in Fig. 12, after a small quantity of soil was stockpiled on top of the cutting.

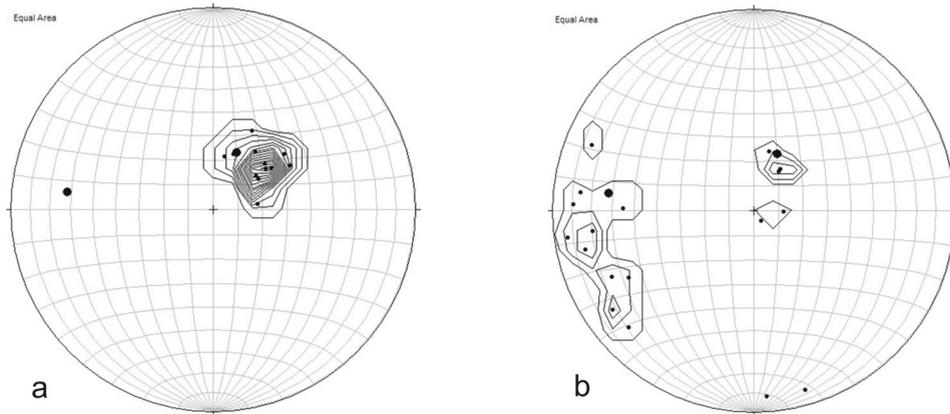
Fig. 13 Relationship of V-slide failure planes to bedding and faulting; a: stereographic plot shows poles of planes in V-slide (large points) superimposed onto bedding plane poles; b: stereographic plot shows poles of planes in V-slide (large points) superimposed on poles to small faults

If the poles to the failure planes of the V-slide are plotted together with the poles to small faults and bedding (Fig. 13), it is clear that the block failure was controlled by faulting and bedding. Note, however, that the plane close to bedding (Fig. 13) also plots with the low-angle faults in Fig. 13, suggesting that the role of bedding may be somewhat indirect, and that small-scale faulting of two types may have been the dominant influence.
