Porosity and compatibility of repair mortars and Hungarian porous limestones

Balázs Szemerey-Kiss, Ákos Török
*Department of Construction Materials and Engineering Geology,
Budapest University of Technology and Economics, Budapest*

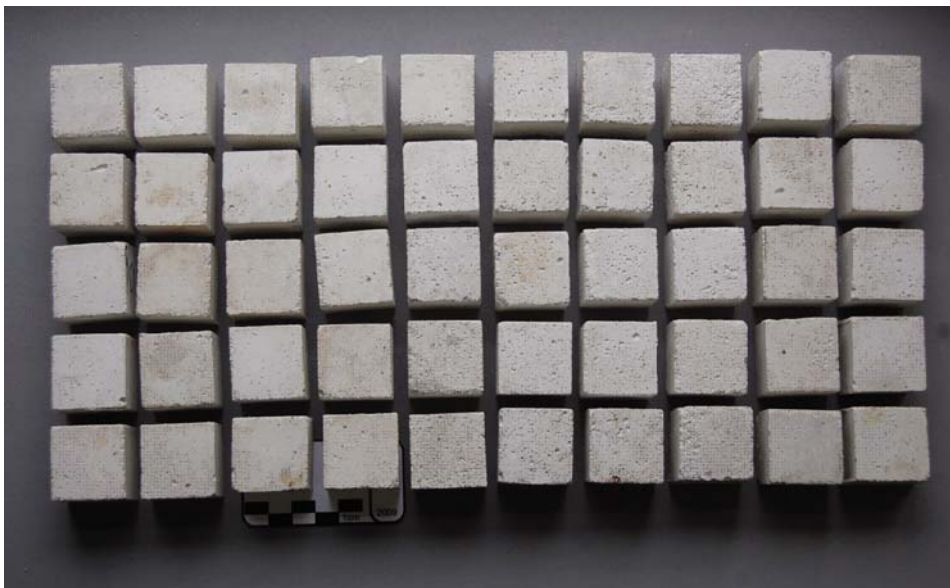
Fig. 1
Repair mortar specimens after being removed from the molds

Repair mortars (Fig. 1) were compared to the typical Hungarian porous limestone from Sósút Quarry (Fig. 2), the most common natural stone used in monuments. This porous, oolitic limestone has a low density, a high total porosity and is easy to work with. The grain size of the stone is variable, from very fine-grained through middle to coarse-grained. In the experiments four types of commercially available repair mortars that are widely employed for loss compensation of porous oolitic limestones were used. An additional type that was prepared in our laboratory was also tested. Twelve different sample sets (Table 1), three mixtures per series were prepared: i) pure repair mortar, ii) 70 wt.% repair mortar + 30 wt.% limestone sand as aggregate and iii) 50 wt.% repair mortar + 50 wt.% of limestone sand aggregate. The repair mortars were deposited under laboratory conditions for 90 days after casting. During the preparation of samples and during the experiments, extreme conditions (warm/cold environment) were avoided. The limestone sand (max. 2 mm in diameter), which is a ground oolitic limestone, was obtained from Sósút Quarry.

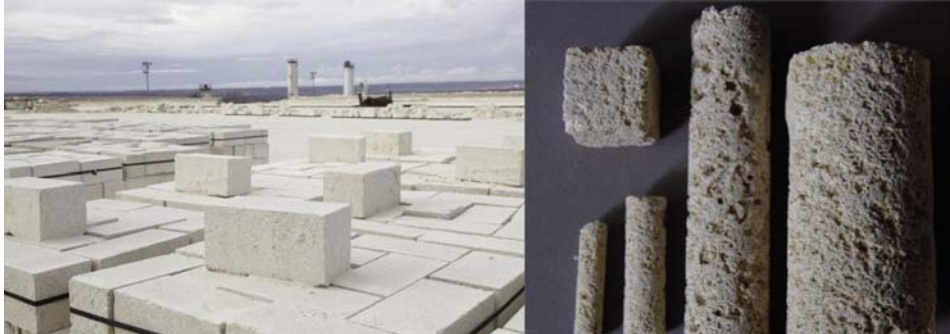
Fig. 2
Sóskút Quarry and Hungarian porous limestone specimens

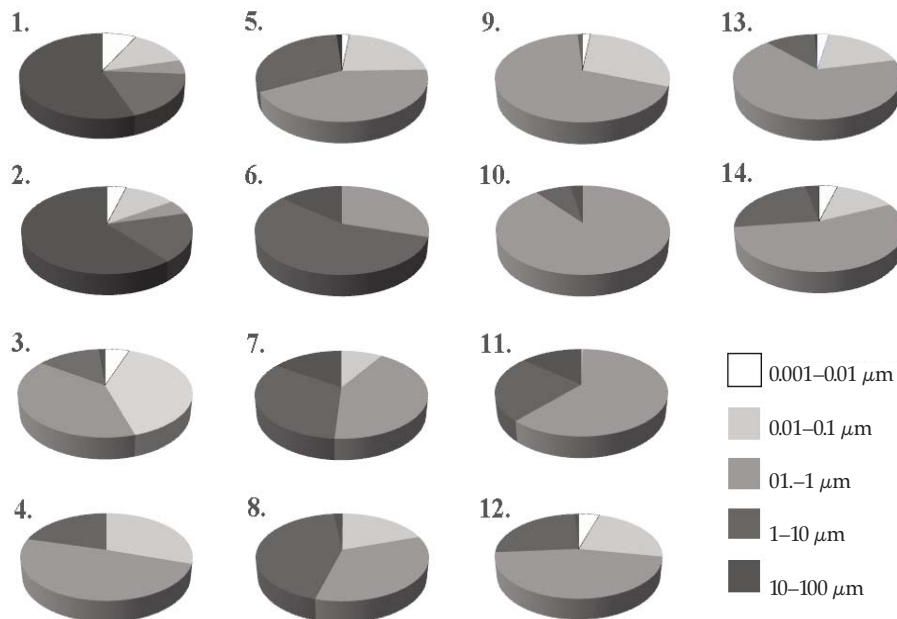
Fig. 3
Visual comparison of the pore size distribution of 14 samples

The limestones exhibit pore radii ranging from 0.001–100 μm and the largest parts of the pores fall into macro-pore categories (10–100 μm). Comparing the results of repair mortar with the limestones it is clear that for repair mortars the micro- and meso-pores dominate over macro-pores. Figure 3 shows the result of the pore size distribution. There is a linear correlation between the porosity and density for all samples (Table 2). A greater amount of aggregates increases the percentage of medium and large pore radii (0.1–100 μm) in mortars. Nevertheless, fine and coarse limestone show higher pore radii (<10–100 μm). From the pore size distributions the average pore size was calculated and is given in Table 2. The visual comparison of the samples can be found in Figs 3 and 4.

An increased meso-pore range was measured for all of the repair mortars. The absence of macro-pores is also a typical feature. Repair mortars have their maxima of pore radii larger than 1 μm but smaller than 10 μm , while limestones have their maxima at pore ranges larger than 10 μm . This result shows that most of the pores are larger than 10 μm in the limestone samples (sample 2) while with the repair mortars this pore range is almost undetected (Figs 3 and 4). The majority of the pores of the repair mortars have radii between 1 and 10 μm . Adding any type of aggregate mixture to repair mortar cause a shift toward larger pores.

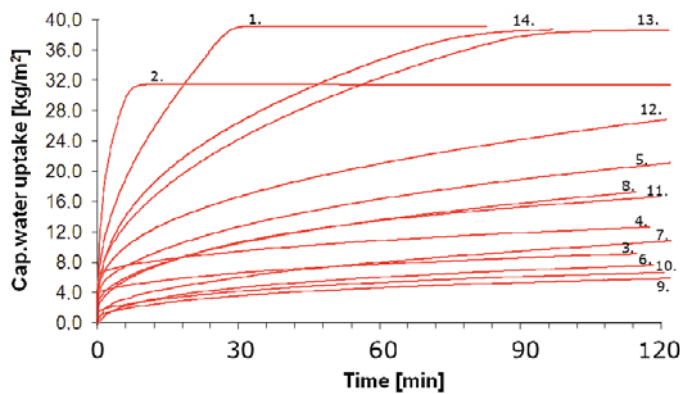
Fig. 5 Comparative water uptake curves all of the samples

The comparison of capillary water uptake curves in Fig. 5 clearly demonstrates that the pore volume distribution of sample 2 differs from samples 6, 7, 8, and 12. The A-coefficient of natural stones of 52.26 and 68.55 kg/m² h^{1/2} is unusual and more than 3-4 times larger than any of the pure or modified mortar. The highly active capillary system and extraordinary water uptake of limestone is attributed to a well-connected pore system.

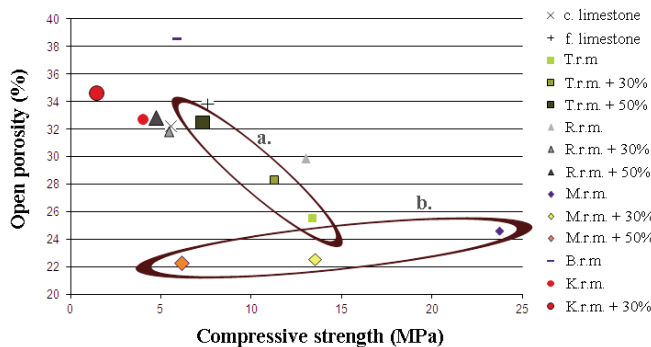
Fig. 6 Open porosity of the samples compared to the compressive strength (after 90 days). (Sample explanation is given in Table 1)

The increasing aggregate content of the studied repair mortar causes a more significant decrease in measured compressive strength values (Szemerey and Török 2011). The studied compressive strength values are shown in Fig. 6 in comparison to the open porosity. According to the results, R.r.m.+30%, K.r.m. and T.r.m.+50% are close to the natural porous limestone porosity and strength as well. In the case of M.r.m. the added aggregate significantly decreased the strength of the repair mortar. Thirty percent aggregate also decreased the strength of the K.r.m. mortar and 50% aggregate probably also cause a serious

decrease. The compressive strength of B.r.m. is almost the same as the case of coarse limestone, but the very high porosity leads to rapid weathering of the mortar (Szemerey and Török 2011). Adding further amount of aggregates to this mortar increases the porosity, except with the M.r.m. set of samples (group "b" in Fig. 6). However, when 30% and 50% of aggregate were added, a decrease in compressive strength was observed in every set of sample.
