# History of Environmental Change in the Sistan Basin

Based on Satellite Image Analysis:  
1976 – 2005

UNEP Post-Conflict Branch  
Geneva, May 2006

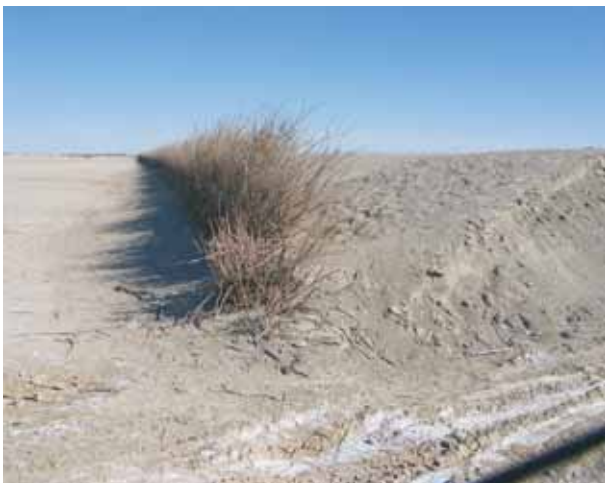
Windbreaker in Baringak. The dune behind the windbreaker was formed within a few years by wind-blown sand

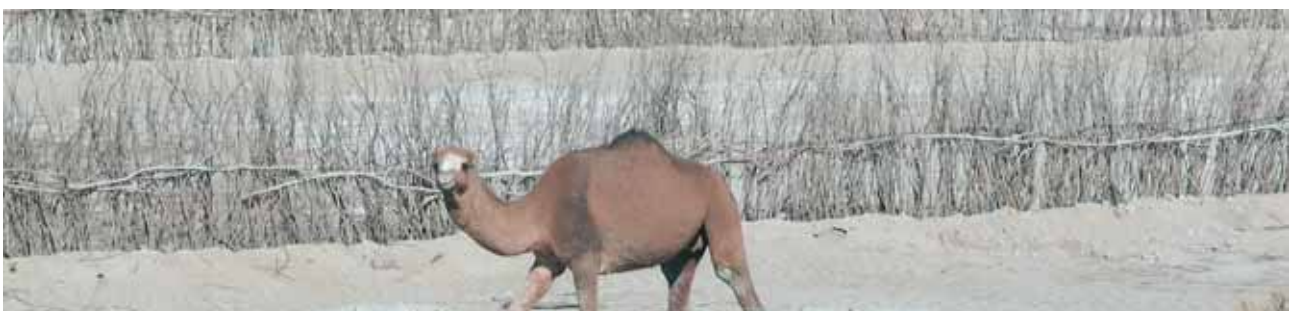
Hundreds of kilometres of windbreakers have been constructed in the lakebeds to trap wind-blown sand

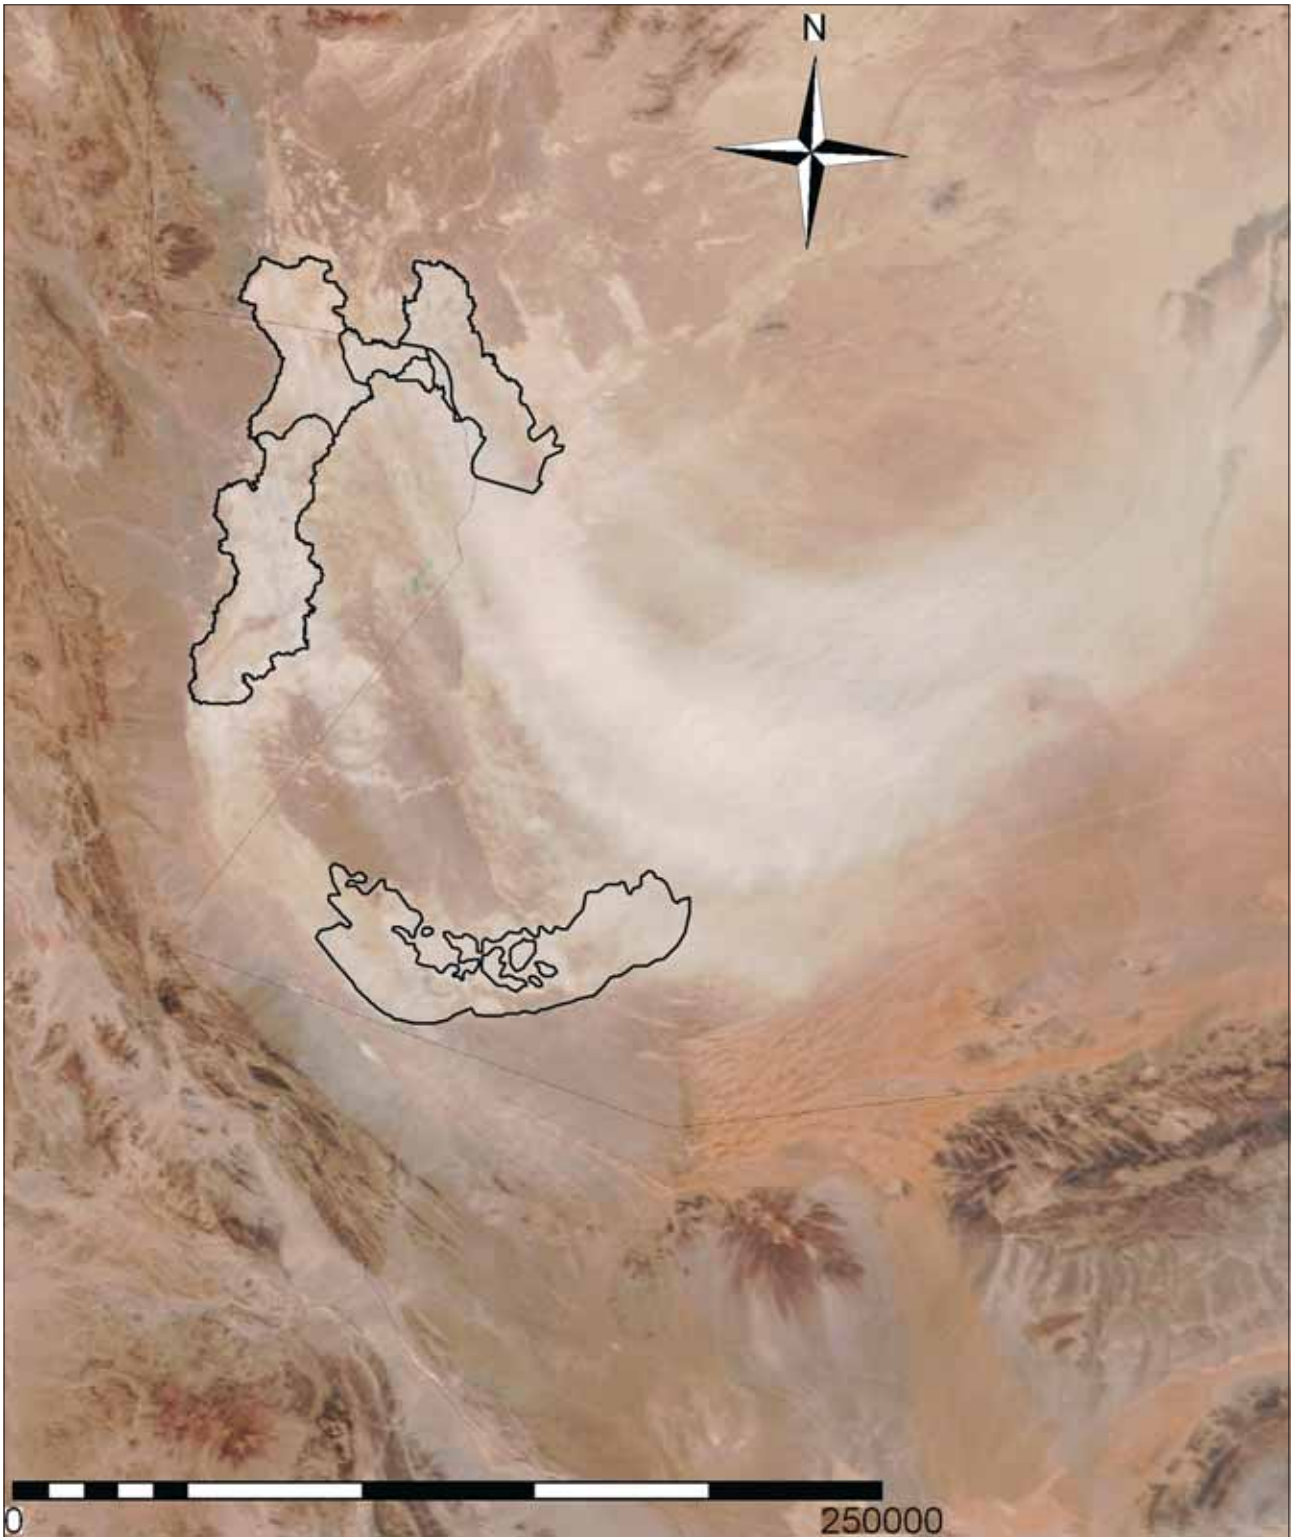
**Figure 2** Wind-blown sand originating from the lakebed of the Hamoons

Captured in MODIS (Terra) image on 1 September 2004. Several satellite images show that sand plumes can cross the Persian Gulf and reach the Arabian Peninsula

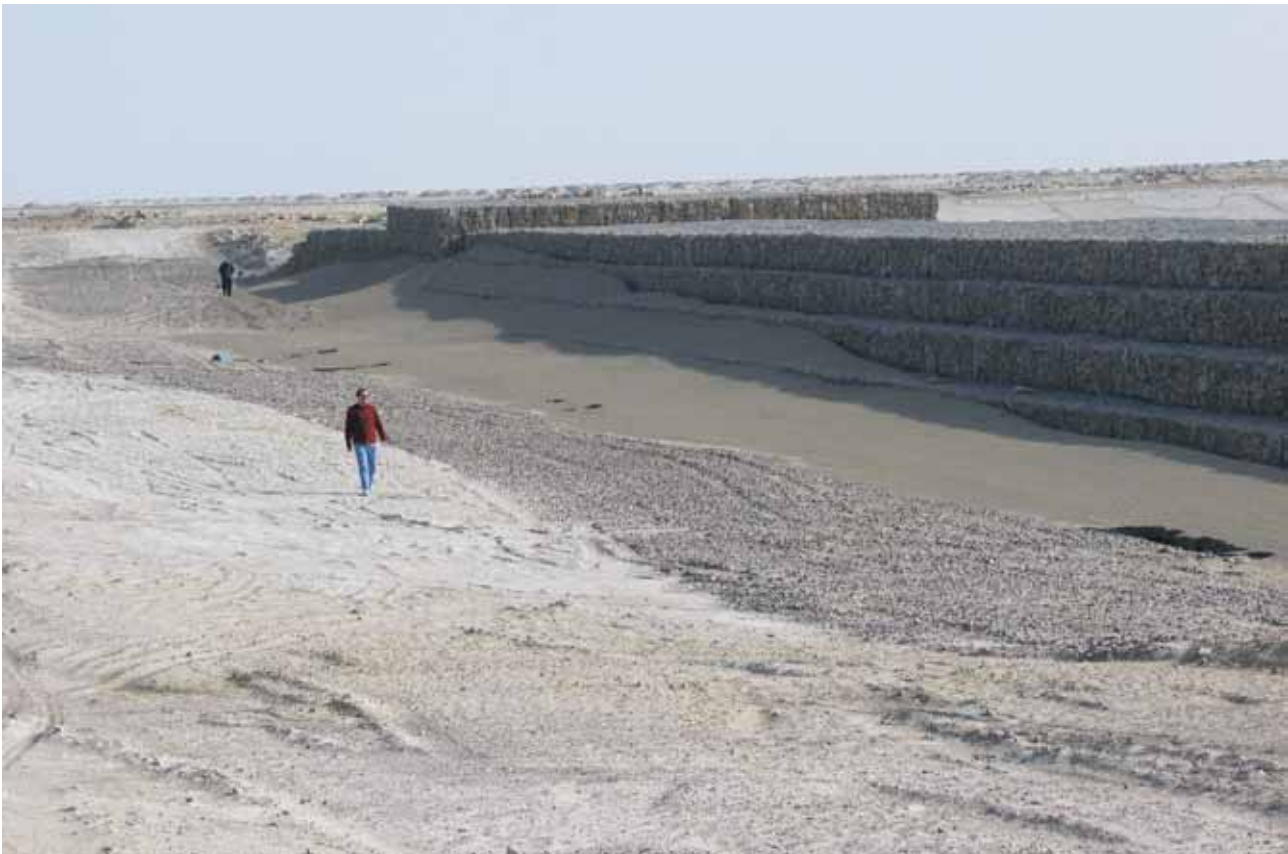
Control structure at the outflow of Hamoon Hirmand

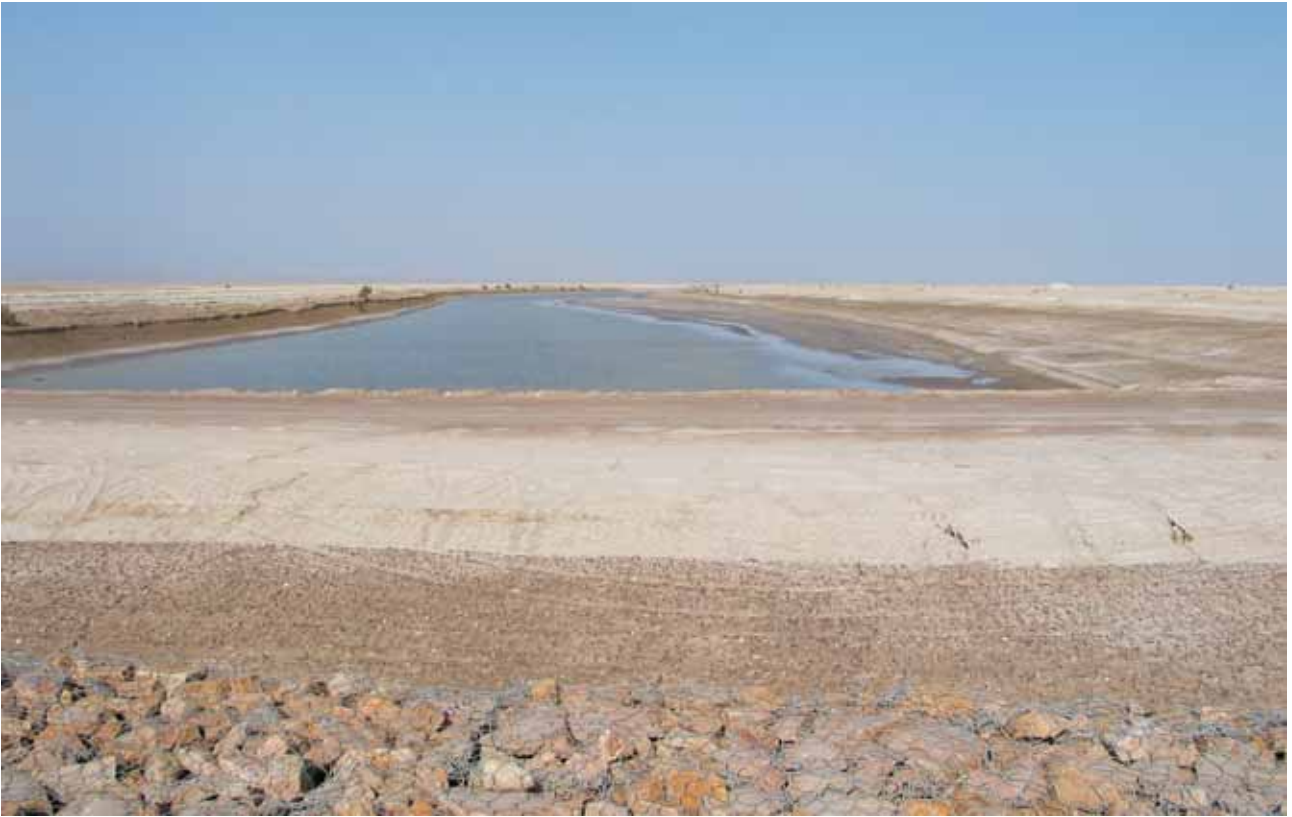
View from the control structure of the overspill canal of Hamoon Hirmand

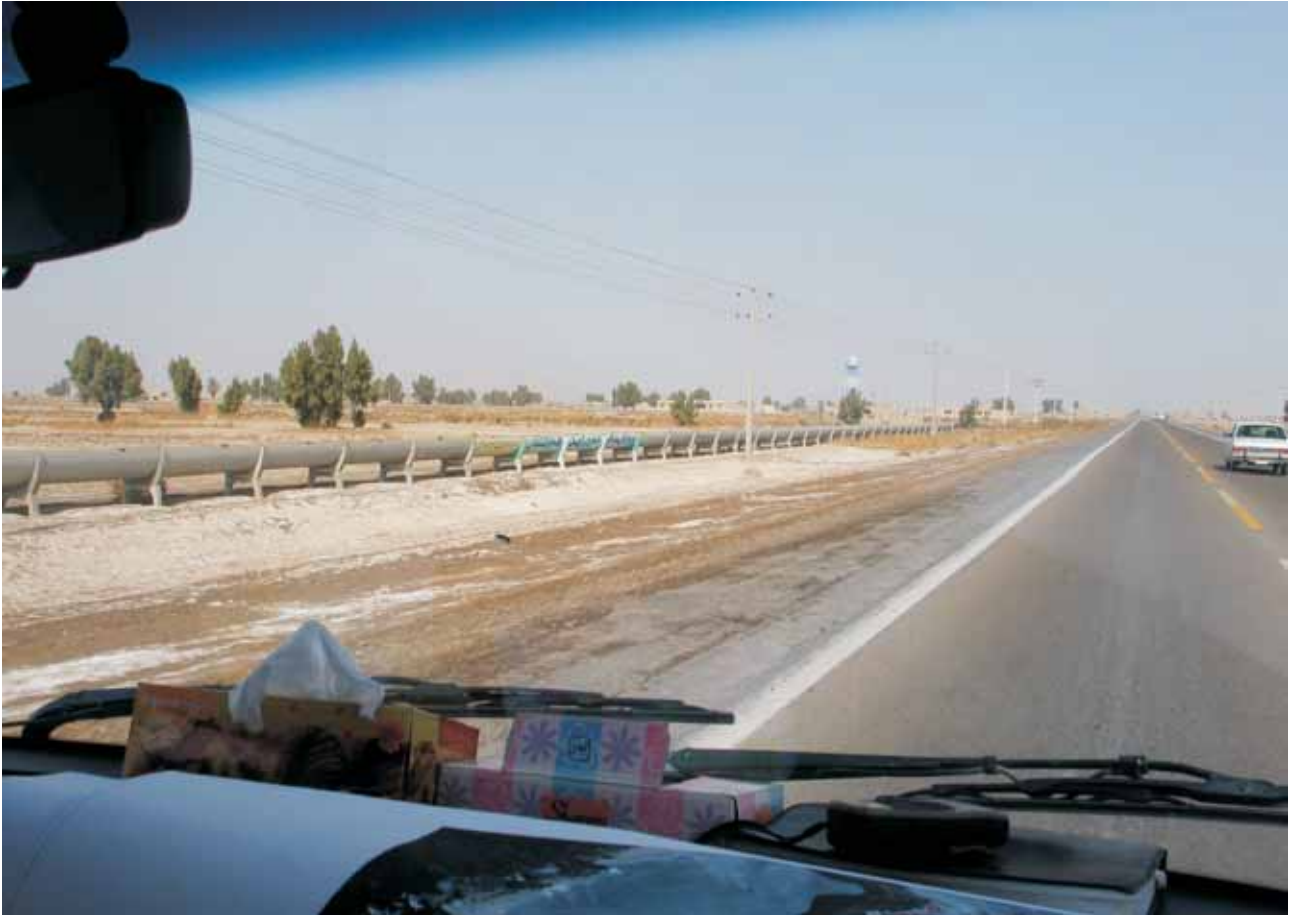
Modern irrigation canal

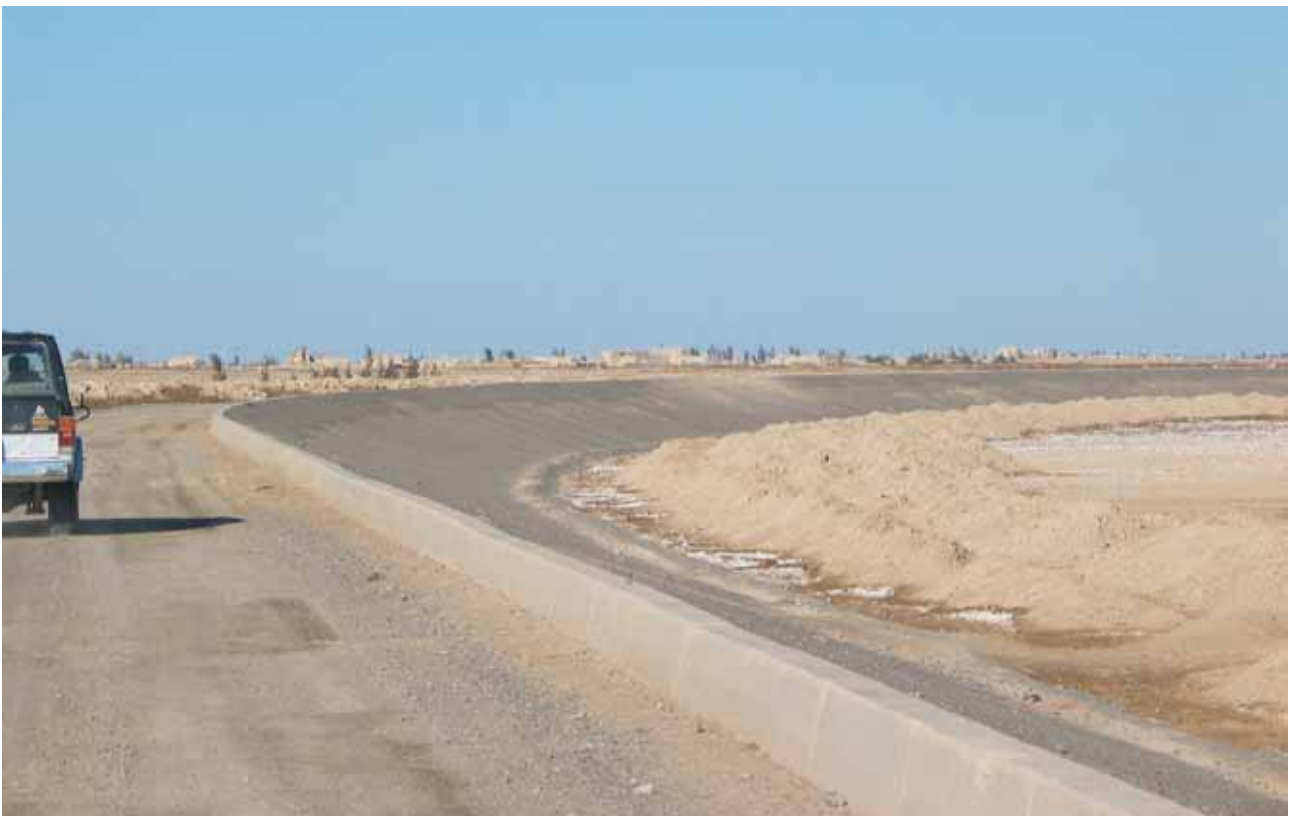
Dike on the western shore of Hamoon-e-Puzak
