Acta Archaeologica  
Academiae Scientiarum  
Hungaricae

# The Roman and late antique site of Montessoro (Isola del Cantone – Genova): A case study of the wattle and daub construction technique

Paolo de Vingo\*, Andrea Bruna and Giovanni Battista Parodi

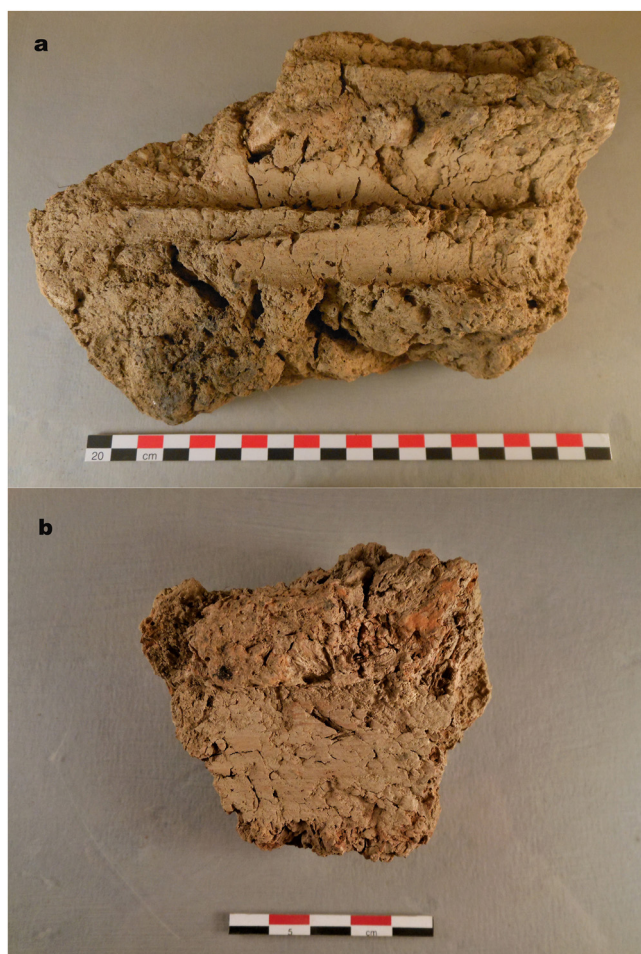
**Fig. 5.** a: Fragment of *concotto* clay (from US 503) with signs of interwoven horizontal branches (photo A. Bruna); b: fragment of *concotto* clay (from US 503) with negative impression of a horizontal slat (photo A. Bruna)

In total, 126 traces of branches were identified, always on the opposite surface with respect to the flat surface (when present) (Fig. 5a). The diameter varies from 12 to 30 mm, with the most common measurement being 22 mm. They were found between 18 and 70 mm away from the flat surface of the wall, with the most common measurement being 40 mm and the distance between the branches varying from 0 to 40 mm.

21 traces of horizontal slats have been recognised. The few slats that could be measured were about 22 mm wide with only one trace measuring 35 mm. A trace left impressed on the *concotto* clay displays a frequently obtuse angle which is rarely acute and never straight; the preserved thickness never exceeds 10 mm (Fig. 5b).
