András Kretz¹, Júlia Hornyacsek²

ADVANCED BUILDING ENGINEERING SOLUTIONS OF THE FACILITIES OF PROTECTION/DEFENSE ORGANIZATIONS IN THE LIGHT OF SUSTAINABILITY

1. WATER AND SEWER NETWORK

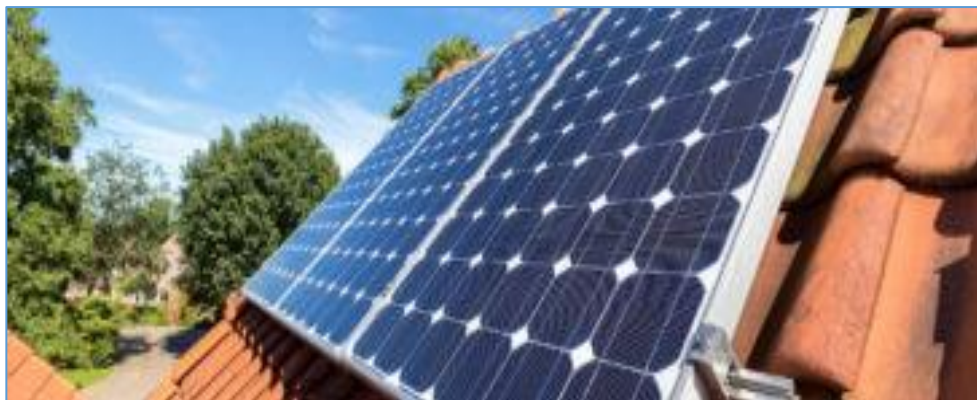
Photo 1. Producing energy using solar panels⁷

policy forces Member States to optimize both their existing building stock and their new buildings in terms of energy. This is the aim of the Energy Performance of Buildings Directive (EPBD 2002/91/EC)⁶ and its recast (EPBD recast, 2010/31/EC), which describes that after 31 December 2020, all new buildings must comply with the nearly zero energy buildings (NZEB) energy requirements.

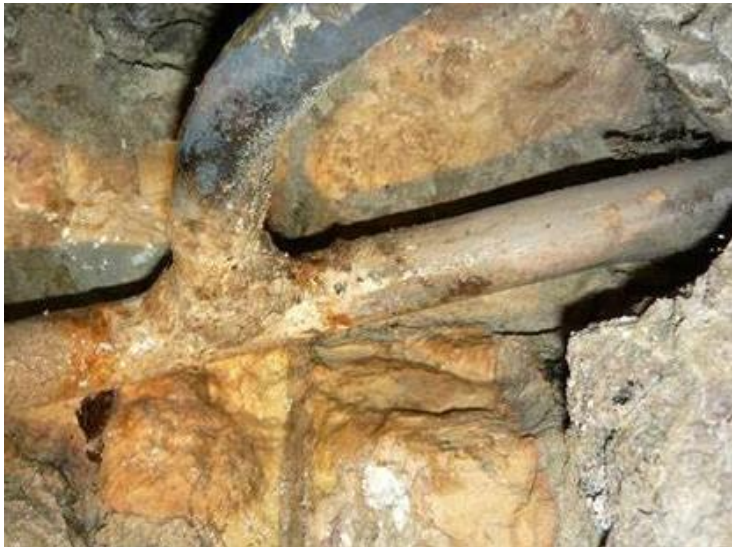
Photo 2. Exploration of worn corroded pipes in concrete-stone foundation

harmful effects of lead became known.¹² Corrosion-resistant materials have not yet been used for plumbing systems built around the 1950s and '60s, and as a result, some plumbing systems may require the replacement of the entire system. When a pipe is ruptured, it is often not possible to replace it completely, but the old pipeline has to be repaired, which is a big challenge to discover, weld and replace the faulty section.

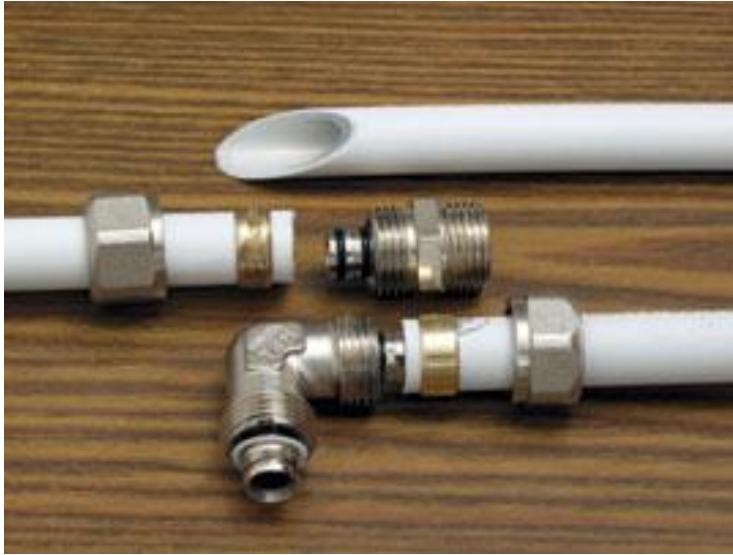
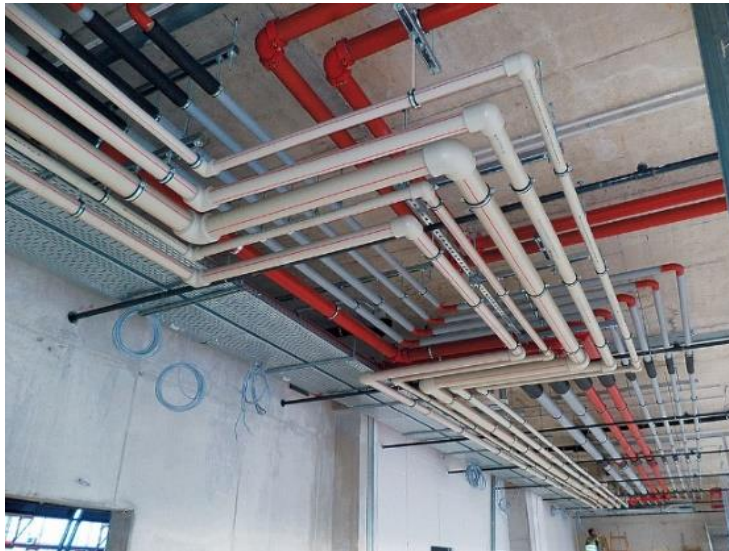
Photos 3-4. Plastic pipelines and an optional placement. Source:¹⁹

Many times, early detection and maintenance could have been a good solution, but without them, only replacements and thus prevention of greater environmental damage were possible. It would be advisable to increase the inspection of buildings with the possibilities provided by building diagnostics. Problems arising from use could be prevented by raising the awareness of appropriate methods as well as paying more attention. Damage caused by faulty construction or the use of poor quality materials is the most difficult to solve, so special attention should be paid to them when constructing new facilities. Plastic pipes are becoming more common, as well as alternative forms of pipe placement, such as driving them in the upper part of a room instead of breaking the concrete, if the type of building allows it.

However, it is not easy to replace the existing metal pipes during a renovation, the replacement by PP-R (polypropylene) or five-layer pipelines is justified by the data in the table below.

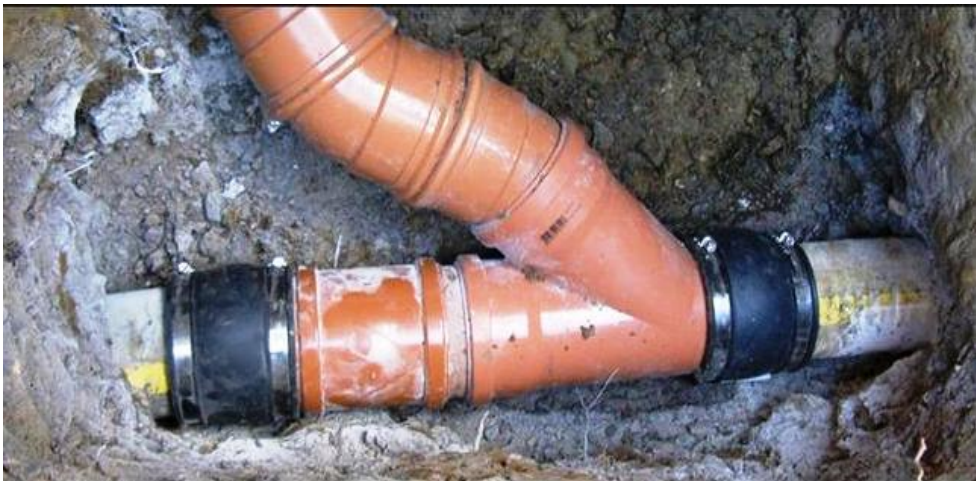
Photo 5: Sewage pipe repair. Source:²¹

In the case of sewage drains, the method of their laying is a key aspect: adequate depth and slope as well as support.

Damaged pipes may require the replacement of a section or the entire length of the pipe. When replacing a section, it is recommended to use a solution with rubber sleeve joints, and an appropriate soil compaction and support.
