Experimental study of failure of glulam-concrete composite beams

Pollack Periodica •
An International Journal
for Engineering and
Information Sciences

19 (2024) 1, 13–18

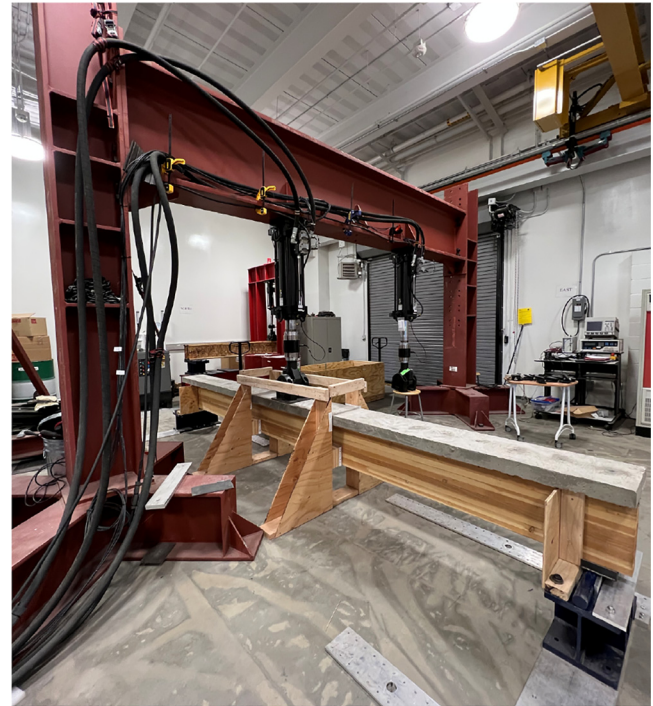
Fig. 1. G-C specimen setup

Three G-C beam specimens with a length of 4.877 m (192 in) were built and setup with a span of 4.623 m (182 in). The timber layer consists of an APA-The Engineered Wood Association-rated 24F-V4 glulam beam, with Douglas fir material and unbalanced layering. The nominal glulam beam width and height is 79.4 mm (3.125 in) and 381 mm (15 in), respectively. The 76.2 mm (3 in) concrete layer consists of a C40/50 (40 N mm⁻², 6000 psi) basalt fiber reinforced normal weight concrete. The timber and the concrete layer are interconnected with a Dayton Superior Sure Bond J58 two component, high modulus, moisture-tolerant adhesive [9]. The adhesive was applied on the top of the glulam in two layers, 10–15 min apart then the fresh concrete was placed in the form 10–15 min later. The glulam is embedded into the concrete by 12.7 mm (0.5 in). Ten steel spikes were added to the timber layer to ensure that a tension failure mode develops instead of a shear failure, 101.6 mm (4 in) from the end of the beam and 203.2 mm (8 in) between the spikes. The main setup of the composite specimen is shown in Fig. 1.

An MTS computer controlled hydraulic loading system was used to conduct the static load tests. A point load at the midpoint using a 445 kN (100 kip) actuator was applied using stroke control with 2.54 mm min⁻¹ (0.1 in/min) loading speed. The loading frame is attached to a strong-floor on which the support fixtures were setup as rollers at each end of the beam. To prevent lateral-torsional buckling, lateral restraining blocks were placed 1.702 m (67 in) from the axis of the vertical supports, with Teflon sheeting added to reduce any friction on the specimen during testing.

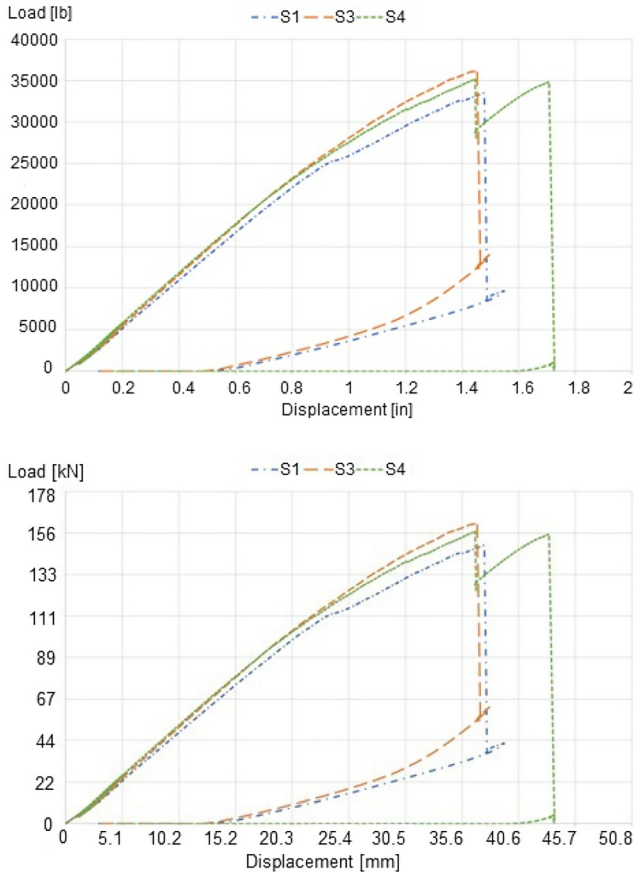
Fig. 5. Measured load-displacement diagrams in imperial and converted SI units (1 in = 25.4 mm; 10 lb = 4.448 kN)

The measured load-displacement diagrams for the three specimens are shown in Fig. 5. Specimens S1 and S4 exhibited tension failure, see Fig. 6, while specimen S3 failed in shear, see Fig. 7.

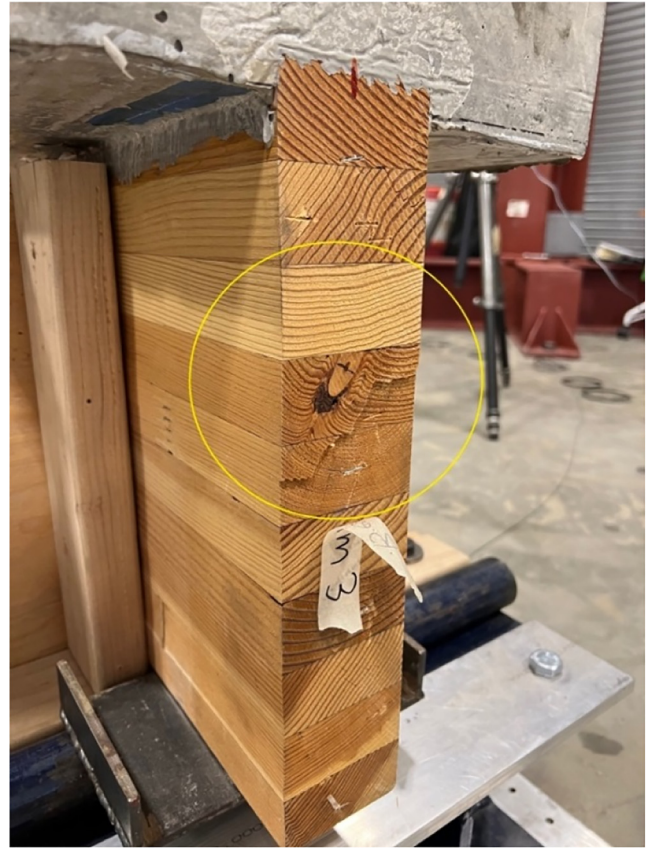
Fig. 7. Shear failure mode (S3)

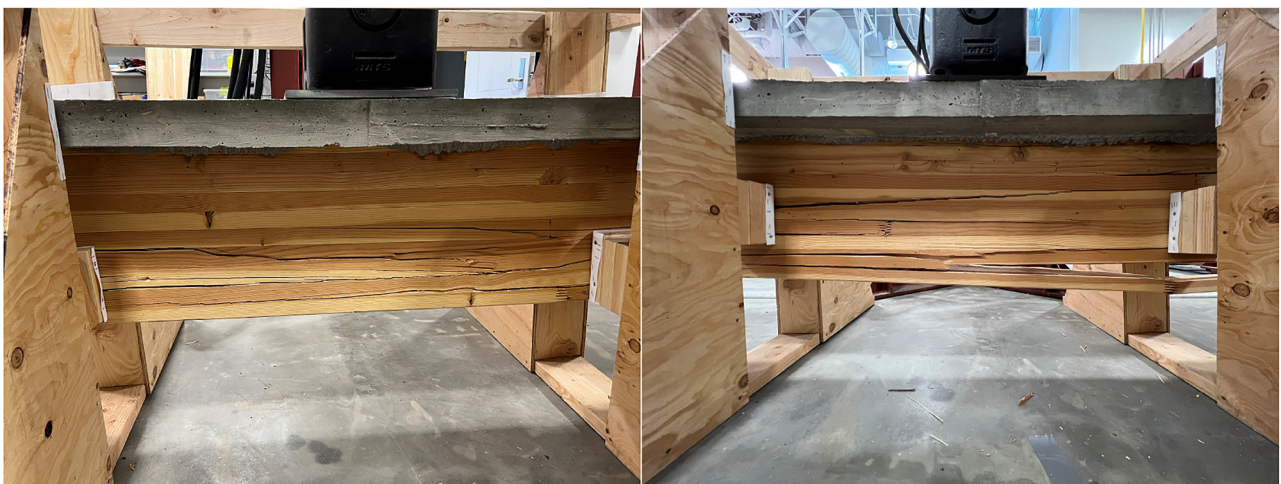
Specimen S1

Specimen S4

Fig. 6. Tension failure mode

The load test results indicate that the shear spikes presumably contained the shear failure in two of the three beams, allowing for a tension failure mode. The tension failure observed appeared to originate from finger-joints present in the bottom layers of the glulam. The sensitivity of accelerometers provides acceptable level of SNR and the placements of them allow for future analyses in failure model determination and proximity estimation. The AE findings will be presented in an upcoming second paper. Instead of using the standard unbalanced glulam configuration developed for members in bending, a different glulam layering can be adopted, optimized for the mostly tension loading in such G-C composite beams.
