STEEL IN ARCHITECTURAL HERITAGE PROTECTION

The current article presents some steel structural solutions implemented in archaeological and architectural heritage protection applied in Romania using case studies. The paper summarizes also some of the engineering challenges of the project team during the design process.

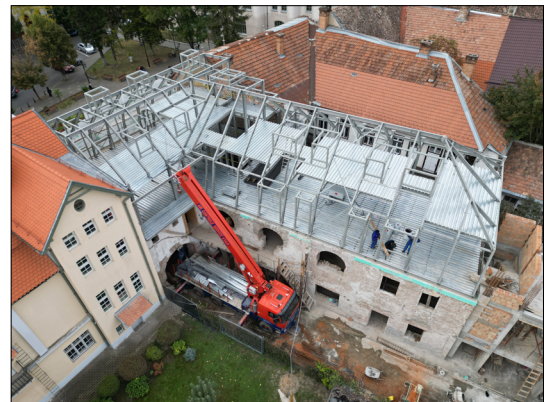
Fig. 3. Bolyai street 11 roof structure during construction.

The second case study presents the rehabilitation process of a historic building located in the city center of Târgu Mureș, during which the original Baroque-style roof structure was reconstructed using a modern metal framework. The study primarily focuses on the design of the roof structure and the metal access staircase. The complex, irregularly shaped roof with multiple planes required careful dimensioning and detailing before being installed on the refurbished masonry walls.

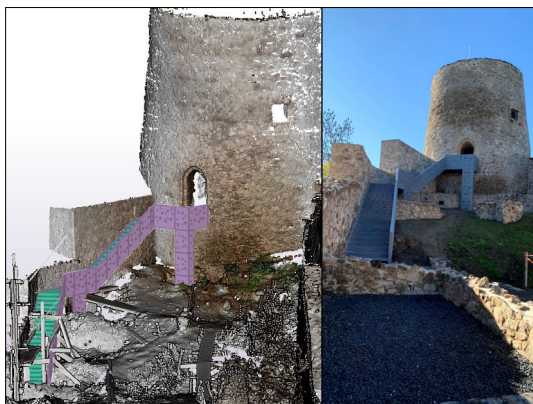
Fig. 4. Designed and executed staircase.

The third case study presents the design work related to the opening of the medieval Sebesvár castle ruins (known as Bologa in Romanian) to visitors, including the measures required to ensure safety. Figure 4 shows the structural model prepared by Gordias Engineering Office and the current state of the bastion. During the works, the castle area was cleared of overgrown vegetation, the walls were repaired, landscaping works were carried out, the wall crown was insulated with turf bricks, access ramps were built, and the old tower was made accessible from the inside with the help of steel structural elements. The compa-

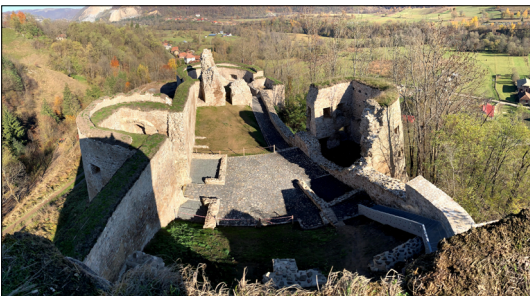
Fig. 6. *Sebesvár castle after restoration.*

In summary, although on-site welding was necessary in this project, the fitting of the elements was successfully executed in an aesthetically pleasing manner, providing an enjoyable visual experience for visitors (**Figure 6**).
