# FLOOD PROTECTION PARTIAL ANALYSIS OF THE OLT BRIDGE IN SÂNTIMBRU

## Abstract

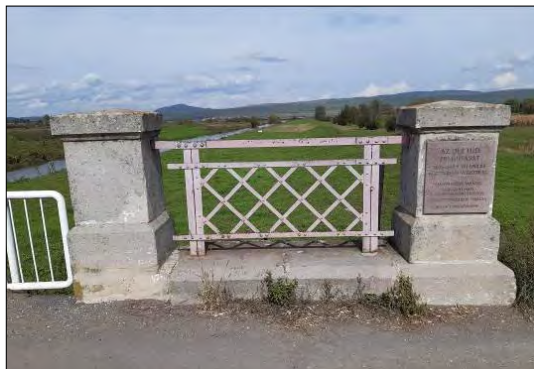
**Fig. 2.** The current state of the old bridgehead.

other places. A postcard illustrating the original state of the bridge is shown in [Figure 1](#). [Figure 2](#) proves that the railing at the bridgehead, which is completely different from the current railings on the bridge's superstructure, corresponds to the one shown on the old postcard.

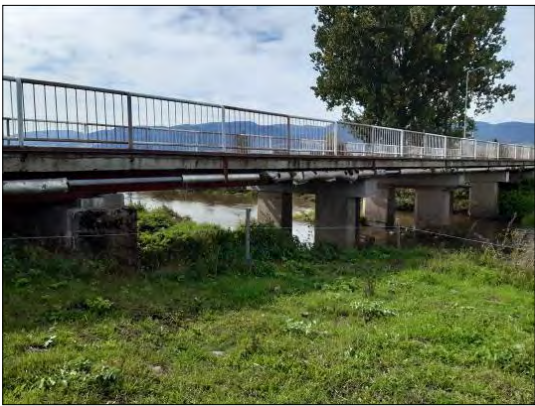
Fig. 4. The road bridge built over the widened riverbed on the site of the old arched bridge.

The current bridge is 52 meters long and has 5 piers, being adjusted to the embankment built on this section of the Olt River after the widening of the riverbed (Figure 4).

The subject of this investigation is the point in the Santimbru section of the Olt River where the bridge illustrated in Figure 1 was located and where the current road bridge shown in Figure 4 is located. The characteristics of this section of the river are shown in Table 1 and 2.

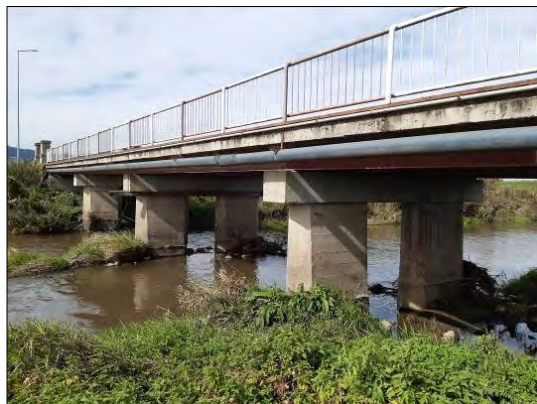
Fig. 9. Deposited riverbed sediment.

Our second conclusion is that the current cross-section does not ensure the free height required by the standards, so it would be necessary to remove the deposited bed sediment (Figure 9) and stabilize the riverbed.
