# Steel-concrete composite corrugated web girders – Experimental study

Bence Jäger, Tibor Pap<sup>\*</sup>, Balázs Kövesdi, László Dunai

Budapest University of Technology and Economics, Faculty of Civil Engineering, Department of Structural Engineering, Műegyetem rkp. 3, 1111 Budapest, Hungary

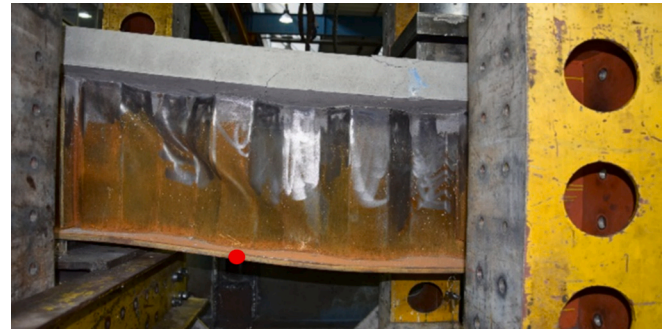
Fig. 13. Shear failure of web in B1/1 (red dot presents inflection point). (For interpretation of the references to colour in this figure legend, the reader is referred to the web version of this article.)

In the case of B1/1 specimen, the load is introduced 1 m from the end support. Fig. 13 and Fig. 14 show the interactive shear buckling of the web and crushing of the upper concrete flange. In Fig. 13 a visible inflection point can be seen and marked by a red dot. Strain gauges are also attached to the top surface of the bottom steel flange. The results can be seen in Fig. 14. The maximum load is 428 kN at displacement of 41 mm. Fig. 15 presents the measured force – strain curve of the bottom steel flange of B1/1 at the load introduction section. The green dot represents the corresponding "A" point where nonlinearity starts.

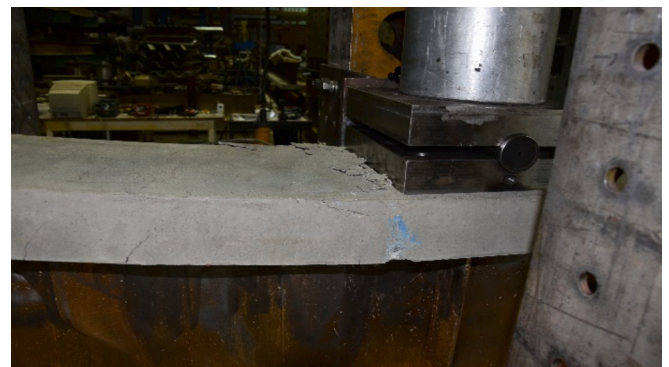
Fig. 14. Upper flange crushing in B1/1.

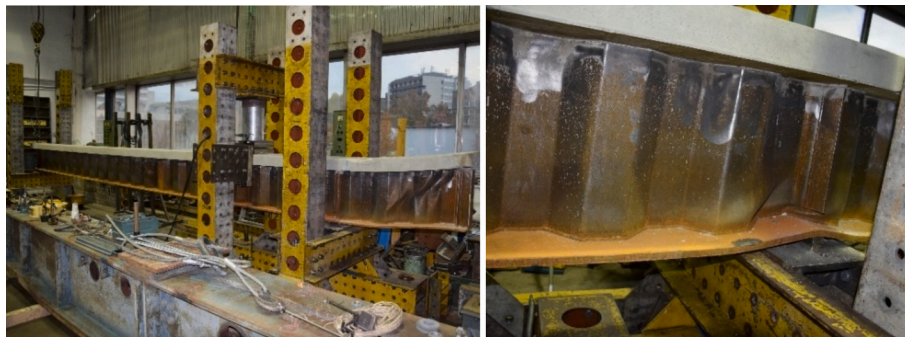
Fig. 16. Deformation of the specimen B1/2.

In the case of B1/2 specimen, the span length is 7 m and the load is introduced 1 m from the end support. The damaged cantilever length is 1 m. Fig. 16 show the failure of the specimen. Due to insufficient vertical stiffener length local web crippling failure occurred at the support, since

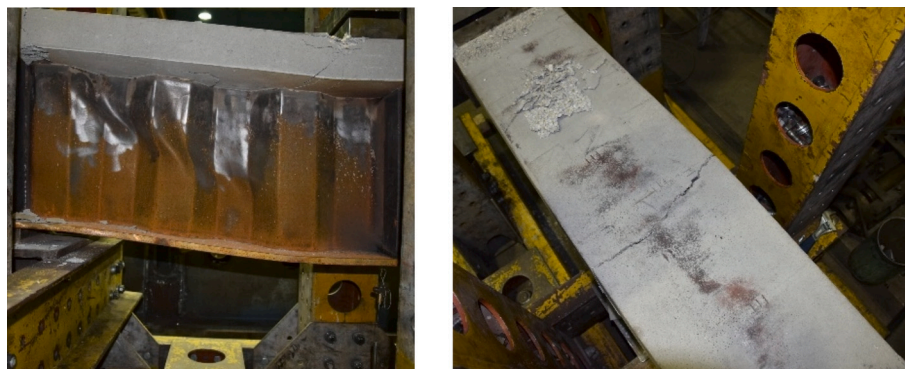
Fig. 17. Web buckling of B1/3; Concrete cracks above the support (close to the load).

In the case of **B1/3** specimen, the span length is 6 m and the load is introduced 1 m from the end support. The damaged cantilever length is 2 m. Fig. 17 shows the failure of the specimen which shows the interactive shear buckling of the web and final crushing of the upper concrete flange due to dominant bending moment with accompanying minor normal force.

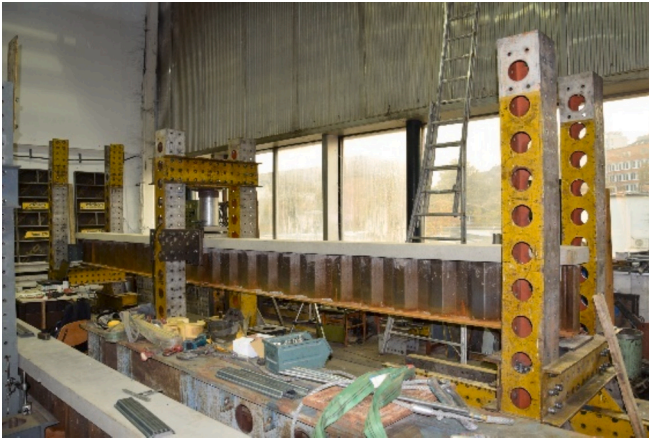
Fig. 18. Applied load in mid-span (B2).

Specimen **B2** is 8 m long, and it is loaded in the mid-span (4 m) as a three-point bending arrangement (Fig. 18). The girder behaves linear until reaching 322 kN where the lower steel flange yields and the neutral

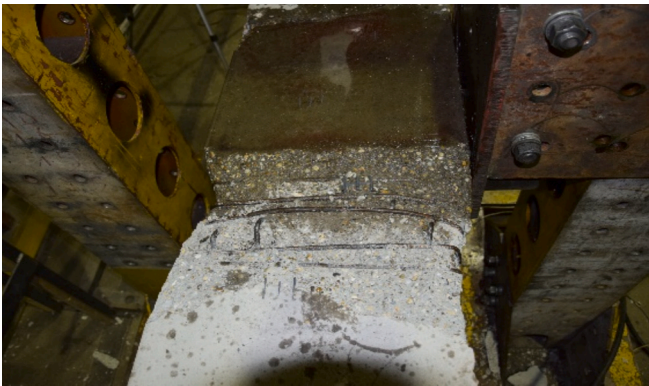
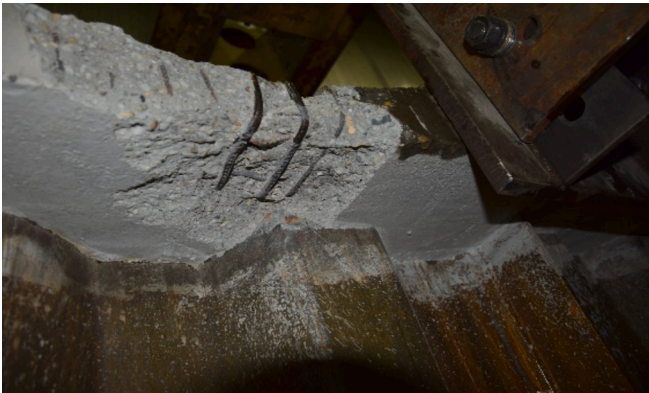
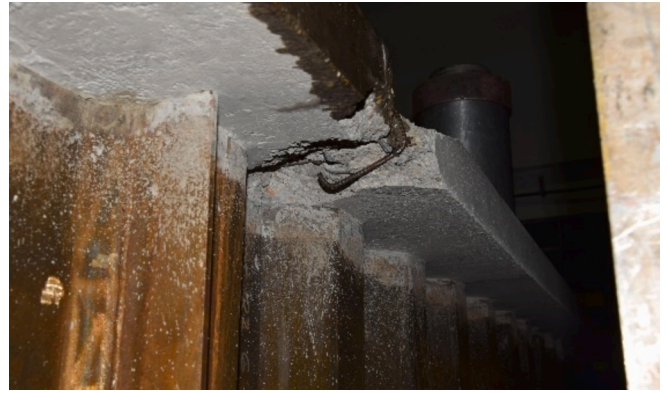
Fig. 19. Concrete flange failure (B2) – view from above.

Fig. 20. Concrete flange failure (B2) – view from below.

Fig. 21. Damage on the upper concrete flange (B2).

axis is shifted up causing extra local bending moment in the upper concrete flanges for the further loads. At load level of 372 kN sudden column type failure of the upper concrete flange occurred. The buckling of the longitudinal rebars between the stirrups can be seen in Figs. 19 to 21.

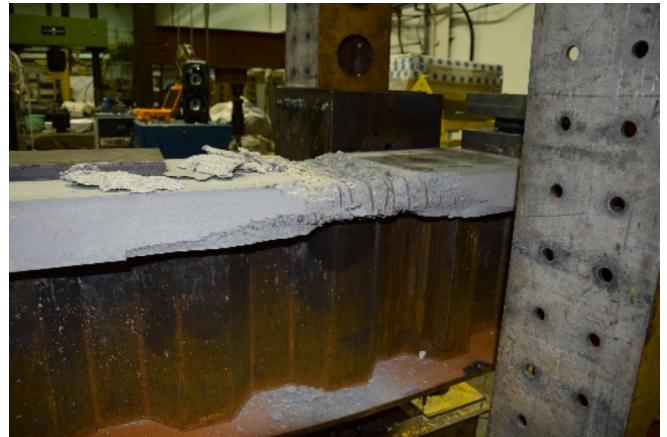
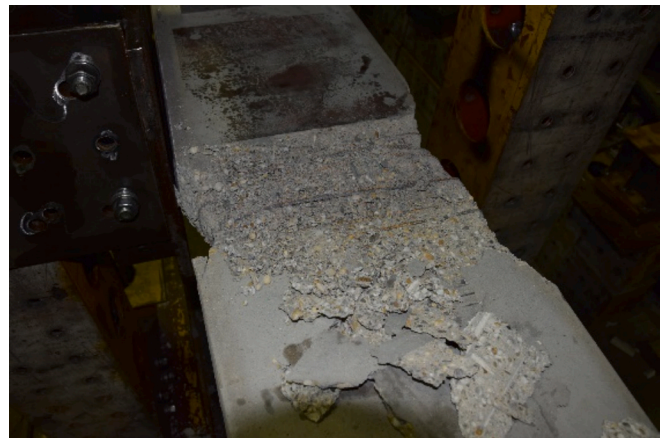
Fig. 22. Upper concrete flange failure (B3) – side view.

Fig. 23. Upper concrete flange failure (B3) – view from above.

Specimen **B3** is 8 m long and loaded 2 m apart from the support (Fig. 22 and Fig. 23). The girder behaves linear until reaching 410 kN where the lower steel flange yields and the neutral axis is shifted up causing extra local bending moment in the upper concrete flanges for the further loads. At load level of 430 kN sudden column type failure of the upper concrete flange occurs. The buckling of the longitudinal rebars between the stirrups can be seen in Fig. 22 and Fig. 23.

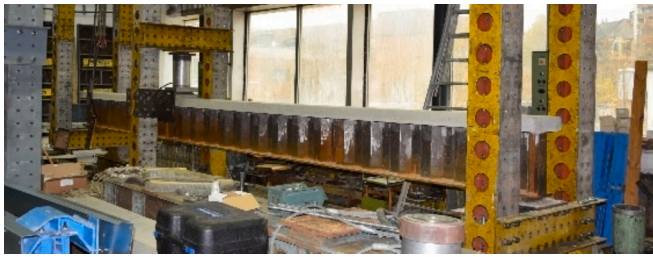
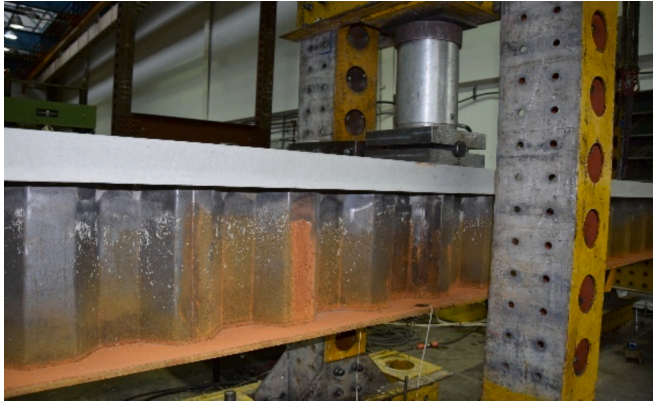
Fig. 24. Test setup of B4.

Fig. 25. Load introduction (B4).

Specimen **B4** is also 8 m long and loaded 3 m apart from the support (Fig. 24 and Fig. 25). The girder behaves linear until reaching 334 kN where the lower steel flange yields and the neutral axis is shifted up causing extra local bending moment in the upper concrete flange. At load level of 384 kN sudden column type failure of the upper concrete flange occurred. The buckling of the longitudinal rebars between the stirrups can be seen in Fig. 26. Fig. 27 presents the load – strain diagrams of the bottom steel flange. The green dot represents the corresponding “A” point where yielding of the bottom steel flange starts.

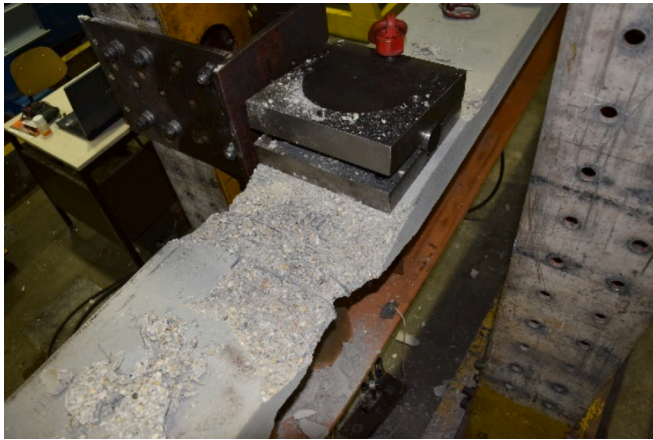
Fig. 26. Concrete flange failure of B4 – view from above.

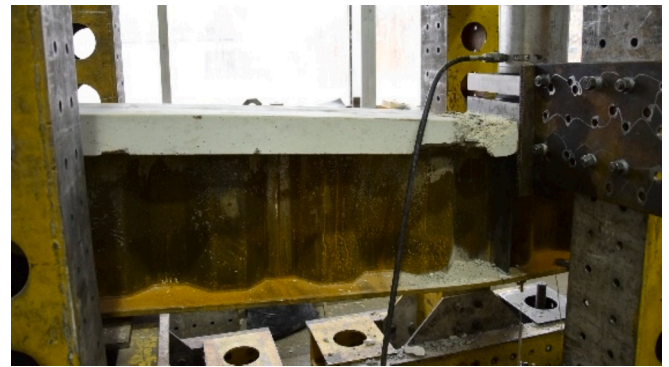
Fig. 28. Crushing of the upper concrete flange of B5/2.

described two failure modes, namely (i) moderate shear deformation develops without visible shear buckling in the web and (ii) the upper concrete flange is subjected to governing local bending moment with accompanying normal force thus not sudden but progressive column-type failure occurs (see later on in Fig. 28).

In the case of the specimen **B5/2**, the span length is 6.67 m; cantilever length is 1.33 m. Load is applied 1.50 m apart from the support. The girder behaves linear until the load of 422 kN. The measured ultimate load is 444 kN. The failure of the upper concrete flange is similar to the bending-type failure mode but with progressive development of rebars buckling and concrete crushing (Fig. 28). On the other hand side no visible web shear buckling type failure occurred.
