## Manufacturing of composites with designed failure

# Manufacturing of composites with designed failure

**Abstract:** The failure of polymer composites is a very complex process, which mainly occurs as a result of interactions between different types of damage in the material, often at random locations and without any particular signs. To increase the reliability of composites and enable their wider use in safety-critical components, it is crucial to make their failure processes more controllable and predictable, which could be achieved by the local modification of the interfacial adhesion. The aim of our research is to develop and investigate a method for designing the failure process of polymer composites in terms of the location and the mode of failure. We produced interfacially engineered composites containing a weakened adhesion zone by adding polycaprolactone (PCL) thermoplastic interlayer material, which was applied directly on the surface of the reinforcing material by fused filament fabrication (FFF). Then, material tests were carried out, and the failure mode and position were evaluated as a function of the geometry of the interlayer material.

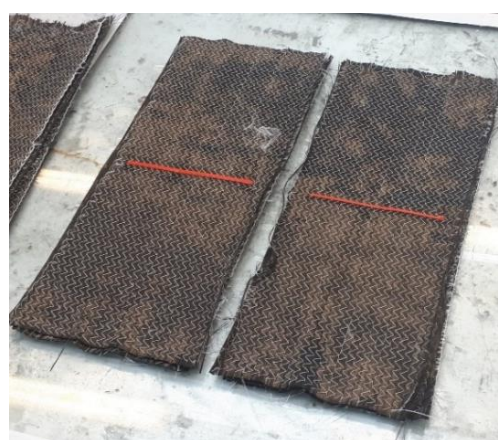
**Figure 2.** UD carbon fabric containing the PCL interlayer material during the manufacturing of the tensile test specimen.

Reference composites without PCL and composite plates containing PCL interlayer material were manufactured with  $[0^\circ]_6$  layup sequence. For the latter, the PCL filament was printed directly on the surface of the carbon fabric by fused filament fabrication (FFF) method using a CraftBot Plus 3D printer. The samples manufactured for the impact tests contained interlayer material inclined at an angle of  $45^\circ$  to the fiber direction, so that the effect of the weakened adhesion zone on the failure location could be better observed. The interlayer material in the tensile test specimens was applied perpendicular to the fiber direction (Figure 1 and Figure 2). The interlayer material, thus the weakened adhesion zone, differed in geometry: the zone had the same width for each plate, only its thickness varied. Composite plates were produced by vacuum-assisted resin transfer moulding (VARTM). Then, specimens were cut from the composite plates with a Mutronic Diadisc (Mutronic, Rieden am Forggensee, Germany) diamond disc cutter.

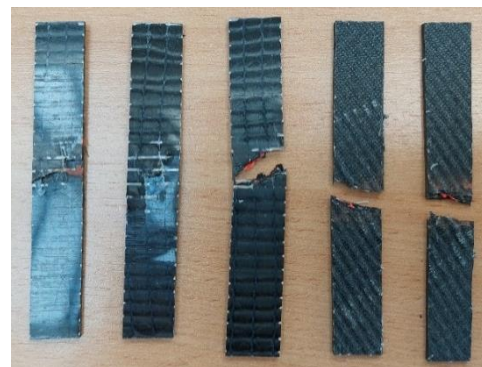
**Figure 5.** The specimens containing PCL interlayer material with a width of 2 mm and a thickness of 0.8 mm after the impact test.

Then, the failure mode and position were evaluated. The results show that the reference composites failed in a brittle manner along the line of the impact, as expected (Figure 3). For the composites containing PCL interlayer material, Figure 4 and Figure 5 suggest that the smaller thickness does not significantly affect either the fracture path or the mode of failure. However, the 0.8 mm thick interlayer material had a significant effect on both failure mode and position: two specimens failed by delamination, while for three specimens, the fracture path was increased, with failure occurring along the line of the interlayer material.
