# Dike failures in the Carpathian Basin

László Nagy

Department of Geotechnics and Engineering Geology, Budapest University of Technology and Economics,  
Budapest, Hungary

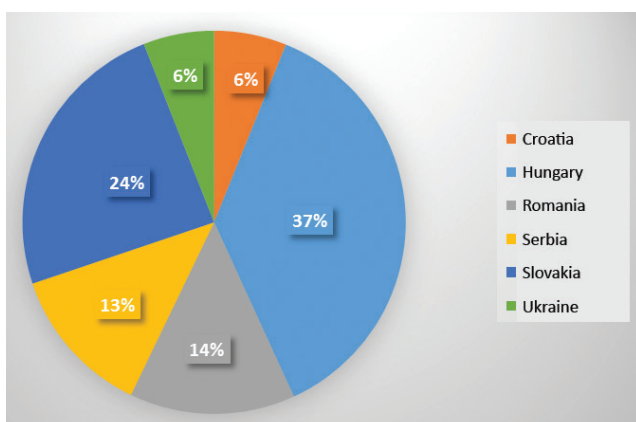
Currently, more than 11,000 km of flood dikes along rivers are distributed between countries according to Fig. 2. A very significant proportion of these – both in length and volume – were built before 1921. Remember, dike failures can only occur where there was a dike.

**Figure 2** | Length of flood protection dikes in the countries of the Carpathian Basin  
Source: author.

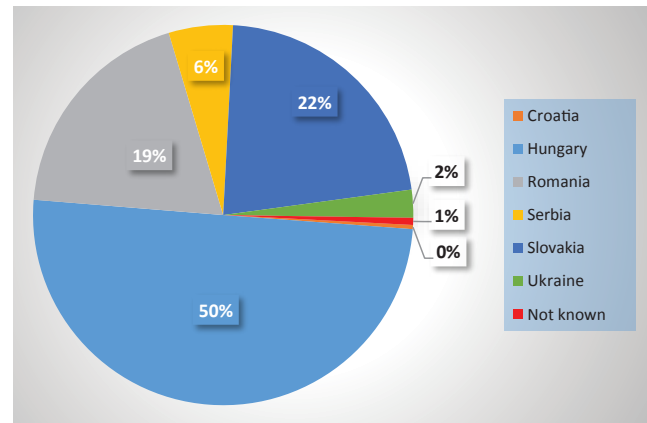
**Figure 3** | Distribution of dike failures by country in the Carpathian Basin  
Source: author.

Rivers running at high speed from the mountains slowed down and spread across the lowlands. After the great water control, torrential waters reached the lowlands, creating high floods in the diked riverbed, which caused high flooding when the dike failed. After the rivers were filled, many dike failures occurred due to the fact that in the 19<sup>th</sup> century it was not yet possible to determine the expected maximum water levels. The present communication deals with 2,858 dike failures in the Carpathian Basin, of which 1,436 occurred on the territory of present-day Hungary. Dike failures are treated in a uniform way, regardless of the country in which the dike is currently located (Fig. 3) in the compact water catchment area of the Carpathian basin.

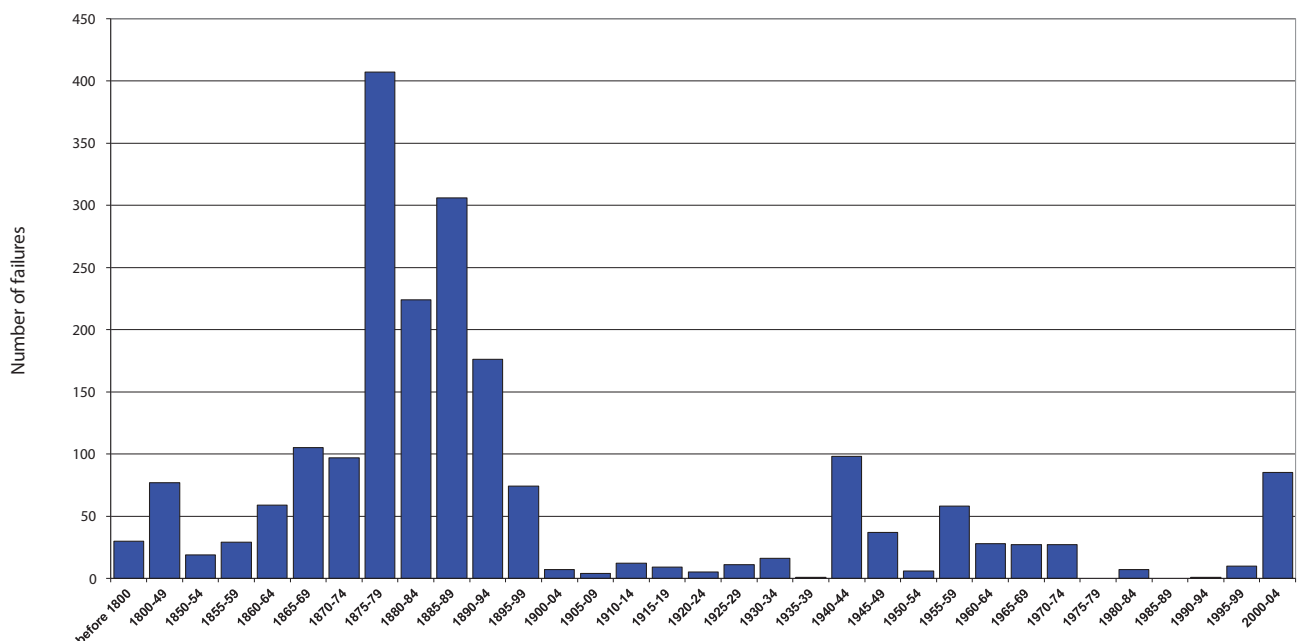
- The number of failures per five-year periods demonstrates clearly that the large-scale flood control project launched in 1845 was not fully successful up to the turn of the century (Fig. 5).

Figure 5 | Number of dike failures in the Carpathian Basin until 2004

The distribution of dike failures over time is a good indicator of the reliability of the dike system. Prior to the 1800s, when there were relatively few flood control dikes, albeit steadily growing, historical accounts record few dike failures (*Fig. 5*). The flood of 1838 caused great devastation in Pest and was the worst flood involving dike failure in the Carpathian Basin in terms of human life. The length of the dikes increased significantly only after the start of the great works for the regulation of the Tisza (27 August 1846). The series of rising water levels and the subsequent high number of dike failures is reflected in the data for the period 1850–1900. Processing the data series, it seems that by 1900 the dike-building boom had caught up with the rising water levels, and a calmer time for flood protection in the Carpathian Basin came, interrupted only by a few major floods, such as the Danube Valley floods of 1940, the 1956 Danube ice flood, the 2001 Tisza floods (*Fig. 5*).

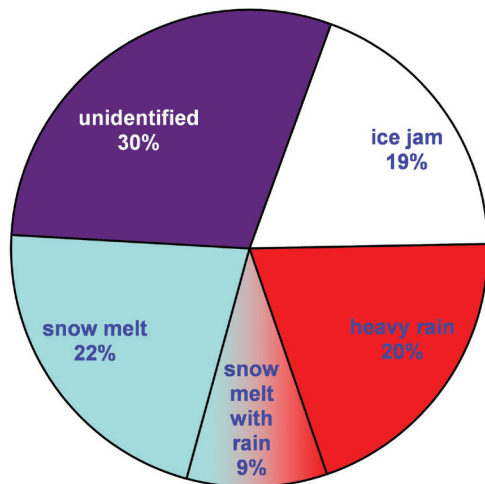
In the Tisza Valley, floods from snowmelt were the most dangerous flood, especially when the snowmelt was supported by warm rain (*Fig. 7*). In the upper Danube water catchment area, on the other hand, the snow melted gradually due to the high mountains, so only in a few cases did the snowmelt cause a significant flood.

**Figure 7** | The origin of the flood caused dike failure in the Carpathian Basin  
Source: Nagy, 2018

floods from rainfall are less significant on the Danube (probably due to its large water catchment area) than on the Tisza and its tributaries. So-called summer dikes were built along the Tisza to protect the cultivated area, as the flood waters from the summer rains usually receded at a lower height than the snowmelt. The distribution of these causes of flood generation are seen in *Fig. 7* (Nagy, 2018).

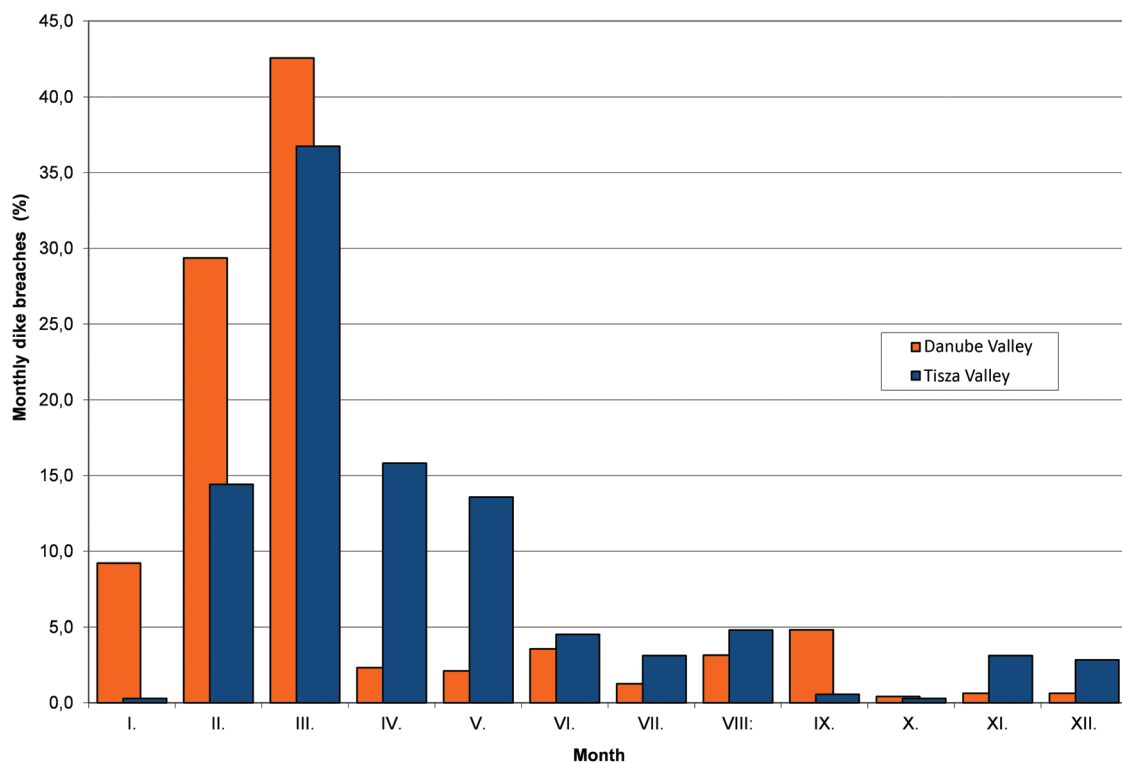
The exact date of 1,688 of the 2,858 dike failures (59.1 %) in the Carpathian Basin is known by the day, and further 449 (15.7 %) is known by the month, in all 2,137 data (74.8 %). The distribution of these data by month are shown in *Fig. 8*, where the most important statements are:

**Figure 8** | Monthly distribution of dike failures in the Carpathian Basin  
Source: Nagy, 2018
