Comprehensive analysis of local corrosion degradation on austenitic pipeline

To cite this article: P Trampus *et al* 2018 *IOP Conf. Ser.: Mater. Sci. Eng.* **426** 012050

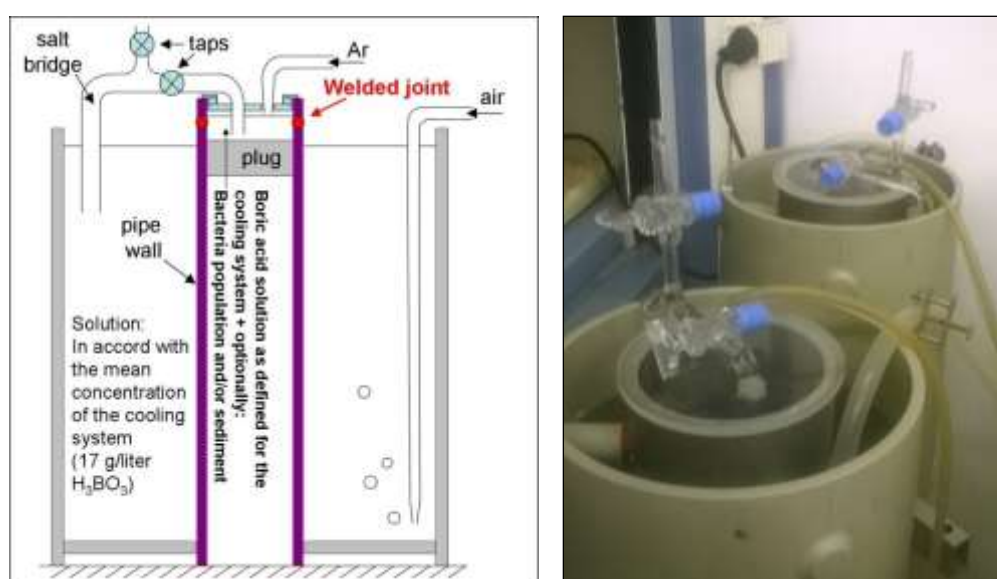
Figure 6. Setup of the differential aeration model (left) and the equipment (right)

experimental setup is shown on the left side of *Figure 6*, the equipment used for the experiment is shown on its right. The following were concluded:

- Long term operation (46 days) of differential aeration cells with large cathode/anode surface ratio confirmed the extreme corrosion sensitivity of weld produced without proper protection. These samples showed approximately ten times faster corrosion velocity than the samples without welds.
- Also, simulation of differential aeration in anaerobe environment revealed biofilm development on surfaces of solid materials. It occurred even in the presence of boric acid. A biofilm is considered as a potential initiation factor for microbiological corrosion degradation.
- On the weld root side of the specimens, the initiation stage of pitting corrosion could be observed, as well as indications for tuberculum development were found. It is to be emphasized that these degradation processes developed in a relatively short time.
