Damage Detection in a Fibre Reinforced Polymer Component by the Vibration Decay Rate

Abstract--- Fibre reinforced polymer (FRP) components can have visible or non-visible damages because of an impact, crush, or fatigue during the regular operation hours. These components or structures have to be continuously monitored in order to ensure an early detection of deterioration. This paper uses the vibration decay rate experimentally as a method to detect damages in a FRP component. Measurement of reverberation time RT_{60} is executed in three different damage conditions of a specimen made of fibre reinforced polymer. The conditions of the specimen vary based on the damage existence in it. The major concern is on predicting damages presence by the measured data. The resulted data showed a clear difference among the three conditions proving the damages existence.

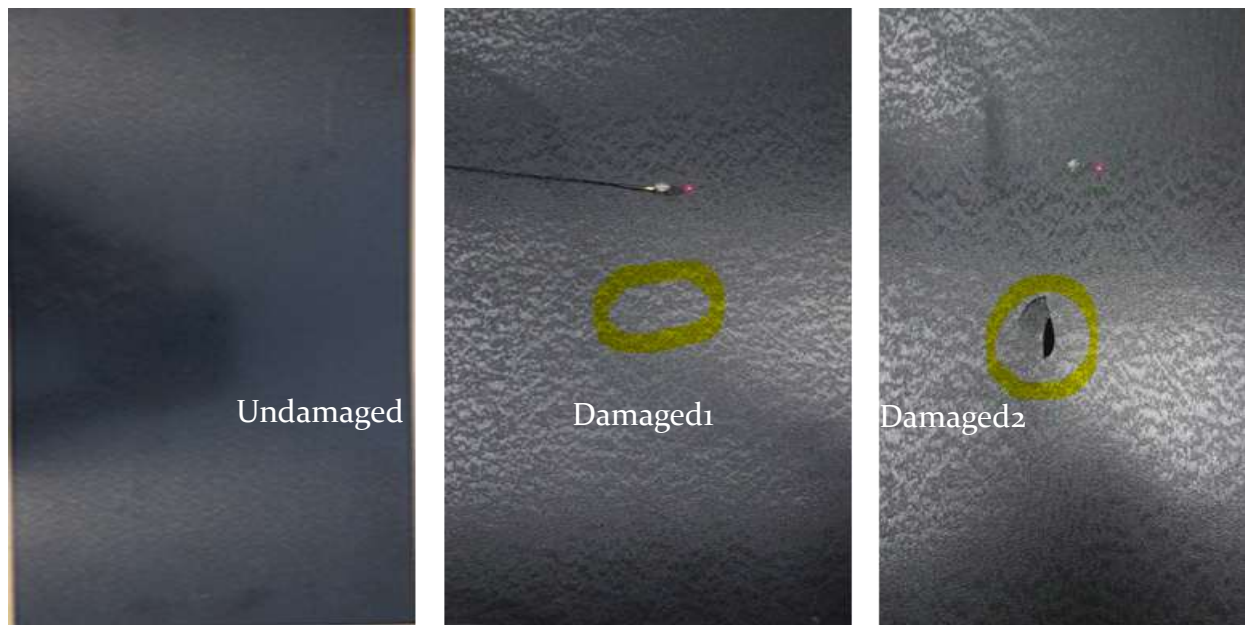
Figure 2: The Test Specimen with Three Conditions

In order to have the specimen cracked, an airgun type Diana 300R cal.177 was used. It has the maximum kinetic energy of $E = 7.5$ J at the muzzle. The gun “fires” lead pellets of the weight $m = 0.53$ g of a calculated speed at the muzzle of 170 m/s. When firing from distance of 10 m, the contact place is barely visible. When firing from 1.5 m distance, the specimen was damaged with a crack of about 5 cm long. So the specimen was tested three times based on the conditions undamaged, damaged 1, and damaged 2.

As mentioned, the test is done three times according to the three different conditions of the specimen. First time, the specimen is free of damages while the second time the specimen is damaged but the crack is barely seen by eye supposing that there are damages in the microstructure of the part which may be detected by the resulting signal. The third test is done when the specimen is fully cracked as there is a gap in the spacemen.

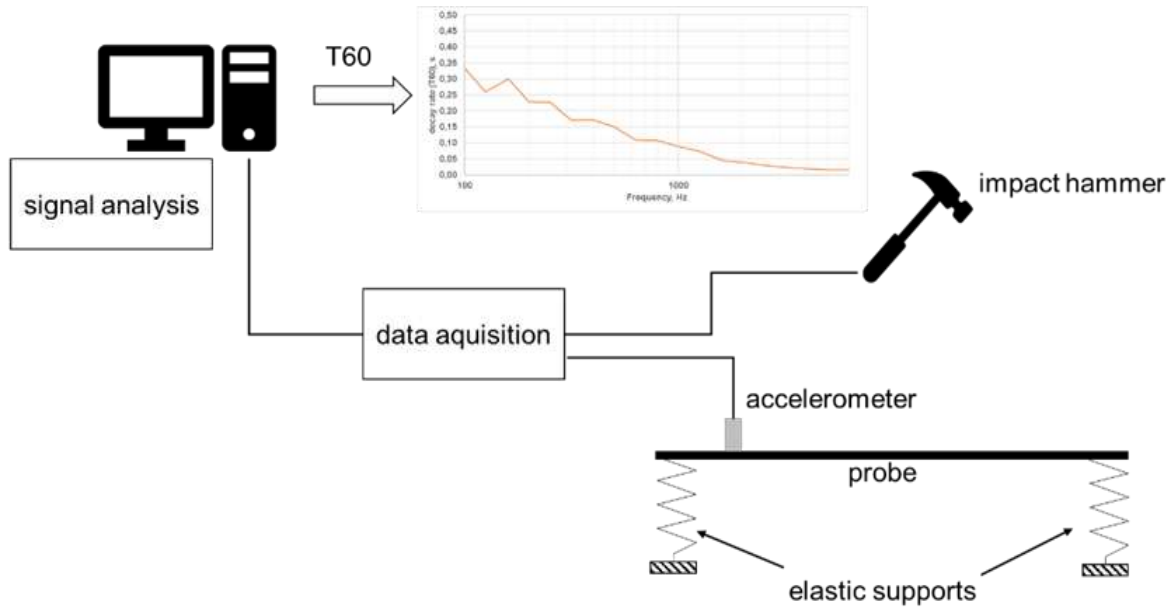
Figure 3: Schematic Representation of the Test Setup

- B&K Pulse data acquisition
- B&K 4397 accelerometer
- Impact hammer (hand-made from a B&K 4397 accelerometer)
- The software

During each time of the test, the excitation points are respectively hit ten times by the hammer and the recorded data were averaged. All recorded data are analysed by the Room Acoustic Wizard software and graphs are generated.

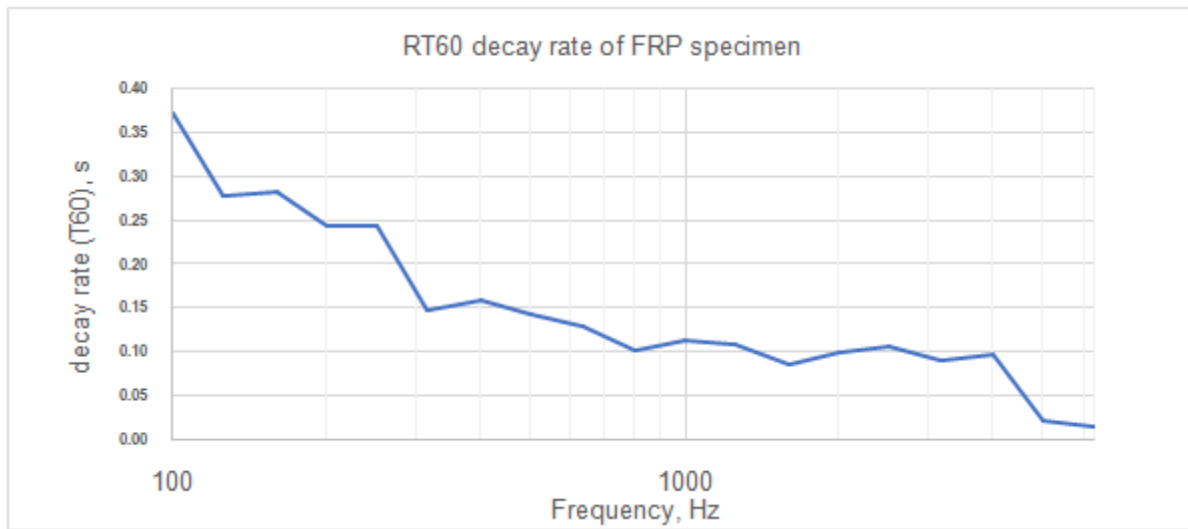
Figure 4: RT 60 Decay Rate of the Original Specimen

The graphs (4-6) individually show the RT_{60} curve for the three cases of the specimen while graph 7 shows the RT_{60} of all three states together. As it is clear in figure 7, after 1000 Hz, there is a big difference can be seen among the three of them. The damaged condition no.2 (grey line) showing the highest RT_{60} conflicting the fact that there is no material (gab), so there is less damping. Same fact can be applied to the damaged case no.2 (blue line) considering that since there is a crack so there is damping less than original case resulting in higher RT_{60} than the original specimen. In accordance with the results above, the presence of damages can be estimated by the vibration decay rate in specific condition.

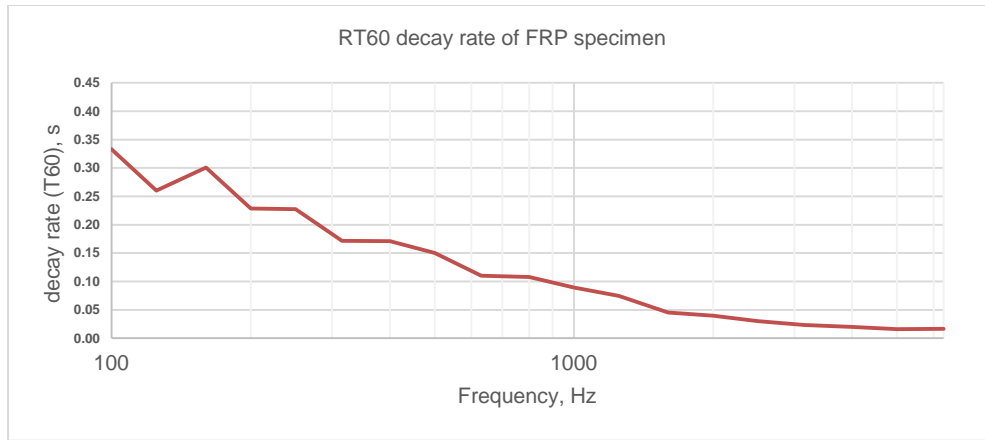
Figure 5: RT 60 Decay Rate of Damaged-1 Specimen

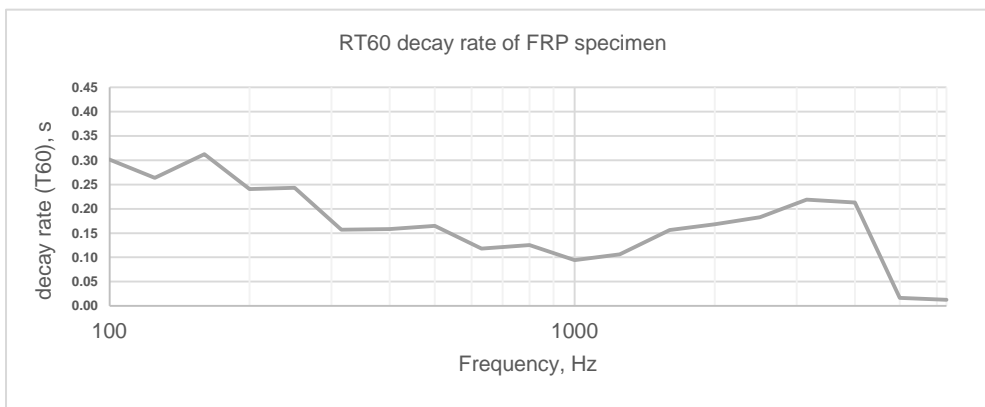
Figure 6: RT 60 Decay Rate of Damaged-2

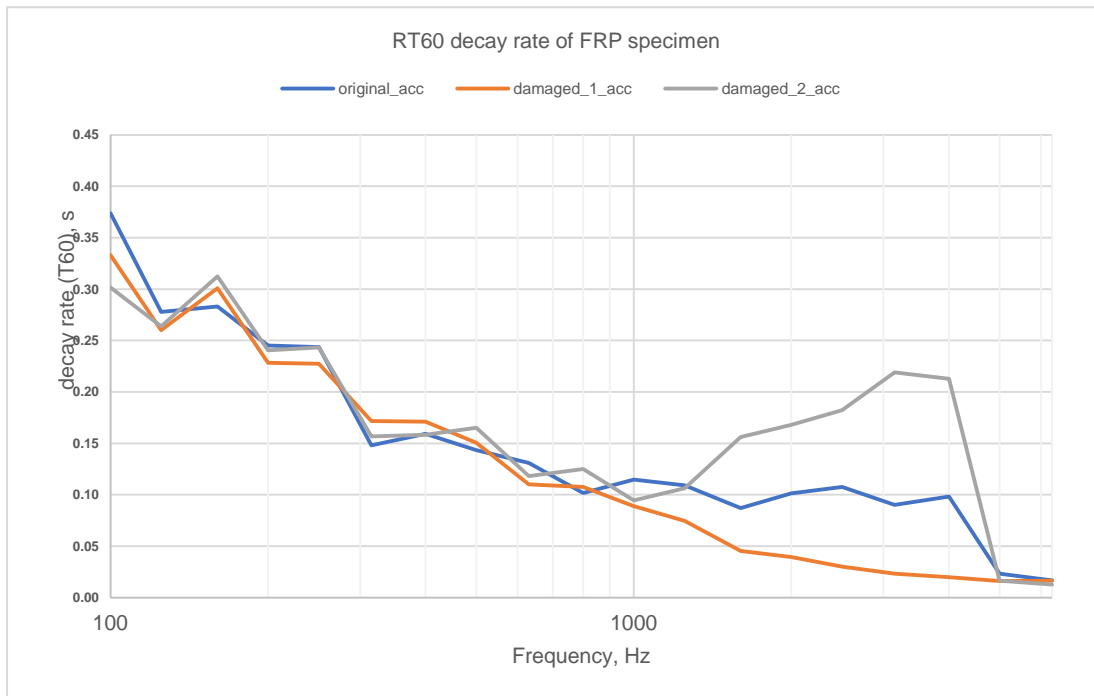
Figure 7: RT 60 Decay Rate of the Three Cases
