THE MEDIEVAL PARISH CHURCH OF BAIÁ MARE: PRELIMINARY RESULTS OF AN ARCHAEOLOGICAL RESEARCH PROJECT

PÉTER LEVENTE SZŐCS¹

Hungarian Archaeology Vol. 11. (2022), Issue 2, pp. 29–37. <https://doi.org/10.36338/ha.2022.2.4>

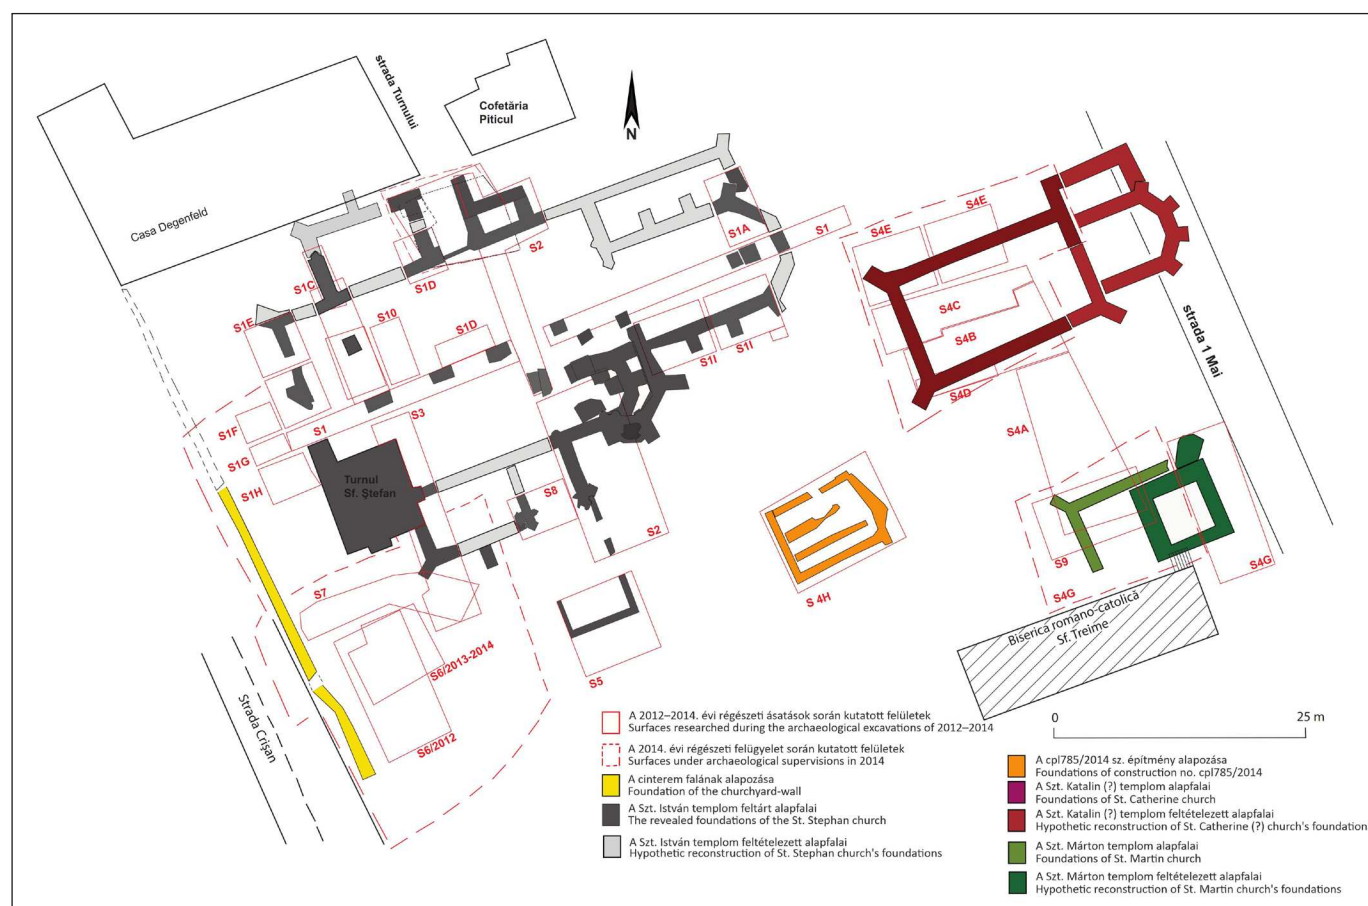
Fig. 1. Baia Mare, P-ța Cetății. Survey map of the excavated area

The site of the parish church and the surrounding park was rehabilitated, the works having been preceded by archaeological excavations between 2012 and 2014.³ The excavations revealed persisting foundations, floors, and internal details of the church building, the relics of lesser buildings, and some graves of a churchyard cemetery. However, the rescue excavation only included the areas directly endangered by reconstruction works (Fig. 1).⁴ The narrow timeframe and resources enabled us to unearth the archaeological layer

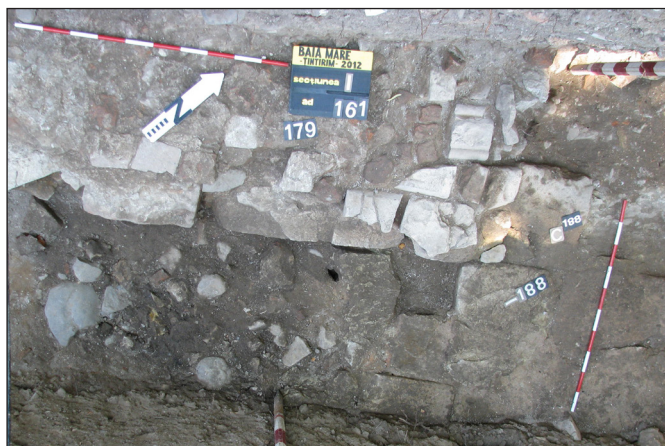
Fig. 3. Remains of the nave's and side aisles' stone floor

identified a semicircular walking surface paved with river stones in front of the western portal, 0.80–1 m below the current surface. It sloped slightly toward the Crișan (Magyar) street. In the interior of the church building, a floor made of stone slabs, also incorporating reused medieval tombstones with inscriptions, corresponded to this outdoor pavement (Fig. 3). Despite most parts of the stone slab floor had been destroyed by gas and electric pipelines and ground rods of lightning conductors, we were able to date it to the early modern period and identify as the last floor phase of the church building.

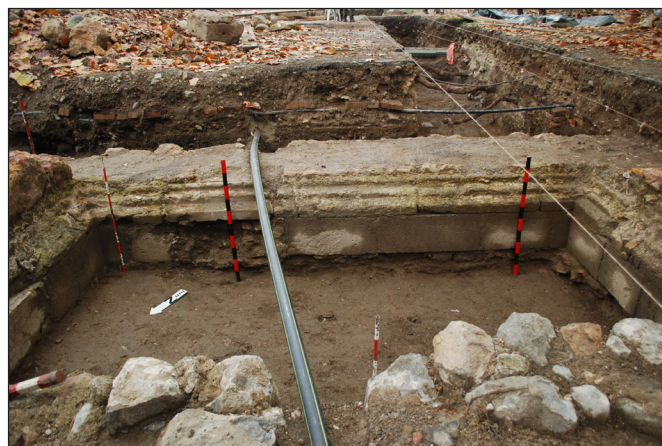
Fig. 4. Plinths of the northern side aisle's northern exterior wall

On the northern side, someplace, the elevation walls were preserved two ashlar-row high. Furthermore, parts of the plinth, compiled of nicely carved cascading oblique and cylindrical elements, connecting foundations and elevation walls, were also preserved in this section (Fig. 4). Moreover, we found the foundations of the northern portico in this zone; it was attached to the exterior walls of the parish church building, and its floor was made of brick. By the eastern side of the portico, a small chapel was created with a rather simple method: a wall was erected between two buttresses, enclosing the gap between them (Fig. 5). We also found the foundations of an additional chapel on the western side of the northern portico. This chapel was wider than the portico and stretched to the westernmost buttress of the northern side aisle's northern exterior wall.

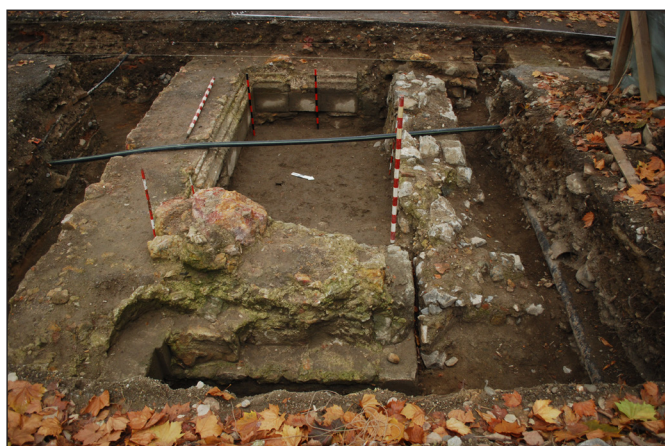
Fig. 5. The northern side-chapel, created between two buttresses

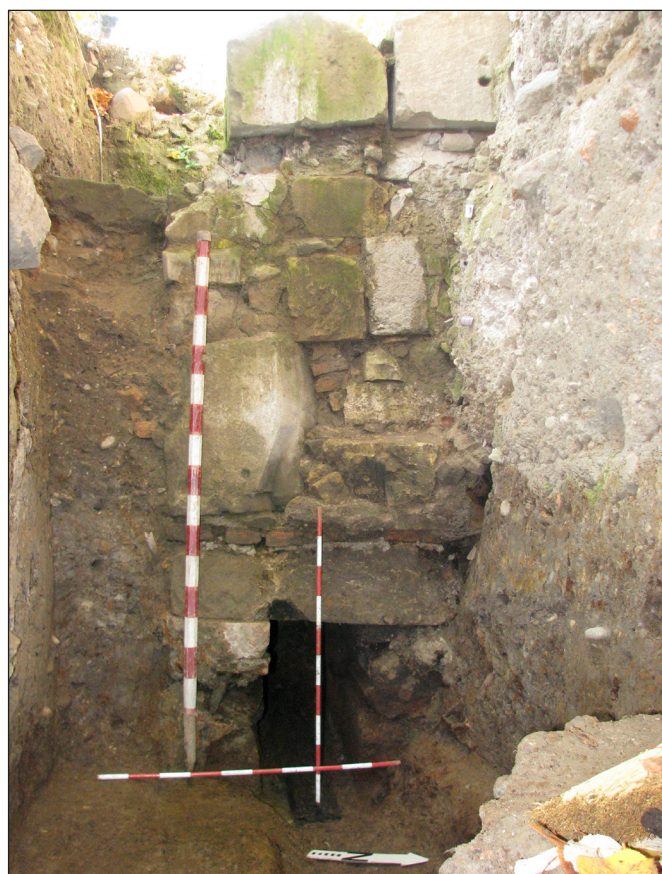
Fig. 6. Foundation of a pillar in the central row

of shafts of these pillars, and it was clarified that they belonged to the last building phase of the church building, as their foundations comprised reused bricks and stone carvings, including a tombstone with inscriptions (*Fig. 6*). Stratigraphic observations also confirmed the pillars' dating: their plinth corresponded to the latest stone floor of the church. These observations confirmed a hypothesis by Szilárd Papp about the present two-nave structure being the result of early modern transformations. The available archaeological record, however, does not enable a more precise dating (PAPP 2011, note 28). Upon checking our archaeological observations with the related written sources, it could be assumed that the transformation can be linked to the major reconstruction after a great fire in 1552 when the whole roof became destroyed and the building remained uncovered for several years. All this happened at a time when Protestantism gained support in Baia Mare (during the 1540–50s), and the local protestant congregation took over the ruined church building. All these factors might have been at work behind the radical transformations. After that, no notable structural modification took place during the building's lifetime except for some reparations after another fire in 1769 (SZÁSZ 2000, 21–33). Those works included the construction of a chapel next to the southern portico and creating stone pavements in front of the western façade and in the southern portico.

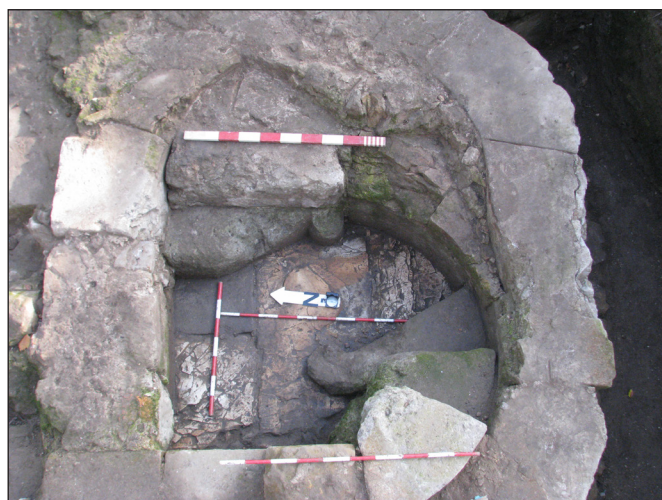
Fig. 8. Remains of a turret and spiral staircases by the south-eastern corner

interior of the southern side aisle and also that the stairs were renewed: we found the remains of two sets of steps, one starting left of the northern entrance, the other by the southern wall (Fig. 8). After the turret had been abandoned, its interior was filled up and used as a burial place.

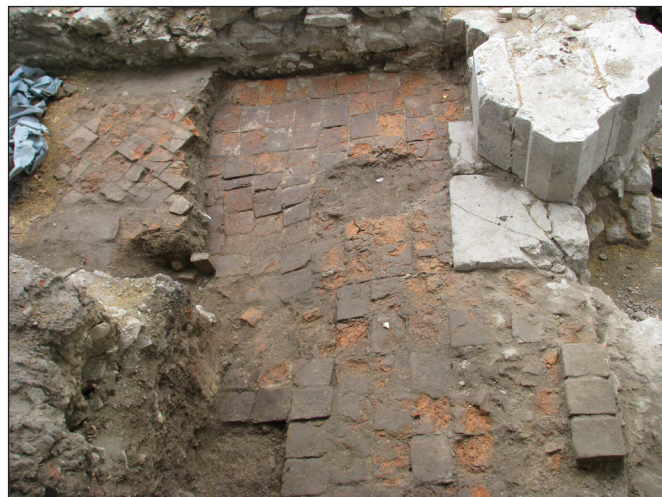
Fig. 10. Brick floors from two building periods in the choir

We have identified several floor levels in the interior of the church building, the latest one of the nave and side aisles, paved with carved stone slabs. The floor of the same period in the sanctuary was made of bricks laid oblique to the building's main axis. We also have identified a previous floor in the choir and the southern side aisle, about 30 cm below the first one (Fig. 10). The older floor was also paved with bricks but in a different pattern: they were arranged with their long sides parallel with the main axis of the building. Several features discovered in the layers between the two floors indicate that the older floor was renewed several times. Furthermore, the in-between layers contained a significant number of artefacts with everyday tools (e.g., a thimble) and coins. The oldest coins were minted during King Louis I (TÓTH 2020, no. 2.32.1.1 and 2.46.1.1), while the youngest one was issued at the time of King Mathias Corvinus (HUSZÁR 1979, no. 718–719).⁵
