## ANALYSIS OF CONSEQUENCES OF A DESIGN BASIS EARTHQUAKE FOR THE REGION AROUND A NUCLEAR POWER PLANT

**Abstract:** In the paper a study is presented for the case if a  $10^{-4}/a$  annual probability design basis earthquake would hit area surrounding the Nuclear Power Plant Paks. Although the plant can be brought to safe shutdown condition and there is no need for off-site protective measures, the plant personnel will need a minimum of logistical support from and communication with the outside area. Therefore, the knowledge of the post-earthquake situation is required for planning of the logistical support of the plant accident management and for the understanding the working conditions for disaster management services. Parameters of the case-study earthquake are selected in accordance with the design basis of the plant. Distribution of population and housing data used in this study has been obtained by population census held in 2011. The study can also help to communicate the seismic safety of the plant showing the disastrous consequences of design basis earthquake while the plant remains safe.

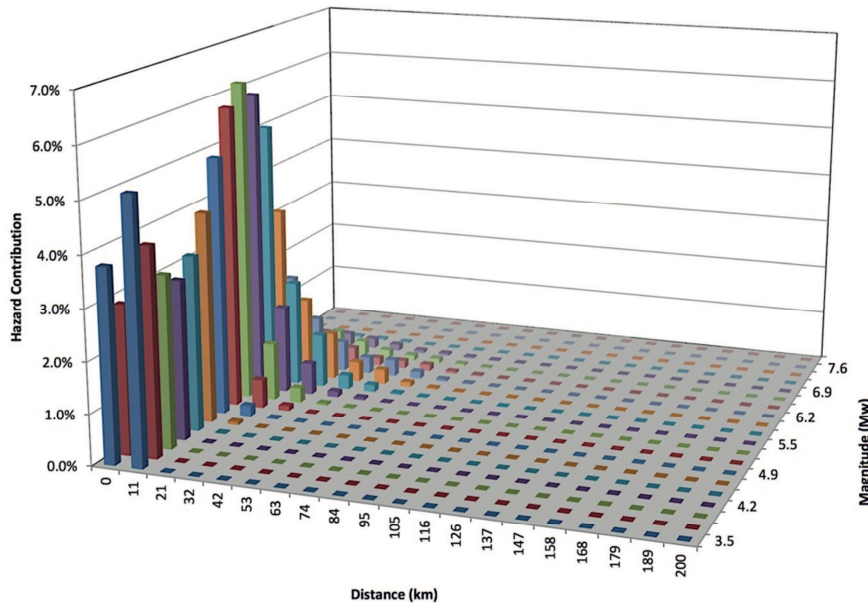
*Fig. 1.* Magnitude-distance deaggregation for  $10^{-4}/a$  level peak ground acceleration

Probabilistic Seismic Hazard Assessment (PSHA) performed for the Paks NPP site provides the hazard curves for probability levels up to  $10^{-7}$  annual probabilities of exceedance, as well as the Uniform Hazard Response Spectra for the base-rock. Deaggregation of the hazard has been performed for  $10^{-4}/a$  (see *Fig. 1*).

According to this, an earthquake of moment magnitude 5.8-6.0 at an epicentral distance of  $\sim 10$  km from the plant site is dominating in the hazard. The free-field ground motion has been obtained by non-linear site response analysis. The design basis Peak Ground Acceleration (PGA) is equal to 0.25 g. For comparison, a PGA of 0.09 g had to be accounted for the Paks site, if the EUROCODE 8 would be applied for a very important structure with 50 years' service life.
