# Geometric Construction in Church Architecture in the Late Gothic Era: The Reformed Church of Nyírbátor

In our study we analyse the Reformed Church of Nyírbátor, a great example of late Medieval church architecture in Hungary. We investigate the potential construction systems used in this building and compare them to each other, highlighting their similarities and differences. Additionally, we offer plausible explanations for the irregularities. The objective of this research is to ascertain the extent to which geometric structures were employed in the Gothic period and the manner in which they manifested within a building.

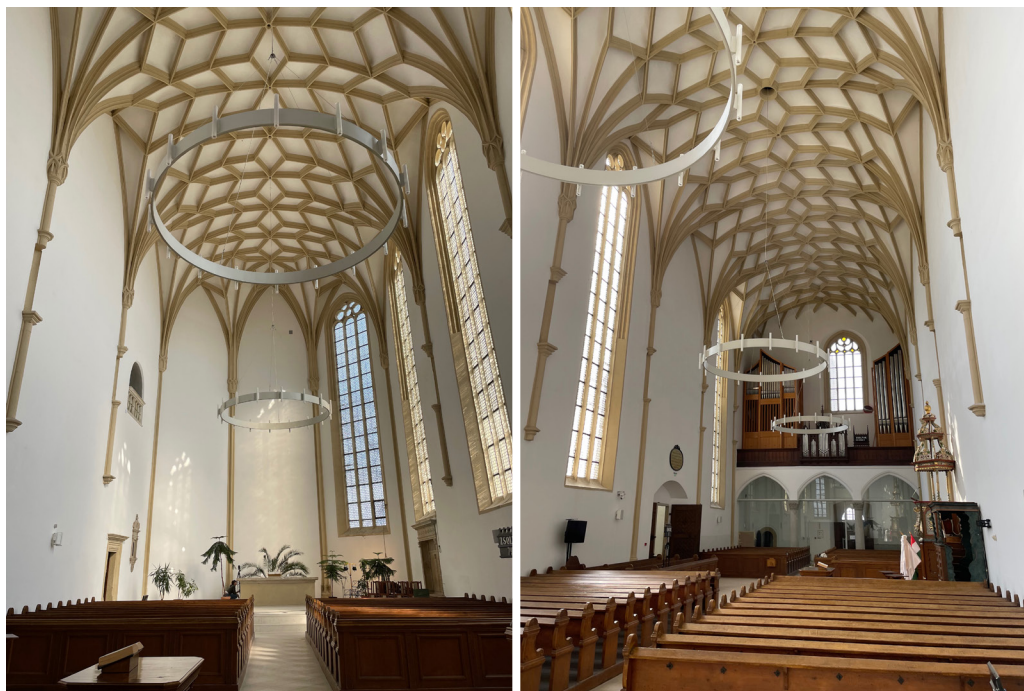
Figure 1. Interior photos of the Reformed Church of Nyírbátor

The Reformed Church of Nyírbátor was originally dedicated to Saint George. It is an aisle-less type church, consisting of a single nave, and the choir is not separated from the nave by a triumphal arch (*Fig. 1*). A tower connects to this space from the west, a sacristy from the north, and a small entrance hall built in the 18<sup>th</sup> century<sup>1</sup> on the south. On the western side of the nave is a small gallery built at the same time as most of the church. The east end of the church is the choir with an octagonal apse. The space is lit by large Gothic windows with detailed tracery. The space is covered by a ribbed net vault. In the interior the vault is supported by narrow demi-columns along the southern and northern wall, following a seemingly regular distribution in accordance with the pattern of the vault ribs. The two easternmost pairs of demi-columns are not running all the way down to the ground but are supported by corbels at around half of the height,<sup>2</sup> which was probably due to the position of the stalls.<sup>3</sup> On the outside, the longitudinal walls are also
