Electrochemical Migration of ENIG surface finish in Na_2SO_4 Environment

Bálint Medgyes, Péter Szabó, Sándor Ádám, Lajos Tar, Miklós Ruzinkó and Richárd Berényi

Department of Electronics Technology,
Budapest University of Technology and Economics
Budapest, Hungary
medgyes@ett.bme.hu

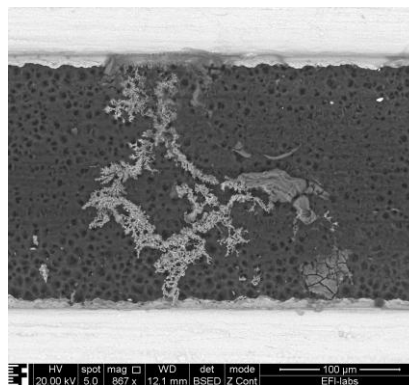
Fig.1. Metallic dendrites formed a short.

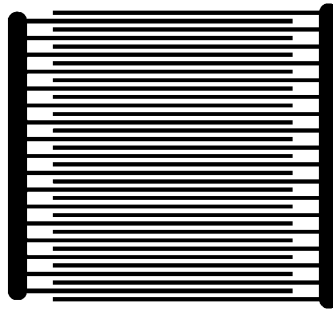
Bare copper layer was covered with electroless nickel and immersion gold surface finish on fiberglass-epoxy resin (FR4) substrate. The gap size between the conductor stripes on the test board was 0.2 mm, while the width of the conductor stripes was 0.4 mm (See the structure of the test pattern in Fig. 2).

Fig. 2. Comb structure of the ENIG test pattern.

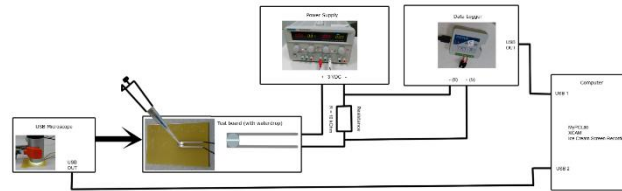
The measuring set up follows the various ECM processes by visually (in-situ) using an USB-microscope and also by a voltage measurement applying a Novus MyPcLab data logger. The real-time voltage measurement indicates the short circuit formation mechanism (e.g. dendrite growth) and help to understand the optical results as well (See Fig. 3).

Fig. 3. Arrangement of the test set up for ECM inspection.

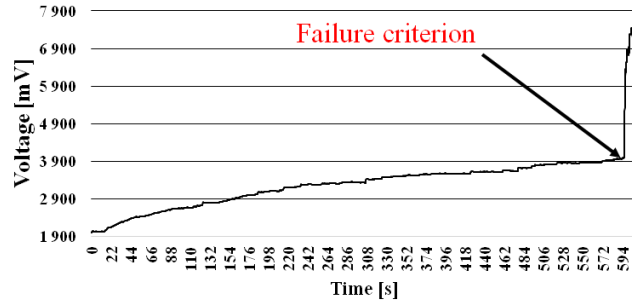
In each WD test a volume of 10 μl droplet was placed onto and between the ENIG conductor lines. During the droplet placement it was always tried covering the same active area. Every WD tests were done at least ten times from the reproducibility point of view. Normal distribution was supposed while Mean-Time-To-Failure (MTTF) and deviations (1 σ) were originated from the electrical measurements. the first significant voltage jump was the main indicator for the failure events caused by ECM (See Fig. 4).

Fig. 4. Example for the failure criterion during WD test.

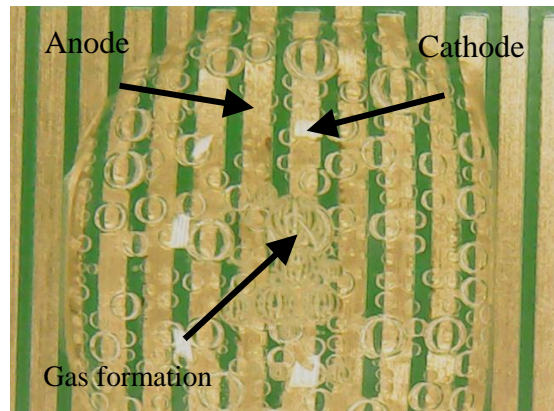
In Figure 5, a typical picture from WD test under biased can be seen. In all cases many (H_2) gas bubbles were observed originated from the cathode side.

Fig. 5. ENIG surface finish under WD test.

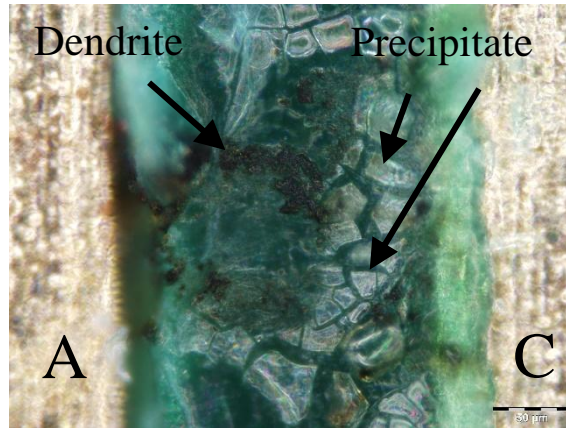
During the real-time electrical measurements the base value was 5.5 VDC and all of the samples were failed due to ECM. The calculated MTTF value was around 1400 sec. This value was 25 times higher comparing to non-solder mask (pure FR4) case. According to the optical microscopy investigations blue-green colored precipitates were detected next to dark dendrites (Fig. 6).

Fig. 6. Dendrites and green-blue colored precipitates were formed during the WD test.

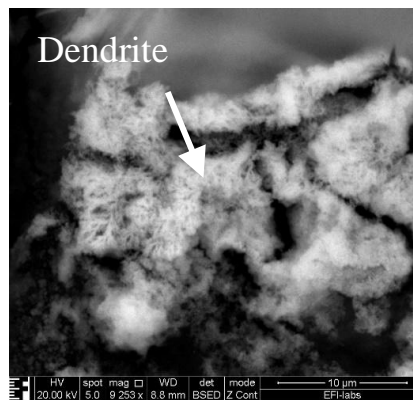
Fig. 7. SEM image of a dendrite and the spot were the data collected during EDX measurement in case of 0.1 mM.

According to the SEM investigations, the dendrites were grown in fibrous form in case of 0.1 mM and Cu was dominated during the ECM processes (Table 1).

Table 1. EDX results from the dendrite (Fig. 7) and precipitate (Fig. 8) in case of 0.1mM Na₂SO₄ after WD test.

O	P	S	Ni	Cu	Au
Pre.	at%	54	1.5	1	9.5	34	-
	wt%	24	1	1	15	59	-
Dend-rite	at%	2.5	-	-	3.5	94	-
	wt%	0.6	-	-	3.4	96	-

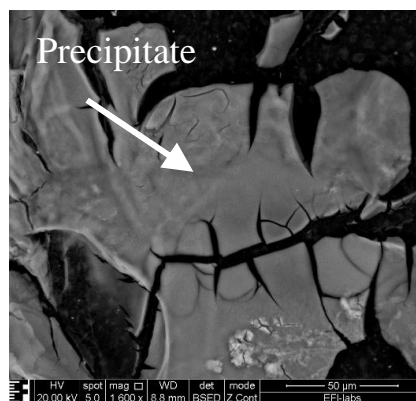
Fig. 8. SEM image of a precipitate and the spot were the data collected during EDX measurement in case of 0.1 mM.

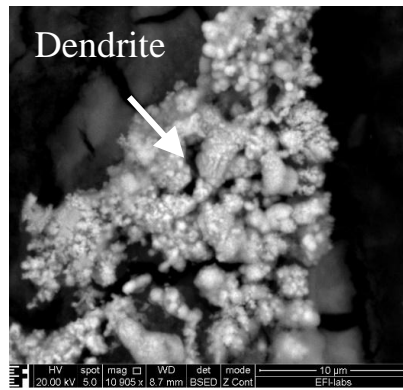
An intensive gas evolution was also observed during WD test and base voltage value was increased up to 6.3 VDC. Meanwhile, the calculated MTTF value was significantly decreased down to around 90 sec. The shape of the dendrite was changed into ball-like or tuberous-like types, while the green-blue precipitates were similar to the 0.1mM case.

Fig. 9. SEM image of a dendrite and the spot were the data collected during EDX measurement in case of 1 mM.

Table 2. EDX results from the dendrite (Fig 9) and precipitate (Fig 10) in case of 1mM Na₂SO₄ after WD test.

O	P	S	Ni	Cu	Au
Pre.	at%	33	1.3	0.70	13	52	-
	wt%	11	1	0.5	16	71.5	-
Dend-rite	at%	12	1	-	1	86	-
	wt%	3.5	0.5	-	1	95	-

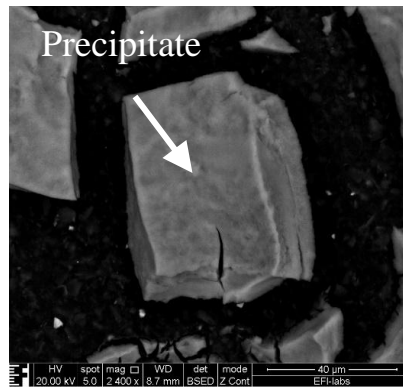
Fig. 10. SEM image of a precipitate and the spot were the data collected during EDX measurement in case of 1 mM.

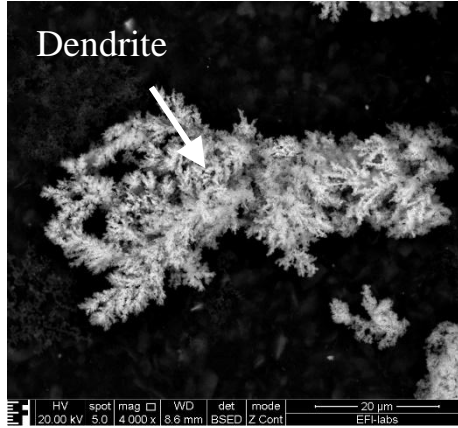
In this case, also many gas bubbles were observed during WD test and base voltage value was increased up to 6.6 VDC. Meanwhile, the calculated MTTF value was around 92 sec, so it was not changed significantly. The shape of the dendrite was changed into fibrous types (See Fig. 11), which was very similar to the 0.1 mM case, while the green-blue precipitates remained (Fig. 12).

Fig. 11. SEM image of a dendrite and the spot were the data collected during EDX measurement in case of 10 mM.

Table 3. EDX results from the dendrite (Fig 11) and precipitate (Fig 12) in case of 10 mM Na_2SO_4 after WD test.

O	P	S	Ni	Cu	Au
Pre.	at%	73	1.5	1.5	19	5	-
	wt%	45	2.5	1.5	35	15	-
Dend-rite	at%	20	-	-	1	79	-
	wt%	6	-	-	1	93	-

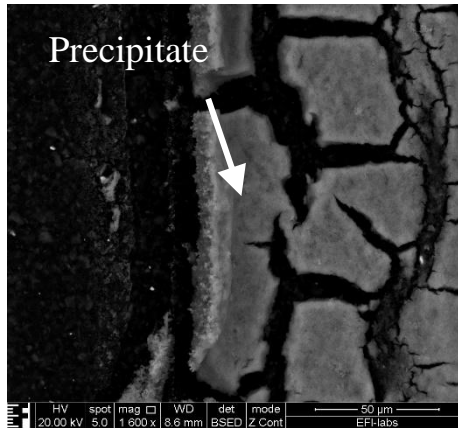
Fig. 12. SEM image of a precipitate and the spot were the data collected during EDX measurement in case of 10 mM.

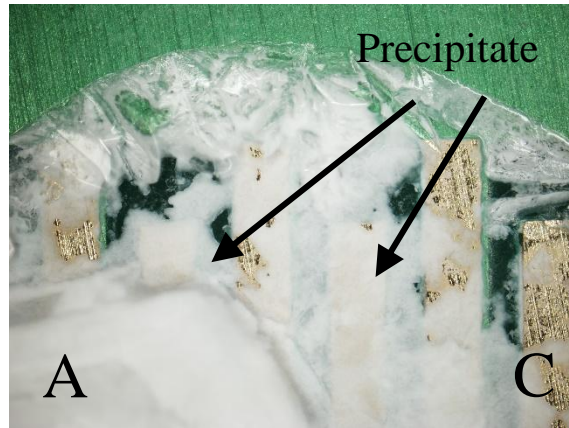
In this case, also many gas bubbles were observed during WD test and base voltage value was increased up to 6.7 VDC. Meanwhile, the calculated MTTF value was around 92 sec, so it was not changed significantly. The shape of the dendrites was not seen due to the thick salt a precipitate layers and the color of the precipitate was change into white one (Fig. 13).

Fig. 13. White colored salt and precipitate after WD test in case 500 mM Na_2SO_4

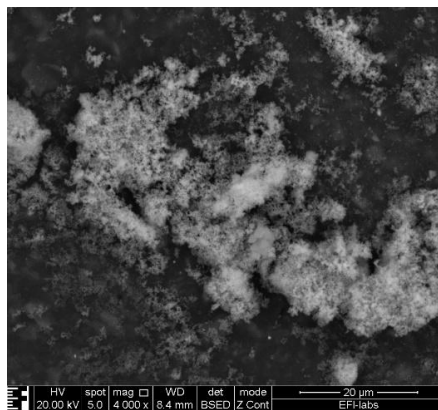
After removing the thick salt layer from the surface (See Fig. 14), SEM-EDX investigations were repeated. Based on the EDX results a relative high Ni content (16 at% and 38 wt%) was detected, meanwhile the Cu content was significantly lower (1 at% and 3 wt%).

Fig. 14. SEM image from the surface after WD test and removal of the salt layer in case of saturated solution.

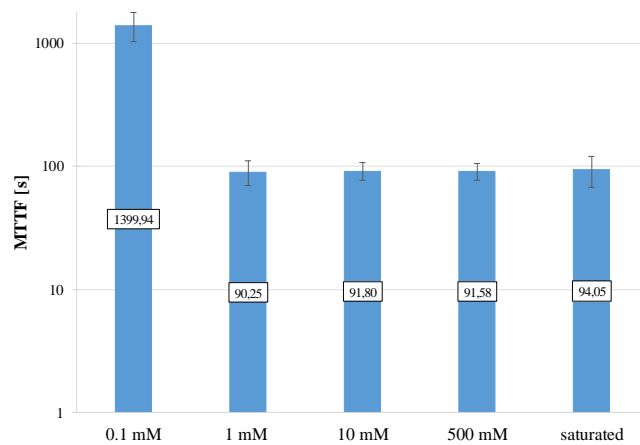
Fig. 15. Comparison of the MTTF values over Na_2SO_4 concentrations in case of ENIG surface finish.

The ECM behavior of ENIG surface finish was studied using Na_2SO_4 solutions with various concentrations. Based on the MTTF data it was shown that ECM susceptibility was decreased at 0.1 mM Na_2SO_4 solution, then on higher concentrations ECM ability significantly increased and stabilized over the concentrations (10mM, 500mM and saturated solutions).
