ELEK BENKŐ

## THE MEDIEVAL WATER SUPPLY SYSTEM OF PILIS ABBEY

**Keywords:** Cistercian monastery, aqueduct, artificial lake, mill, medieval period

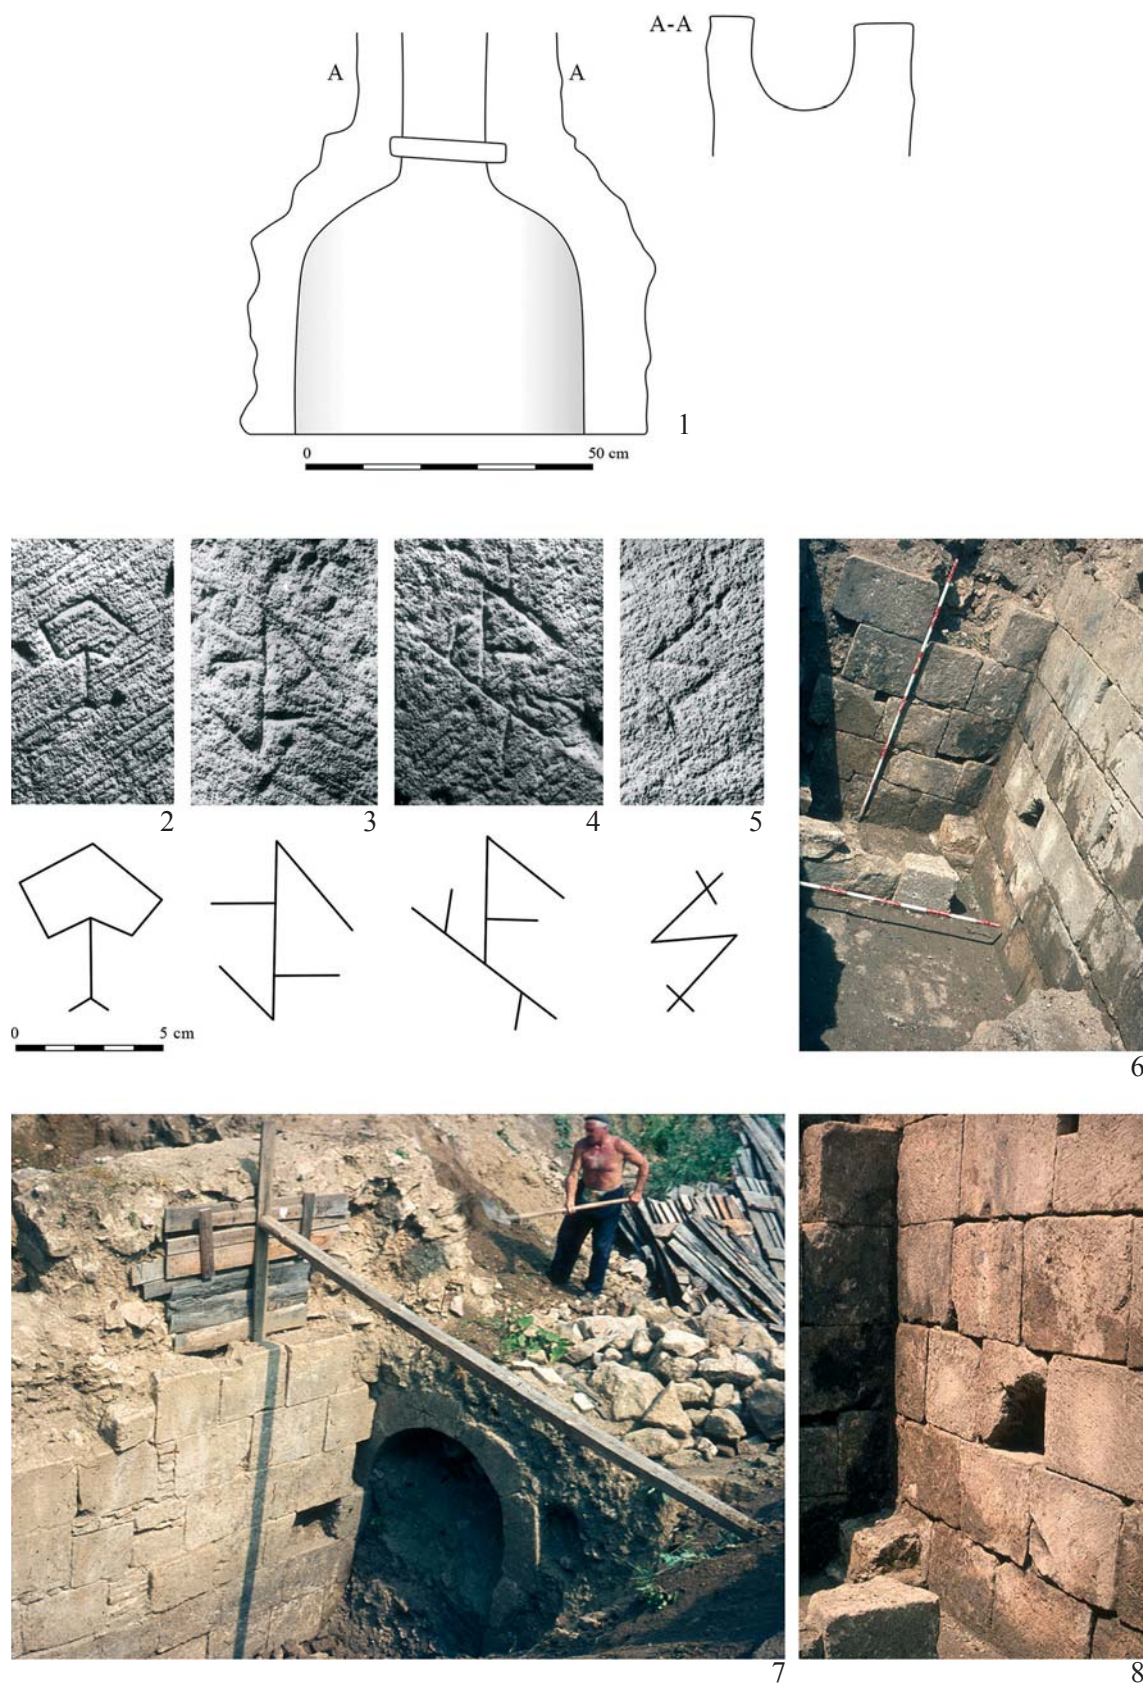
Fig. 3. 1. Pilisszentkereszt-Klastromkert, the stone conduit transporting water from the artificial lake onto the mill wheel terminating in a funnel with a notch made for the latch (Drawing: Zsóka Varga after sketches made by Endre Egyed); 2–5. Masons' marks on the ashlars of the mill race (Photographs: Lajos Sugár); 6–8. The excavation of the mill race and walled channel (Photographs: Lajos Sugár)

It should be mentioned that a remarkably large number of ashlar with masons' marks were built in the masonry of the wheel trench (*fig. 3. 2–5*). These masons' marks differ from the early mason's marks of the Pilis abbey dated to the beginning of the 13th century. Imre Holl found their analogues on stone carvings dated the second half of the 14th century.<sup>12</sup> Fragments of brick and roof tiles were observed between the stones of the sidewalls at some places.

The deep ditch of the water wheel is closed in the east by an arched, gate-like opening (height: 2.2 m, *fig. 2. 1–2*, *fig. 3. 7*), after which the trench continued into a vaulted stone channel that was about 62 cm in width and 60–62 cm in height (*fig. 4. 4*). A short section of this large structure was discovered on the south-eastern side of the monastery as early as 1968 and was referred to as the “main sewer”. Its continuation was not found at that time. “The base is made of smooth rectangular stones and its semi-circular vault is built of bricks.” The drawings made during the excavation confirm that the bottom of the channel was made of large flat pieces of stone, but the other parts of the vault appear to have been constructed of stone slabs rather than bricks. The exact track of the channel was not identified during the excavations by Gerevich. It was detected by the extensive geophysical measurements of 2003–2004.<sup>13</sup> These measurements clearly showed that the channel ran straight from the trench of the mill wheel to the north. Then, it changed its direction to the north-east at the level of the former refectory and ran towards the monastic latrine. This corresponded to the general practice of medieval Cistercian monasteries. According to this, a longitudinal, walled channel was constructed under the seats of the large toilet block upstairs, behind the dormitory. A watercourse, usually a stream, was led through this, which continuously removed the contents of the latrine. An excellent example of this is the 13th-century latrine block of the Cistercian abbey of Royaumont (Île-de-France), with a 32 m long and 2.35 m wide walled stone channel, as well as 31 openings in the vault connected to the upstairs lavatories (*fig. 4. 1*).<sup>14</sup> A similar facility survived in the Cistercian monastery in Zwettl, Austria (*fig. 4. 2–3*). The foundation walls of the Pilis latrine were excavated at the end of excavations supervised by Gerevich. Apart from a ground plan showing the periodisation – that is, the construction order – of the walls, little documentation is left of it. However, it still reveals that the large common latrine of the dormitory and the infirmary built on its eastern side followed the usual tradition of Cistercian monasteries: its superstructure rested on long, parallel walls and the water coming from the artificial lake could wash through the bottom of the latrine covered with stone slabs between the walls. Leaving the latrine, the water could run towards the Dera stream meandering below the abbey (*fig. 4. 4*). The length of the Pilis latrine was 24 m.

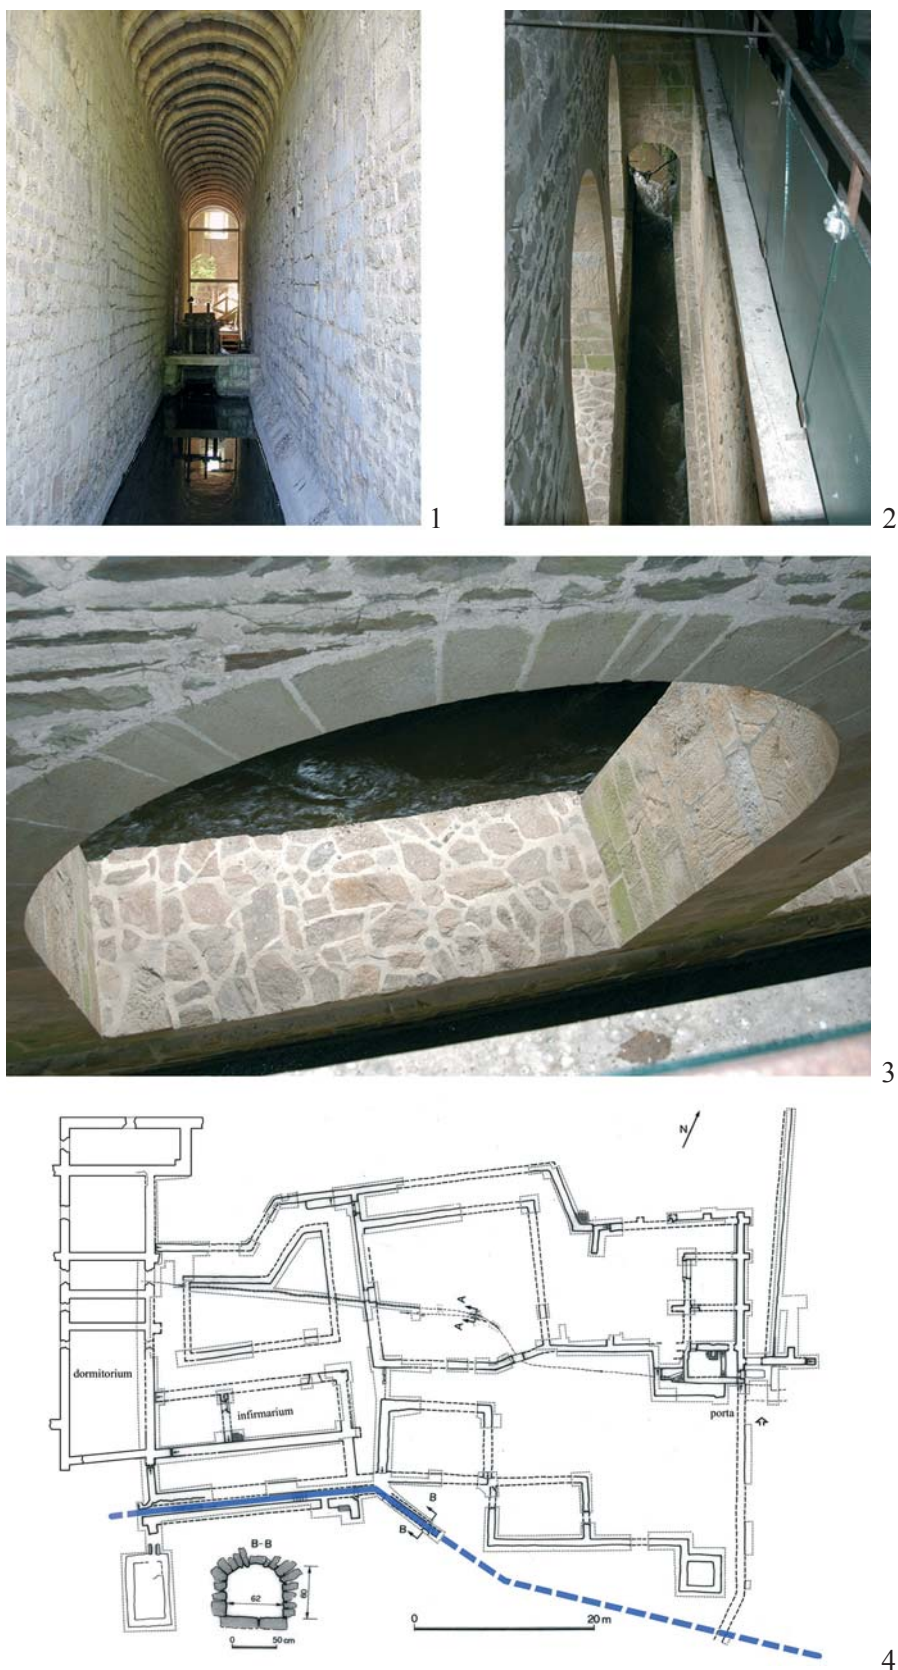
Fig. 4. 1. Royaumont, the latrine of the 13th-century Cistercian abbey (after *Renaud 1999*);  
 2–3. Zwettl, the reconstructed shaft of the latrine in the Cistercian monastery (Photographs: Elek Benkő);  
 4. Pilisszentkereszt-Klastromkert, the upstairs dormitory, the infirmary, and the eastern wing of the building with the latrine and the water conduits in the Cistercian monastery (Drawing: Endre Egyed)

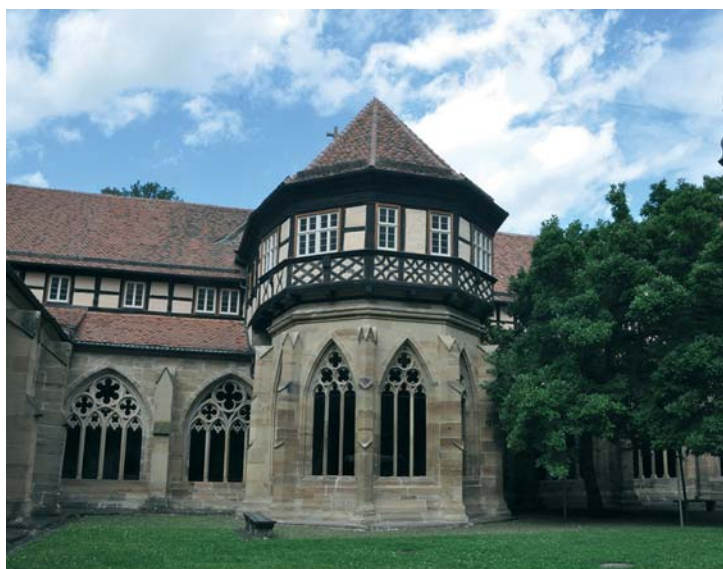
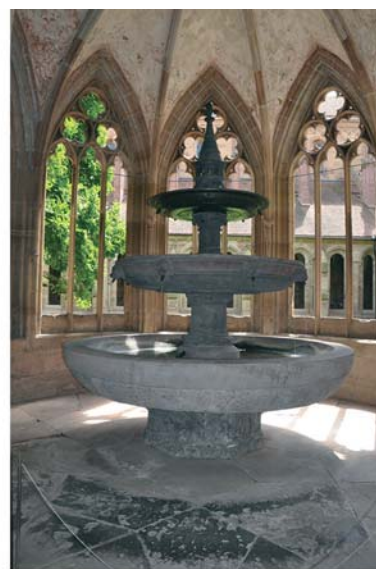
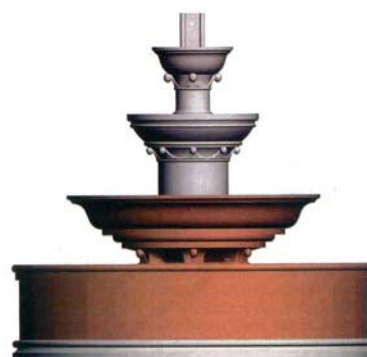
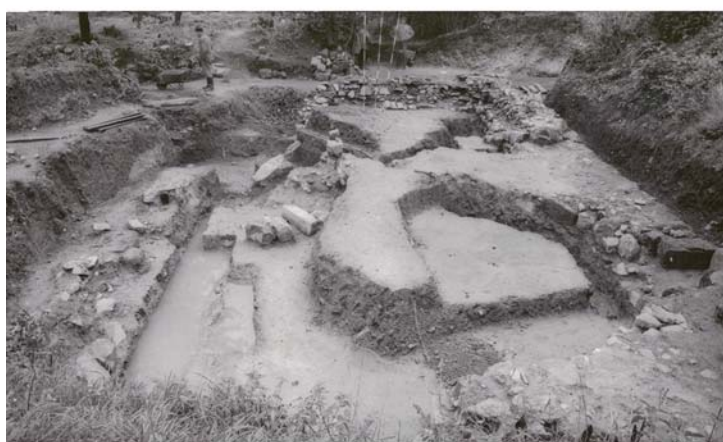
Fig. 7. 1–2. Maulbronn, Cistercian monastery, fountain house and *lavabo* (Photographs: Elek Benkő); 3. The reconstruction of the fountain in Pilis Abbey (after Takács 1992); 4. The heavily damaged remains of the fountain house at the time of the excavations led by László Gerevich (Photograph: Tibor Kádás); 5. A modified reconstruction of the fountain (after Takács 2007)

The lavabo with a composite structure stood in a stone basin 3.2–3.3 m in diameter, the base of which was assembled from white hard limestone elements. The remaining carvings reveal that the bottom of the basin was made sloping so that the water pouring in it from above would enter the drain found in the middle of the fountain (*fig. 6. 10, fig. 7. 3*). The curved side panels of the basin carved from red marble were fixed to this pedestal with pegs. These side panels surrounded the 55 cm high cylindrical basin (*fig. 6. 9, fig. 7. 3, 5*). In the middle of the basin, there was a thick marble column, supplemented by six additional pillars placed radially, crowned by a flat red marble capital decorated with leaves (*fig. 6. 11*). This held a large red marble fountain dish (diameter: approx. 2.5 m, *fig. 6. 7*), from which water flowed into the lower basin and then down the drain. In the centre of the large red marble dish, a large cylindrical column was placed, which was bored through vertically (diameter: 7.5 cm). This column had a base and presumably a capital too, on which a smaller dish was placed. The dish was made of limestone and had openings for spouts placed under the rim (*fig. 6. 8*). A slender pinnacle was attached to the upper basin, and it had a vertical borehole of the same size as that of the column mentioned above (*fig. 6. 6*). From this pinnacle, water flowed through narrower holes in four directions. According to this reconstruction, the height of the fountain was above 2.65 m (*fig. 7. 3*).<sup>24</sup> Subsequently, Imre Takács made some modifications. He added one more small-sized dish at the top of the fountain. The base of the lavabo is made of white limestone. The side panels of the basin, the central pillar, and the lower, large fountain dish were carved from red marble, while the two dishes above it together with their columns, as well as the pinnacle crowning the structure were made of white limestone (*fig. 7. 5*).<sup>25</sup>
