## BUDAPEST, I. KERÜLET, TÁNCICS MIHÁLY UTCA 9. (HRSZ. 6546)

## BUDAPEST, DISTRICT I, 9 TÁNCICS MIHÁLY STREET (PLOT NO. 6546)

*Site ID: 52327*

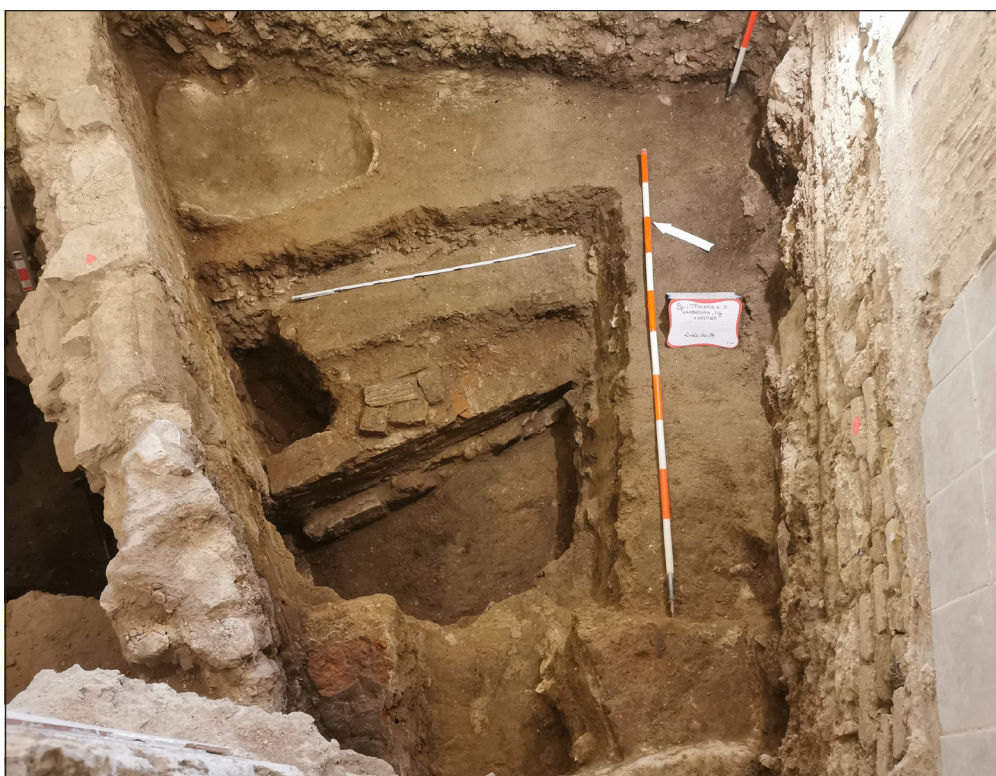
3. kép: A feltárás teljes területe a bontás végén (Fotó: Magyar Eszter)  
Fig. 3. The excavation area at the end of the dig (Photo by Eszter Magyar)

kora újkori leletanyaggal. Tovább bontva laza, barna, erősen kő- és téglatörmelékes réteg került elő, amely alatt néhány cm vastag, sárga, agyagos, keményre taposott járószintet figyeltünk meg. Ez a járószint akkor keletkezhetett, amikor a korábban idehordott omladék egy üreget képzett a területen, ezt fedte le. Az üreg teteje beszakadt, benne megtaláltuk a korábban leírt laza omladékréteget, valamint északi oldalán egy nagyjából K-Ny-i irányú, kőalapozású, téglából épített falat, amelynek déli oldala vakolva volt. Ezt hozzáépítették a 2016-ban megtalált É-D-i irányú falhoz. Erre a falra ráfedett egy második téglapadló részlete. Az üregből kibontottuk a laza, omladékos réteget, és alatta egy tömör, kevert, kötörmelékes réteg volt. Ezen a szinten megálltunk, mivel a tervásatás célját teljesítettük. (3. kép)

so excavation continued only in the central part. After removing the brick floor, a yellowish-reddish clay layer with Early Modern artifacts appeared. Further excavation revealed a loose, brown, heavily stone- and brick-filled debris layer. Beneath this was a few centimeters thick, yellow, clayey, hard-packed floor level. This floor likely formed when previously dumped rubble created a cavity in the area, which was later covered. The ceiling of this cavity collapsed, and we found the previously described loose debris layer inside, as well as a roughly east–west oriented stone-based brick wall on the northern side, with its southern side plastered. This wall had been attached to the north–south wall found in 2016. A second brick floor segment was partially covering this wall. The loose, collapsed debris layer from the cavity was removed, revealing a compact, mixed, stone debris layer below. Excavation stopped at this level, as the goal of the planned excavation had been met (Fig. 3).

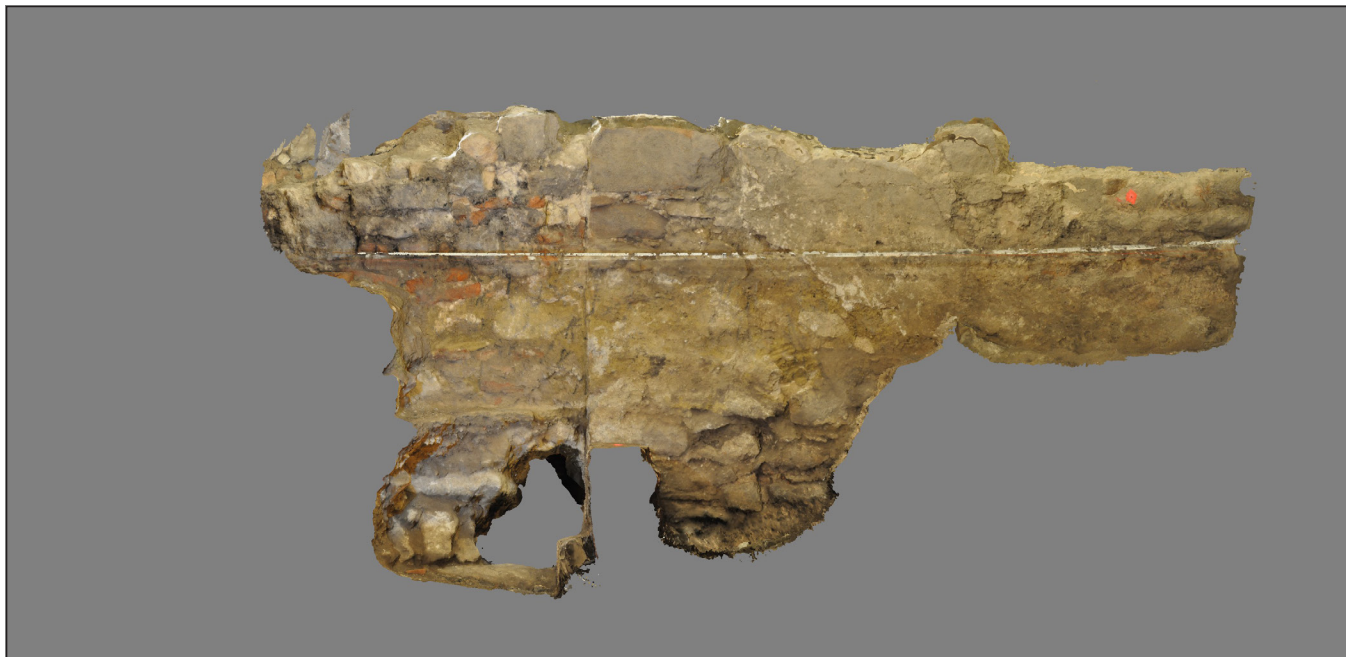
4. kép: Részben középkori eredetű fal a terület ÉNY-i szélén (Készítette: Viemann Zsolt)  
Fig. 4. Partially medieval-origin wall at the NW edge of the site (Prepared by Zsolt Viemann)

A déli részen elbontottuk a metszetfal egy részét, és kiderült, hogy ott egy K-Ny-i irányú fal van, ami szintben jól illeszkedett a felső téglapadlóhoz. A fal mindkét irányba befut a kaszárnyaépület alapozása alá, így nem megállapítható, hogy a 2016-os É-D-i irányú fallal milyen kapcsolatban áll. (4. kép)

In the southern section, we dismantled part of the profile wall and discovered an east–west oriented wall that aligned well with the upper brick floor. This wall extends in both directions under the foundations of the barracks building, making it impossible to determine its relationship with the north–south wall found in 2016 (Fig. 4).
